# OFFICERS CLUB Building No. 114

Sandy Hook Unit  
Gateway National Recreation Area  
Fort Hancock, New Jersey

Historic Structure Report

June 2006

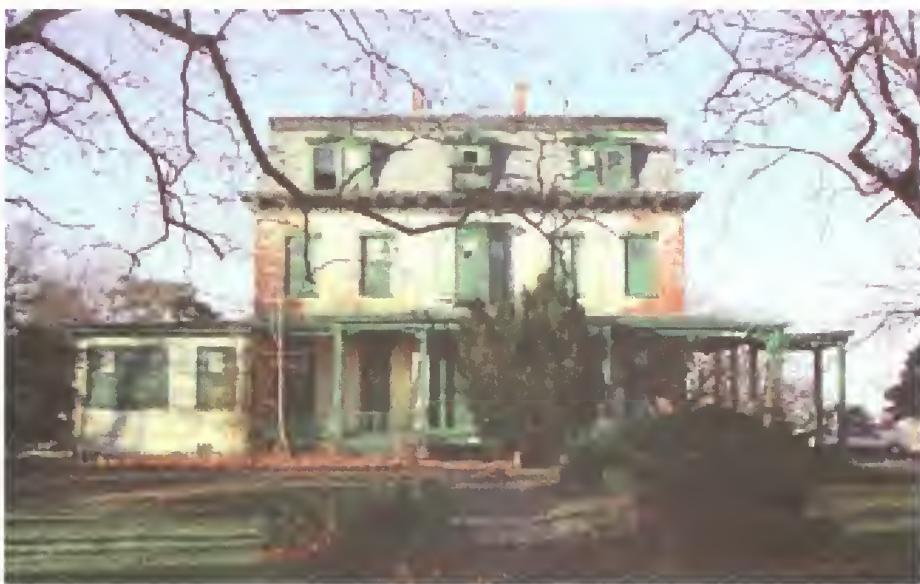
Figure 82. Officers Club, east facade, 2004.

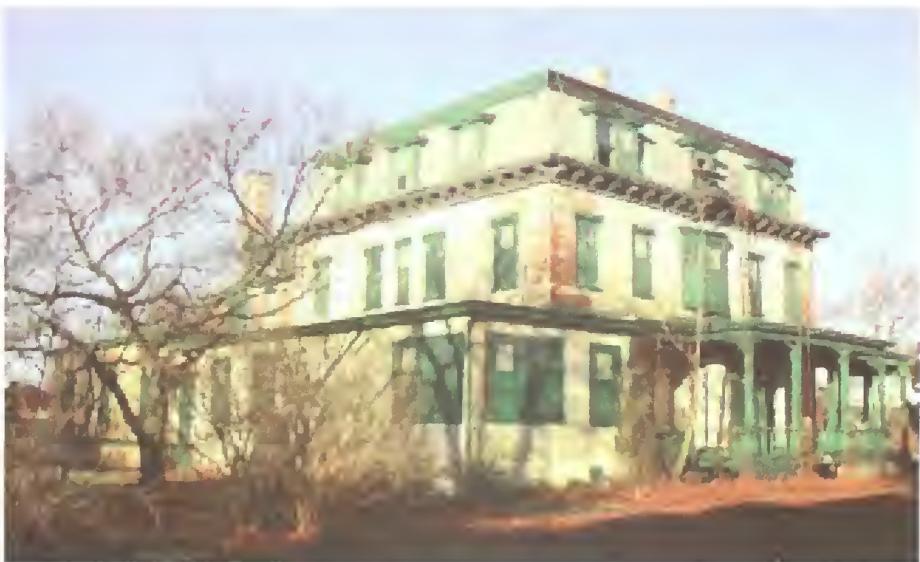
Figure 83. Officers Club, east façade and south elevation, 2004.

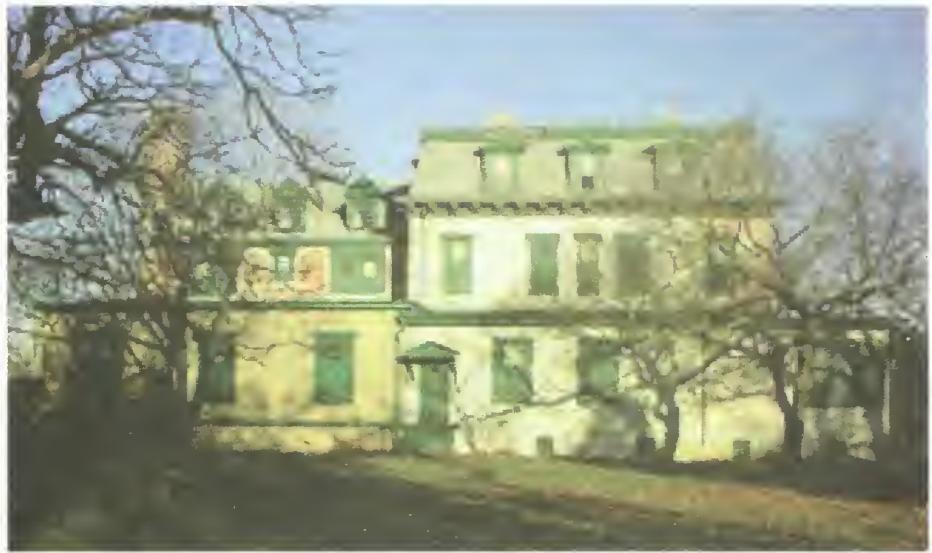
Figure 84. Officers Club, south elevation, 2004.

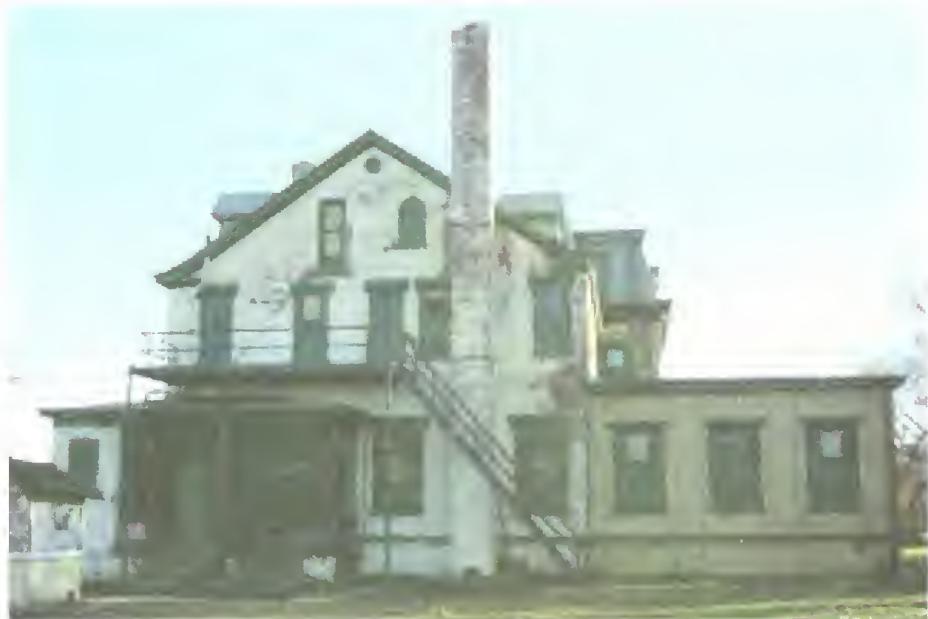
Figure 85. Officers Club, west elevation, 2004.

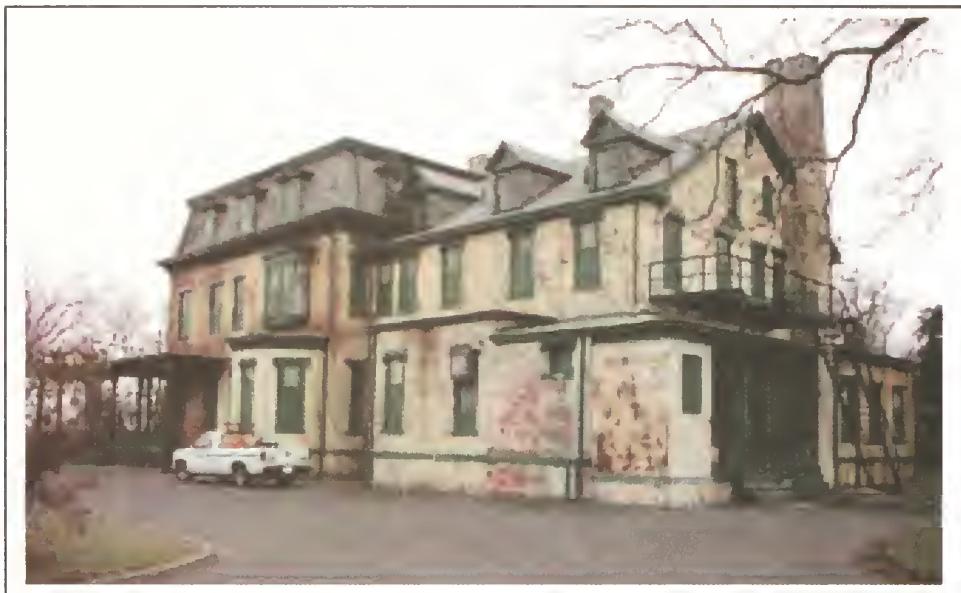
Figure 86. Officers Club, north and west elevations, 2004.

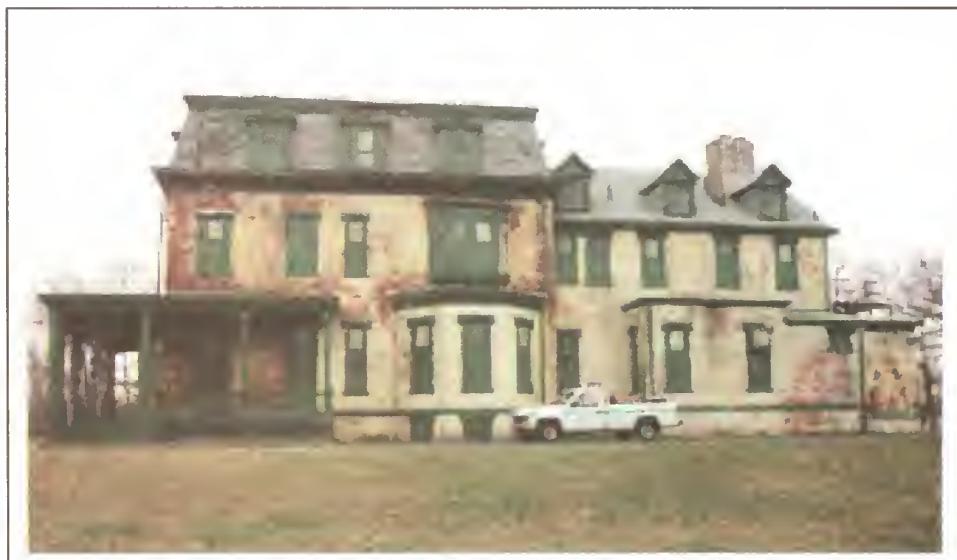
Figure 87. Officers Club, north elevation, 2004.
