## Historic Structure Report

The Mumma Barn

# ANTIETAM

April 2000

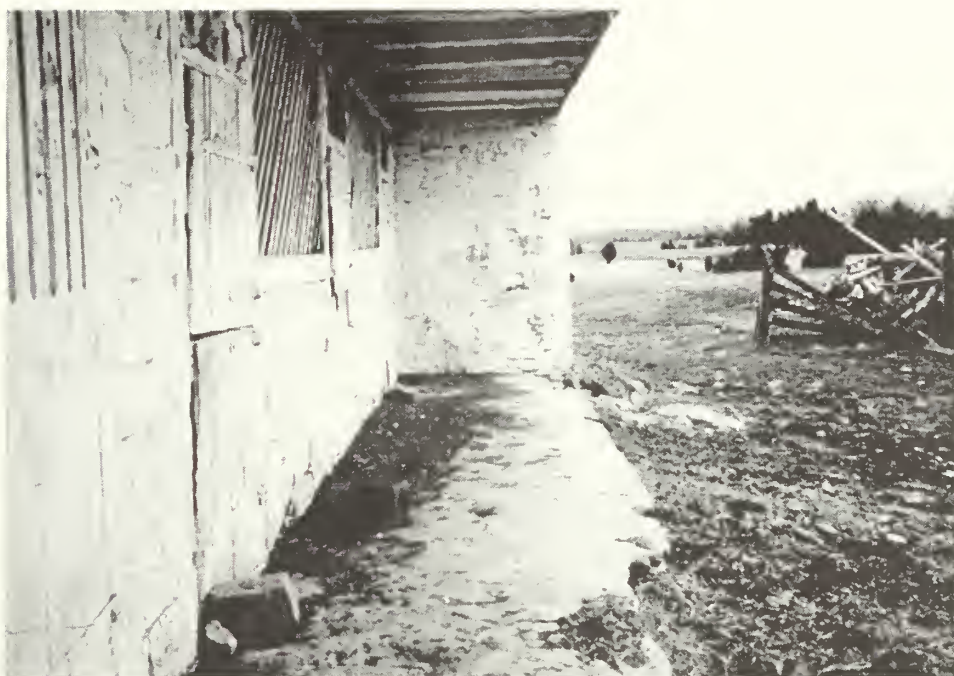
Another irregular feature of the Mumma Barn is the way the forebay is supported on either end. On the east corner, it is closed by an extension of the stone foundation wall (Fig. 38), and on the south corner, it is supported by a timber post (Fig. 39).<sup>45</sup> Although this variant does not appear in Fig. 32, Ensminger does discuss in his book the existence of a "Half-Open-Forebay Standard Barn", which would describe the Mumma Barn well.<sup>46</sup>

Figure 38: Closed-forebay end at eastern corner of barn

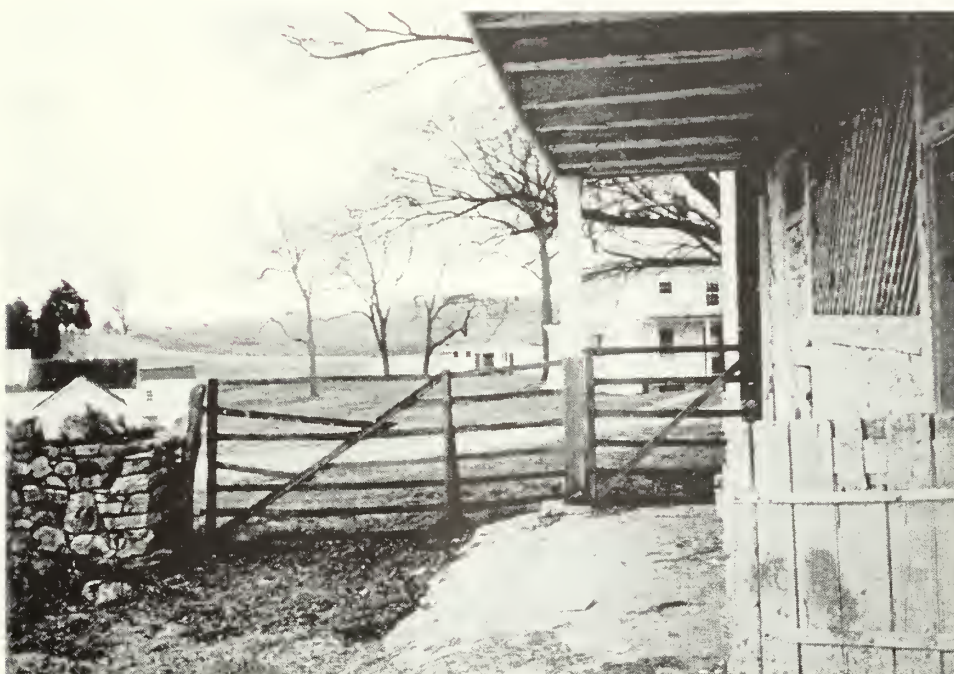
Figure 39: Posted-forebay end at southern corner of barn.

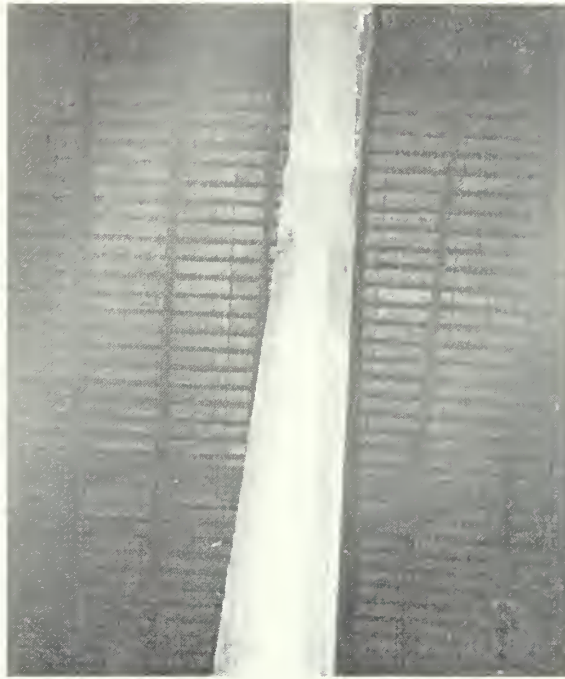
Figure 85: Rotted sill at threshold of winnowing door.

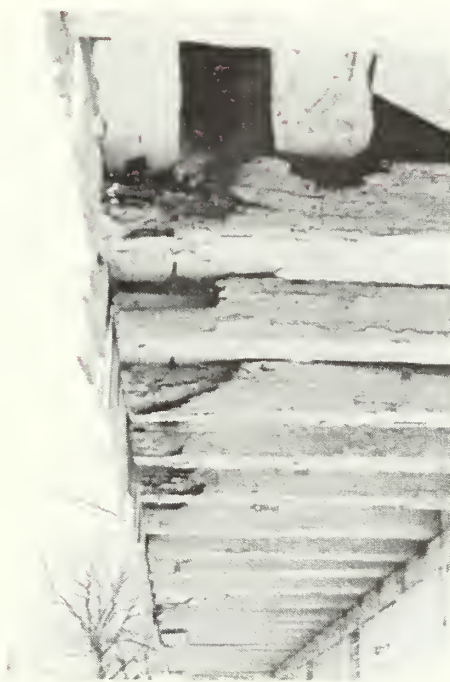
As mentioned above, several of the mortise and tenon connections on the bents are beginning to fail, especially on the southeast side of the barn. The southeast posts of the bents bear directly onto the ends of the floor joists. These joist ends are quite damaged and can no longer properly support the framing (see next section). At one of the central bents, failure has occurred where the rafters, wall plate, and tie beam intersect (Fig. 88). With proper repairs, these failures can be corrected to preserve the character-defining features and structural integrity of the barn.

Figure 88: Rotting at tie beam connection to post (forebay side of interior).

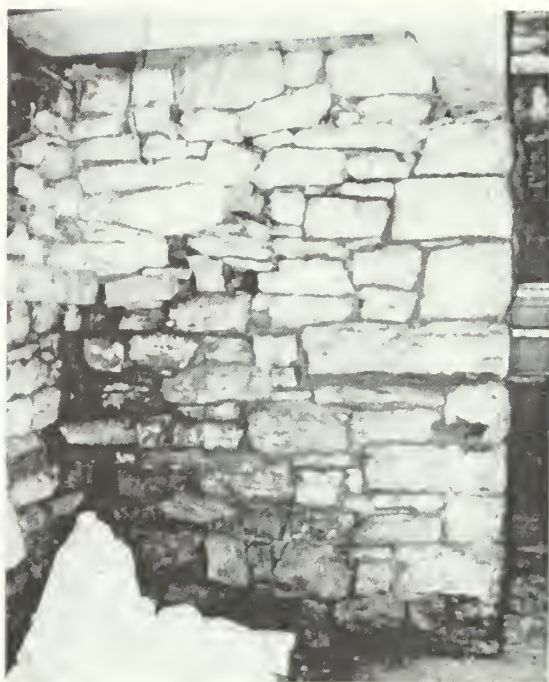
The stone typically used for these foundations is the rubble that dots the local fields. It has a high lime content (as does the mortar used to build with the stone) and when exposed to heat, it cracks and fractures and loses its structural integrity. A perfect example of this can be seen at the ruins of the Sherrick Barn. As the photographs indicate (Figs. 113-114), if the barn was to be rebuilt,<sup>65</sup> the damaged foundation, which was stabilized for safety and for interpretative purposes, would have to be replaced or significantly rehabilitated. Additionally, the stone, when exposed to extreme temperatures, often turns reddish in color (Fig. 115). The stone at the Mumma Barn shows none of this characteristic damage. There is an occasional stone that is pinkish in color as some of the original stones may have been reused, but it is generally in very good condition (Fig. 116). The same argument could be made when examining the basement of the Mumma Farmhouse. The stone there is also in good condition and was therefore, was replaced after the house was rebuilt.

Figure 116: Fieldstone foundation of the Mumma Barn. Note that the stone is generally sound and in far better condition than the Sherrick Barn foundation.

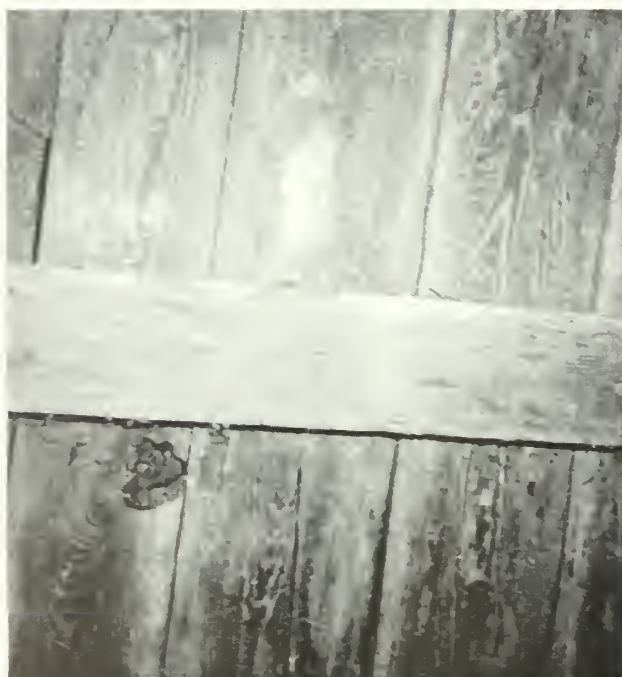
Figure 131: Insect damage at interior siding of north granary.

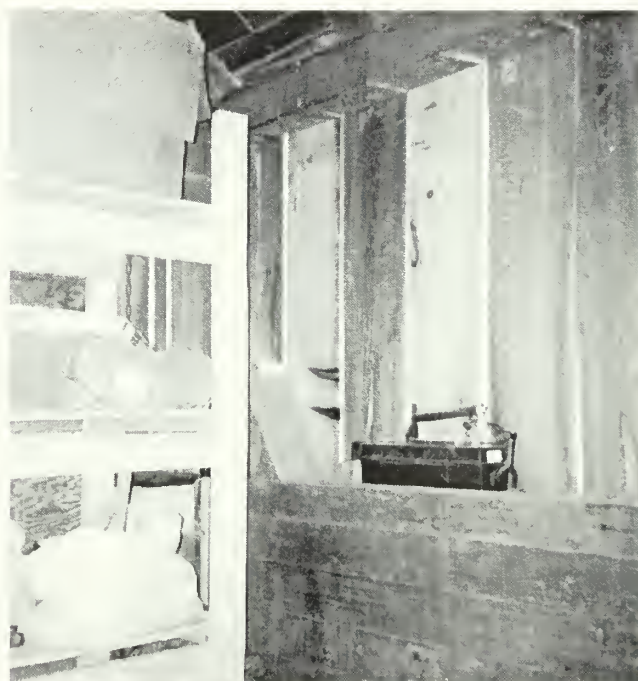
Figure 135: New siding at the west granary.

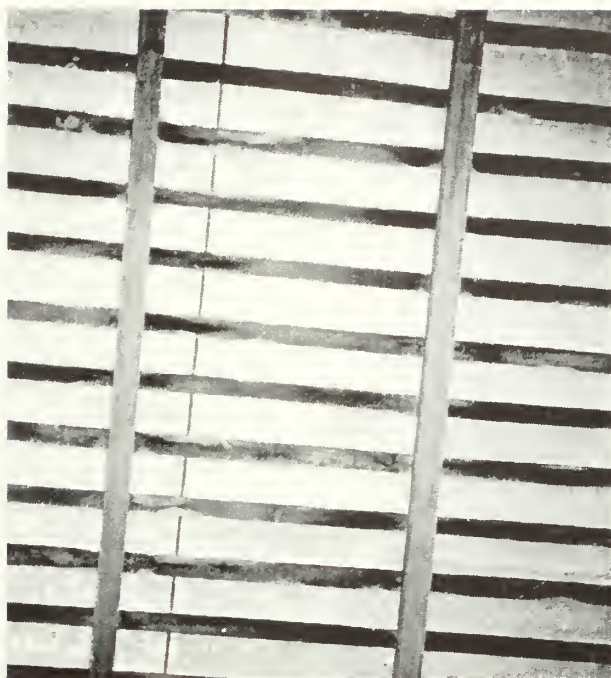
Figure 136: Interior of the west granary showing new siding in place.

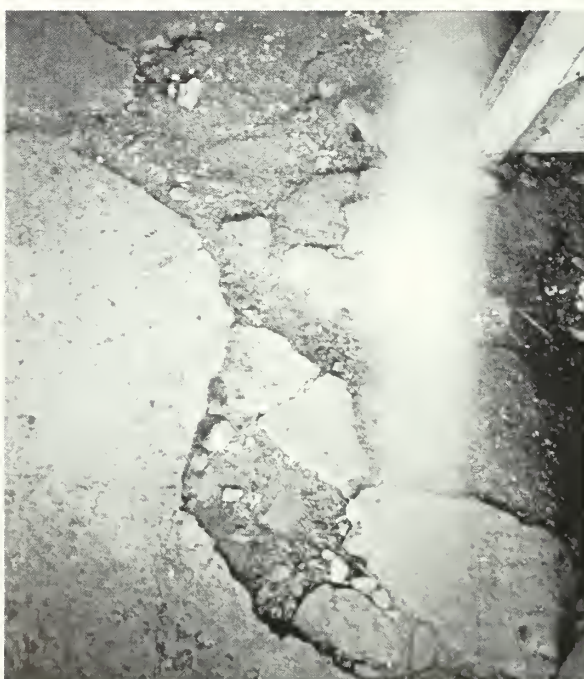
...two stables and one feeding entry have been concreted for dairy use, twenty-one head stalls for cattle were built in.<sup>70</sup> (Figs. 62-63 and Fig.145)

Figure 145: Entrance from north end of barn into dairy area.

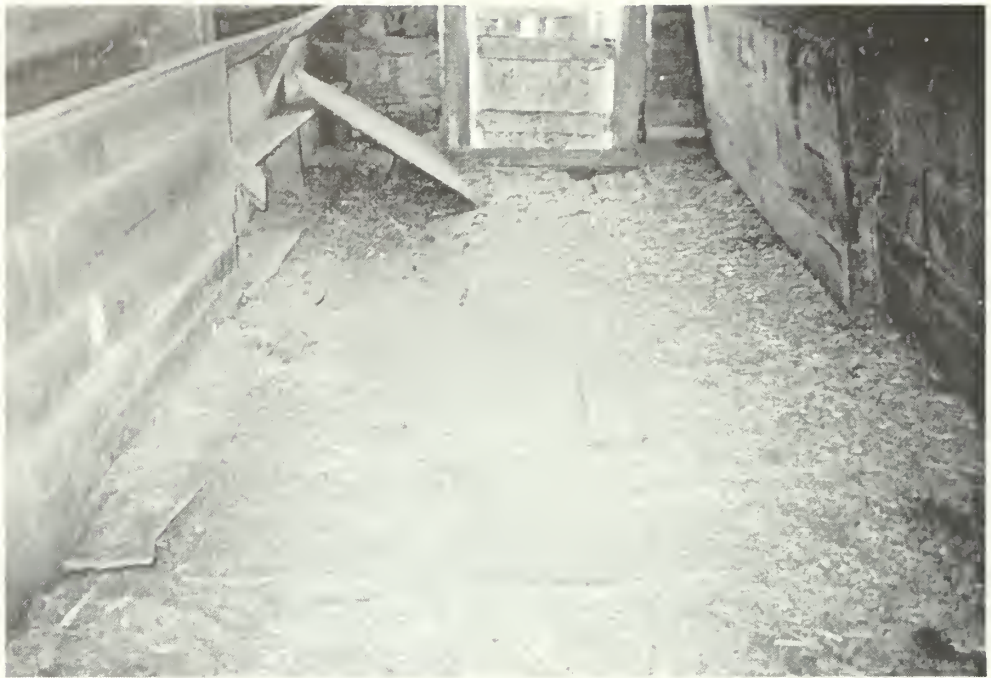
Figure 156: Evidence of rodent infestation.

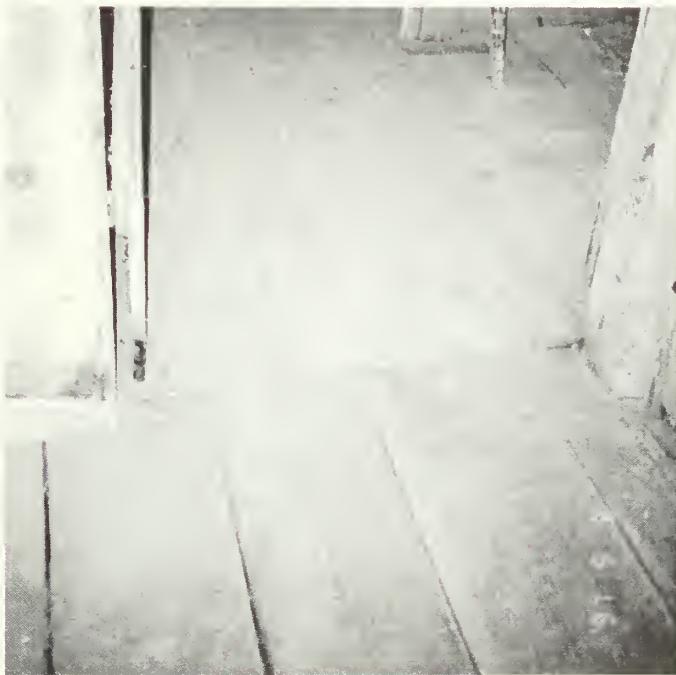
A curious condition that is visible under each granary is that the original log joists below, which support the floors of the granaries above, have been cut short and replaced by milled lumber (Fig. 159). It is not clear when or why this repair was completed, but one can speculate that the joist ends became moisture damaged and required replacement. Both the north and west corners of the barn traditionally have had drainage problems. The floors of both granaries may also have been replaced at this time. The floorboards are similar in appearance to the replacement floorboards just in front of the wagon doors (at the northwest elevation)(Figs.160-161).

Figure 159: Original log joist cut below outshed/granary. Typical under both outsheds.

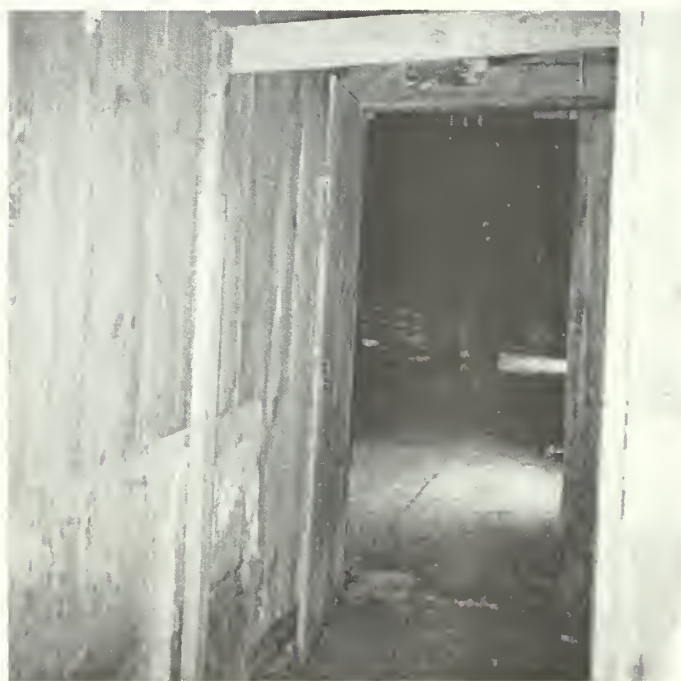
Figure 161: Floor replaced at granaries.

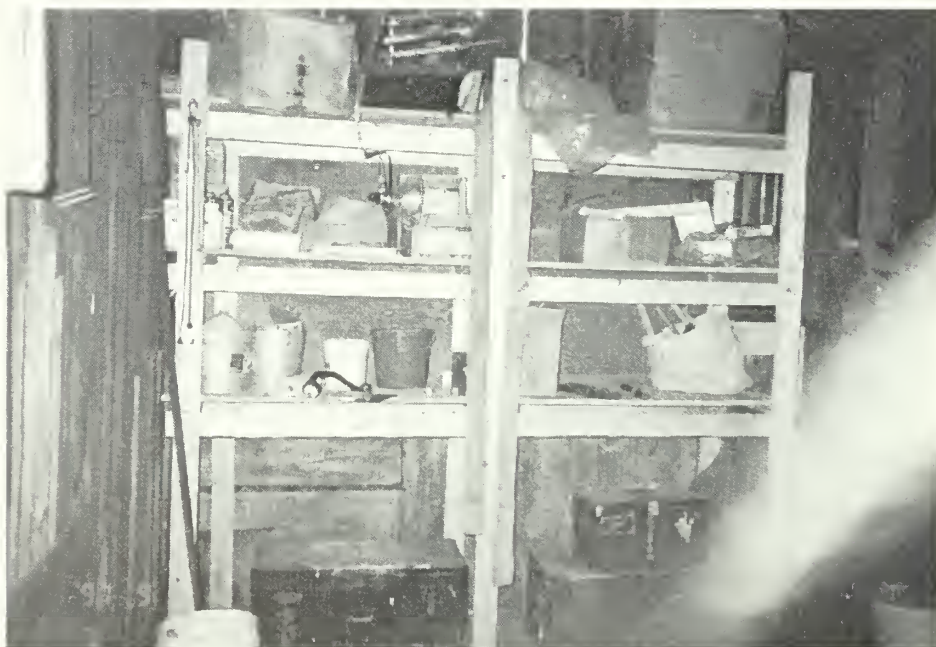
Figure 165: Entrance from the barn into the west granary.  
Note non-original infill panel above door.

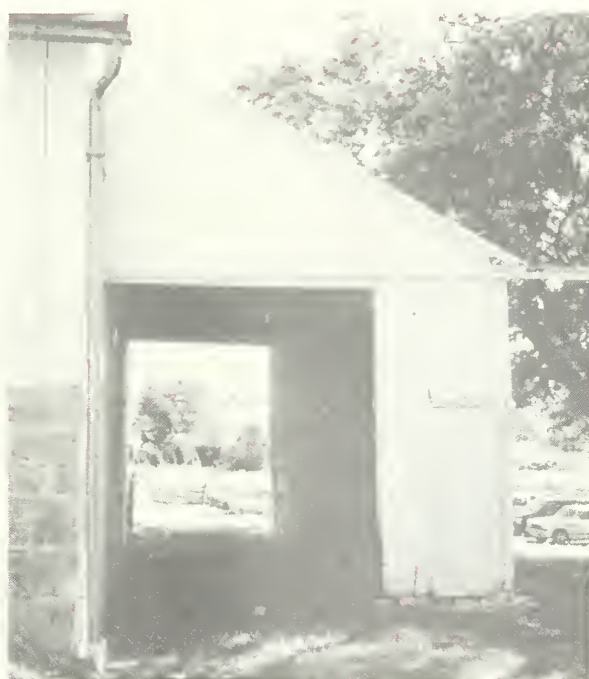
A continuous corrugated-metal shed roof covers both features (Figs. 170). This roof was repaired in 1991/1992 by the Williamsport Preservation Training Center as part of an emergency stabilization effort.<sup>73</sup> Also in 1992, deteriorated sliding wooden doors were removed by park staff from the northwest elevation of the wagon shed (Fig. 167) and not replaced, leaving it open on both ends. The siding and foundation of the wagon shed are in good to fair condition (Figs. 171-172).

Figure 167: 1975 photograph of the wagon shed with the sliding doors still in place. They were removed in 1992 due to severe damage.

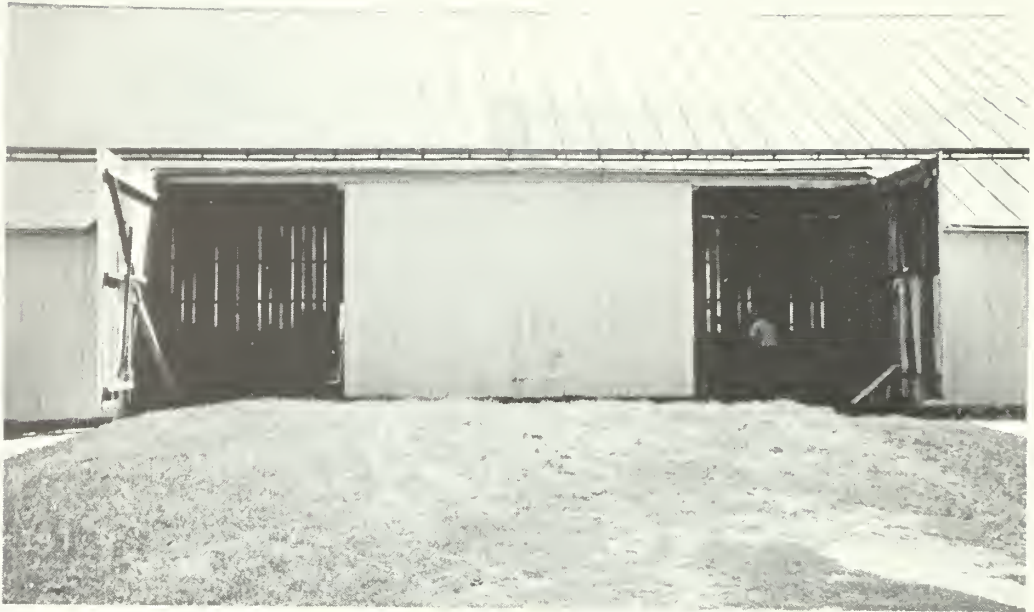
The condition of the animal stalls is poor, although most of their original layout is still intact (Fig. 62 [plan] and Fig.180). The few repairs that have been made to the assorted stalls, grain troughs, hayracks, wooden partitions, and wooden gates, have been haphazard.

Figure 180: Original hayrack in one of the feeding areas.

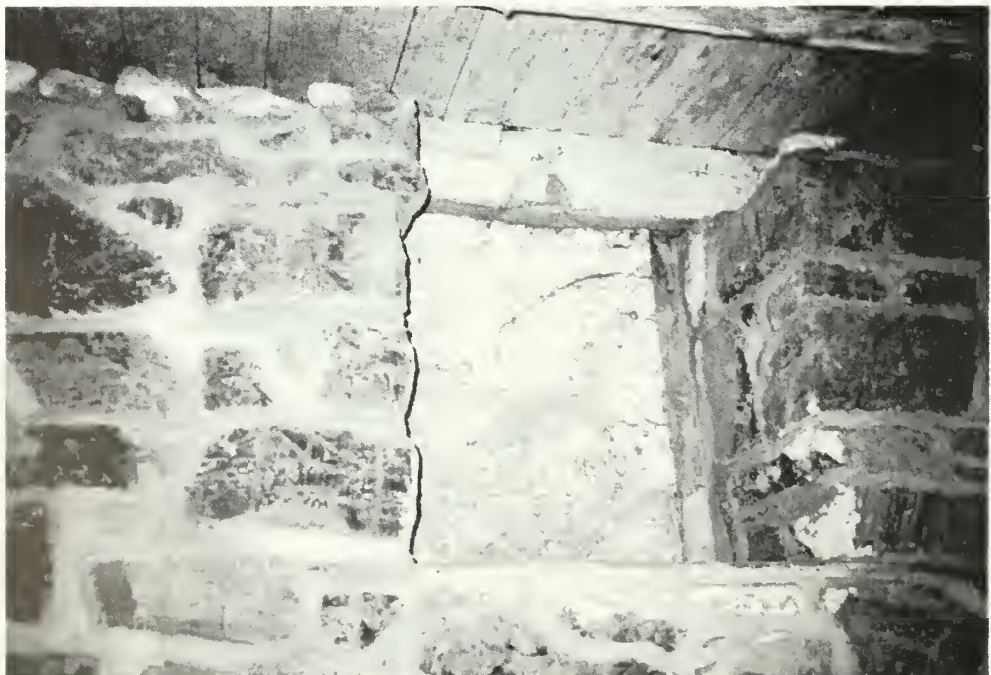
Figure 194: A typical opening (at the northeast elevation) covered over with sheet metal.

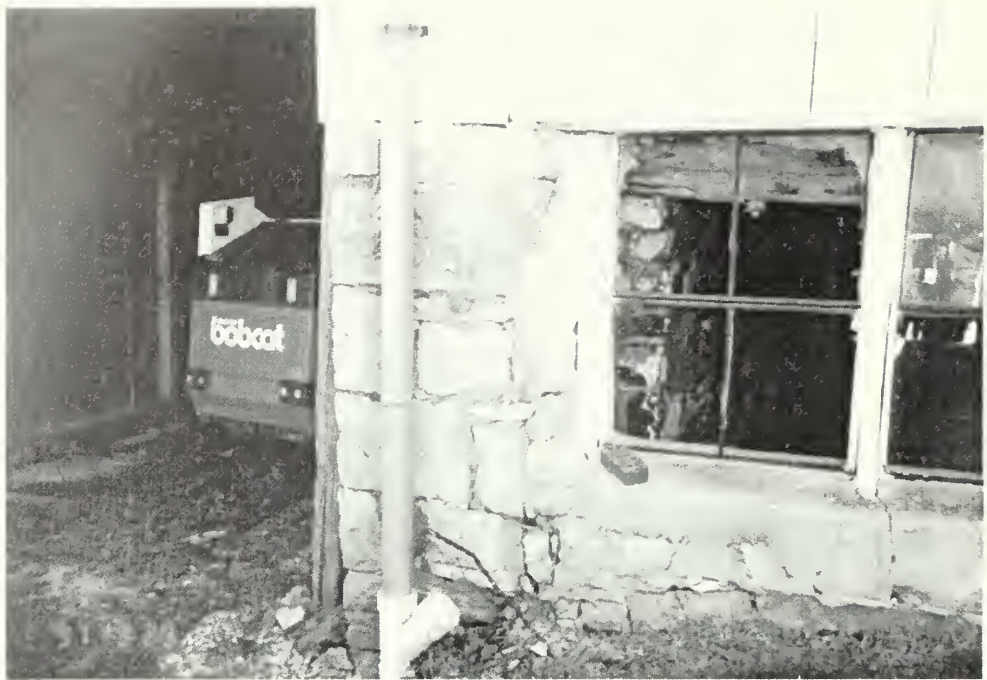
Figure 197: New downspout at the dairy area leading into sub-grade drainage system (north corner of the barn).

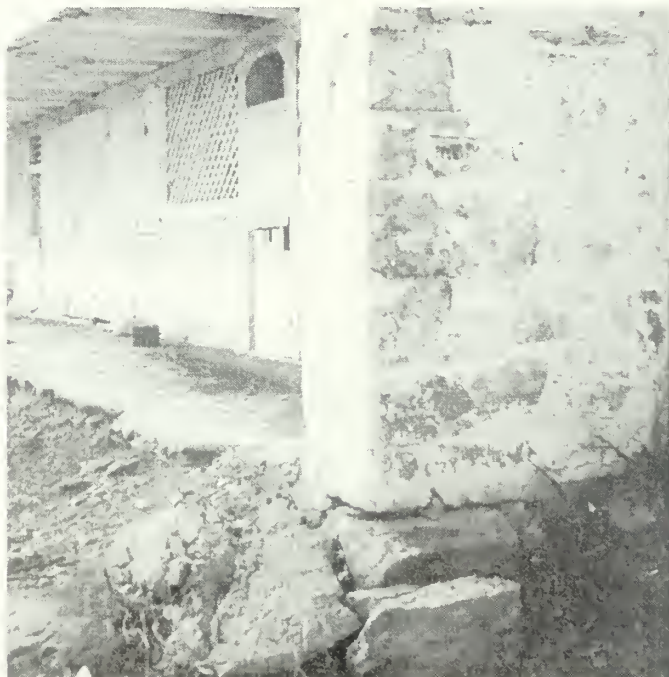
There are notable drainage problems on the southeast side of the barn, as gutters and downspouts in this area were not replaced in 1993. At the east corner of the barn, where the stone foundation wall projects out to support the forebay, rain water passing through a faulty gutter and downspout is causing damage to both the stone wall and the siding above (Fig. 198). There is significant erosion at grade in this area. It appears that this condition has been happening for some time and needs to be remedied.

Figure 198: Moisture damage at east corner of barn due to faulty drainage.

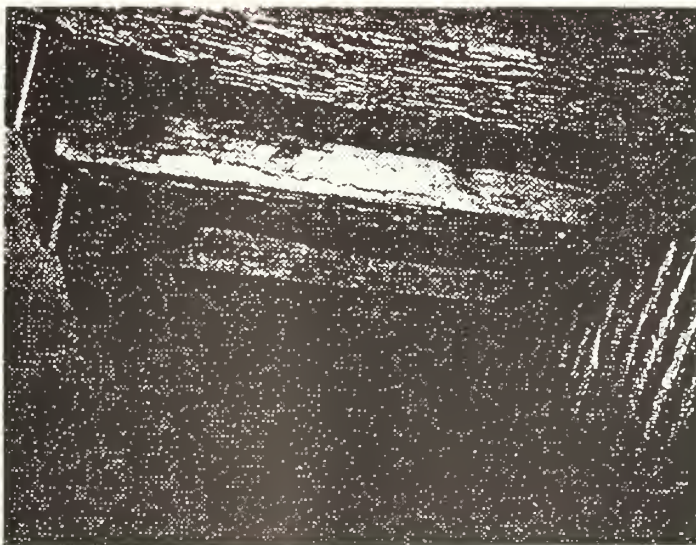
Bldg. 43 - Barn Mumma Farm  
Item 1 - Broken girder - small vertical  
post added for support

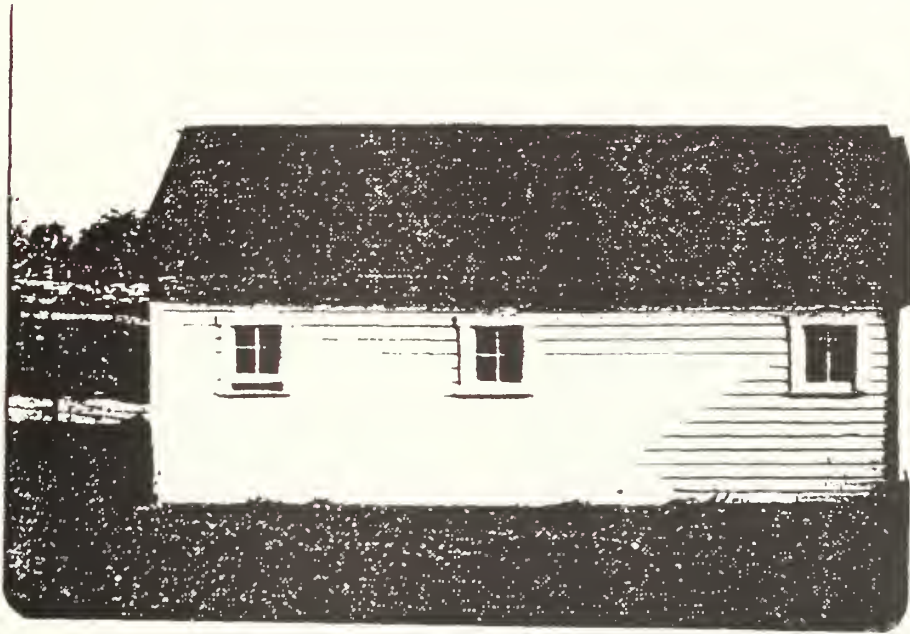
Bldg. 46 - Garage - Mumma Farm  
South side

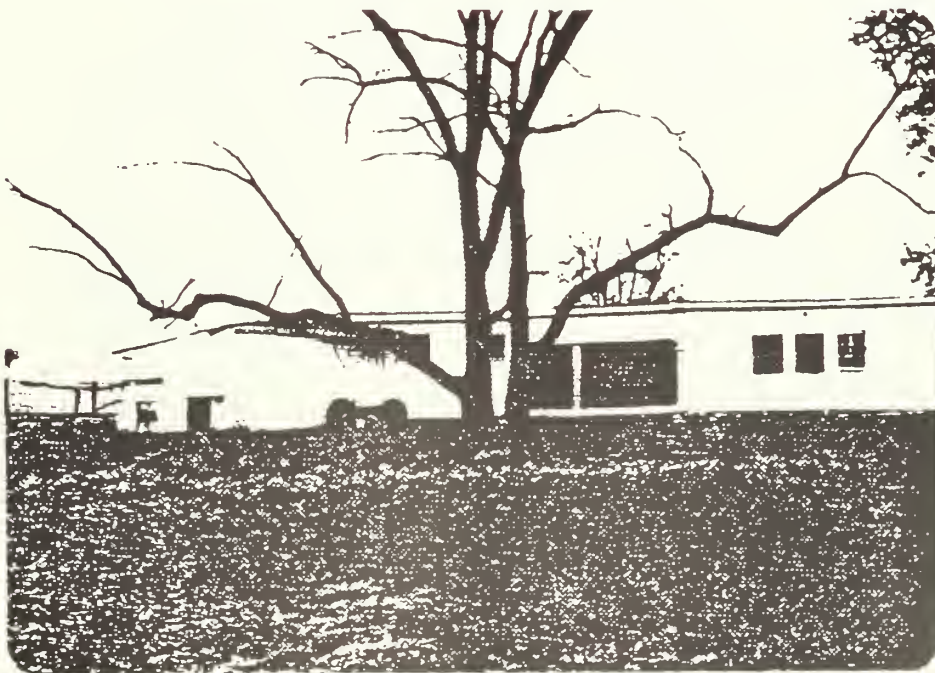
Bldg. 48 - Chicken House - Mumma Farm  
East view

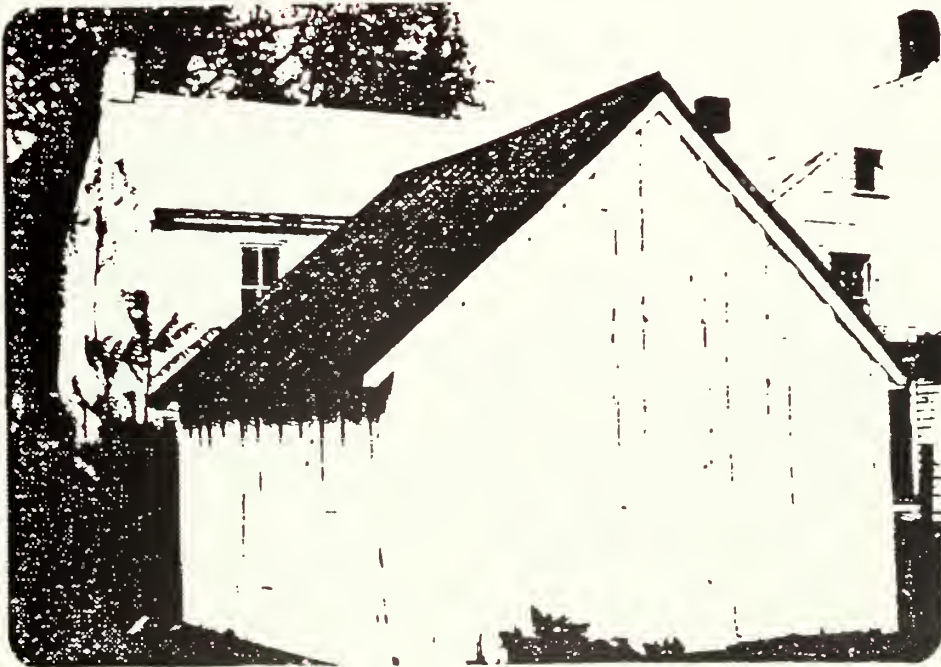
Bldg. 40 - Mumma Farm  
Meat Storage House south and west sides

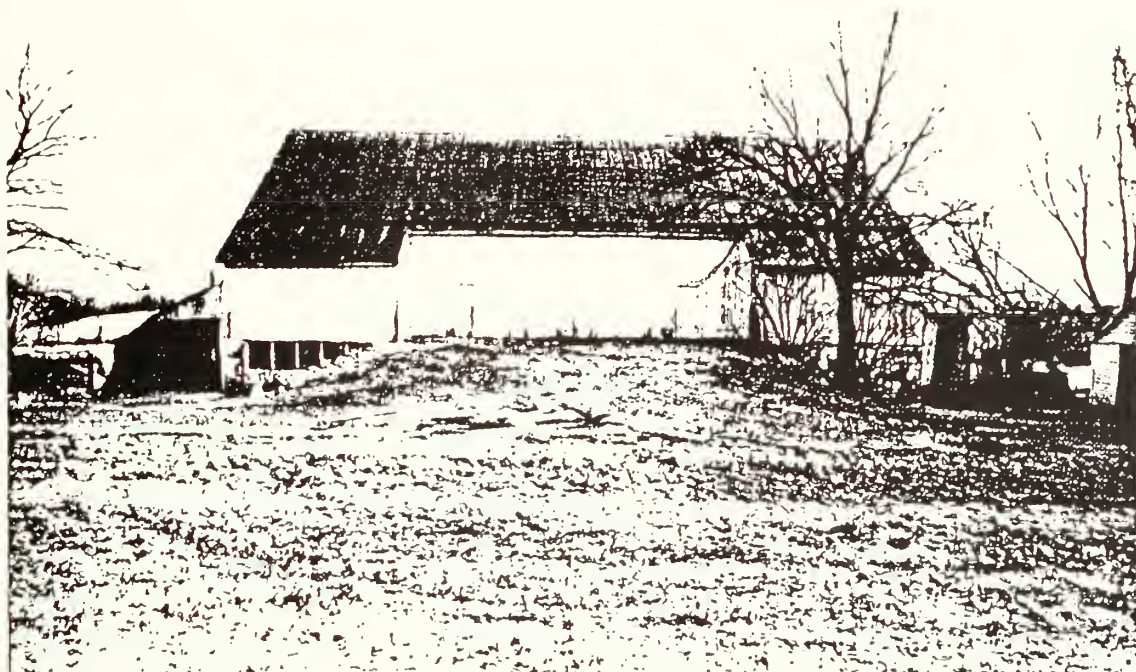
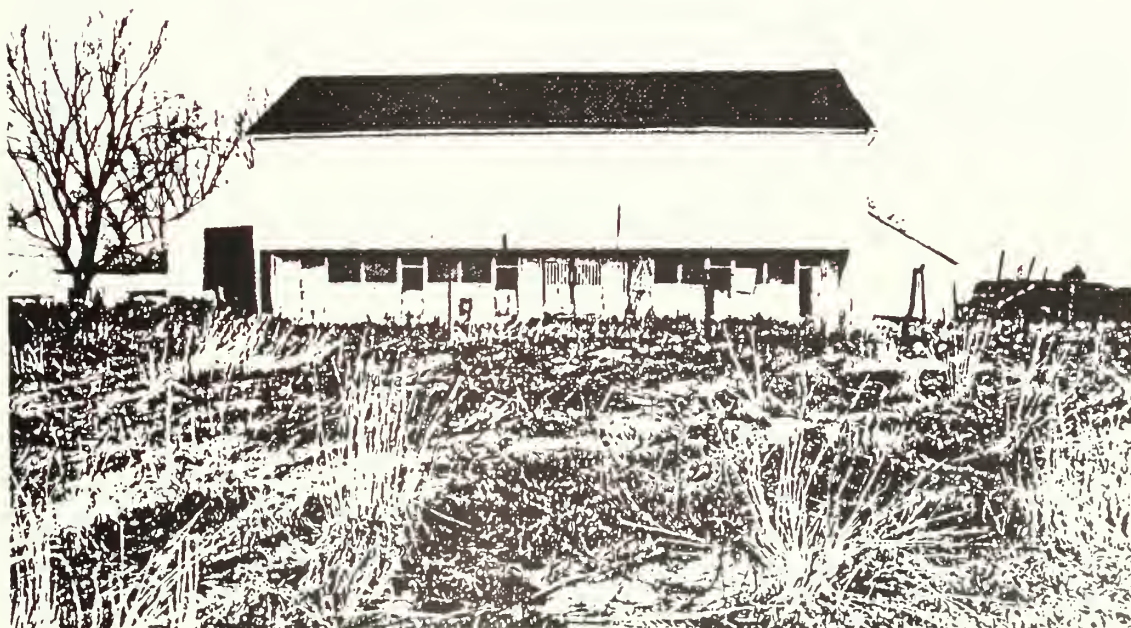
MUMMA BANK BARN: Northwest Elevation (above)  
Southeast Elevation (below)
