**ELLIS ISLAND
STATUE OF LIBERTY NATIONAL MONUMENT**

**HISTORIC STRUCTURE REPORT
POWERHOUSE**

Volume 3

**Beyer Blinder Belle/
Anderson Notter Finegold**

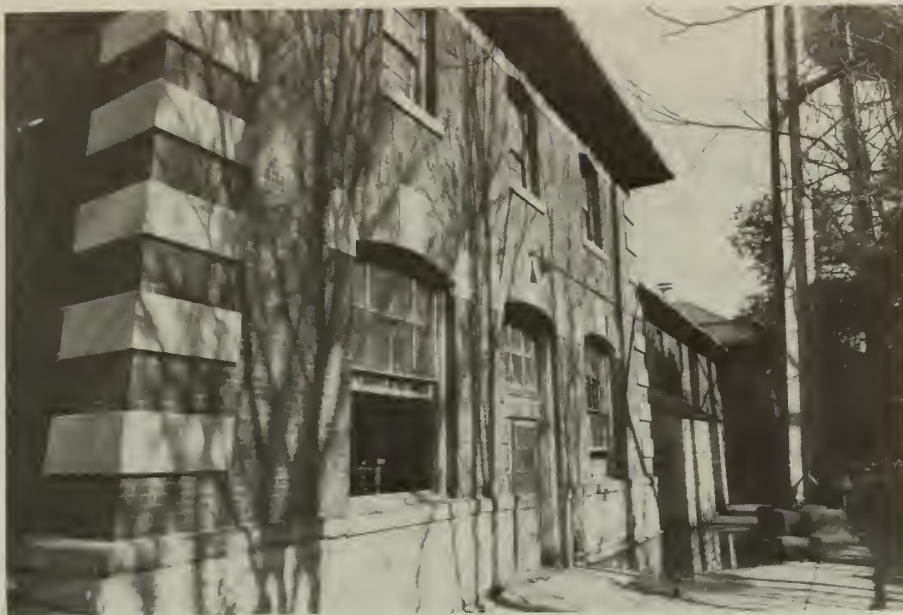
Wood window enframements are in poor condition and are not reusable. Most window sash is splitting and warped. Muntin joints are open and much of the glazing is broken or missing (photos 1, 4, 7, and 36). Several of the dormer windows are no longer extant and have been filled in with plywood.

1. South pavilion, east elevation, view northwest.

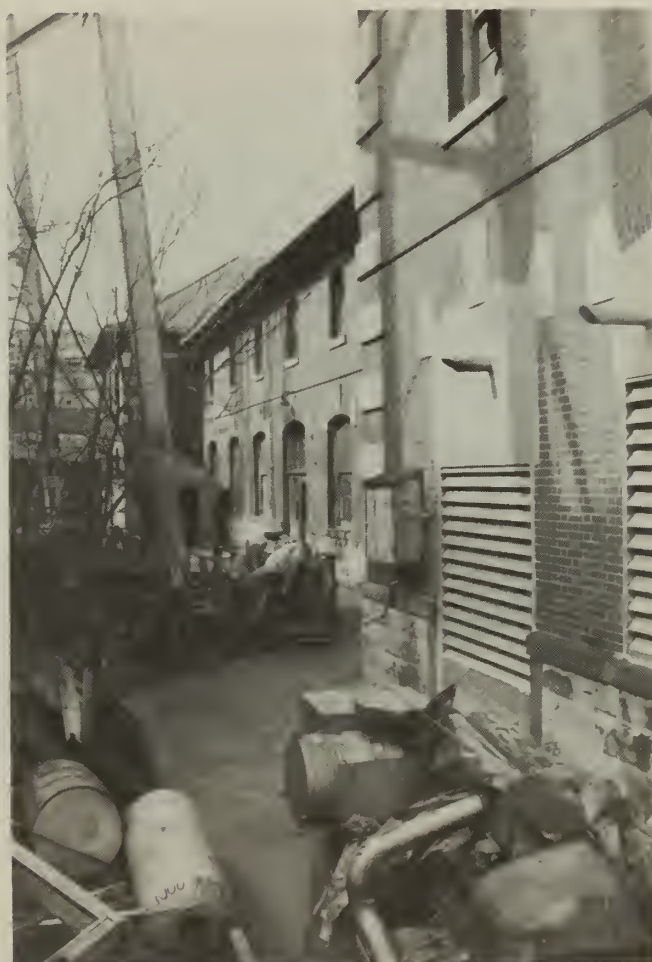
18). One entrance on the east facade has been replaced with louvered vents (photo 2). Two doorways on the east elevation have been filled in with brick (photo 19); one of these has a small four-over-four window. All existing doors, with the exception of those at the northeast entrance, are not original.

2. East elevation, view southwest.

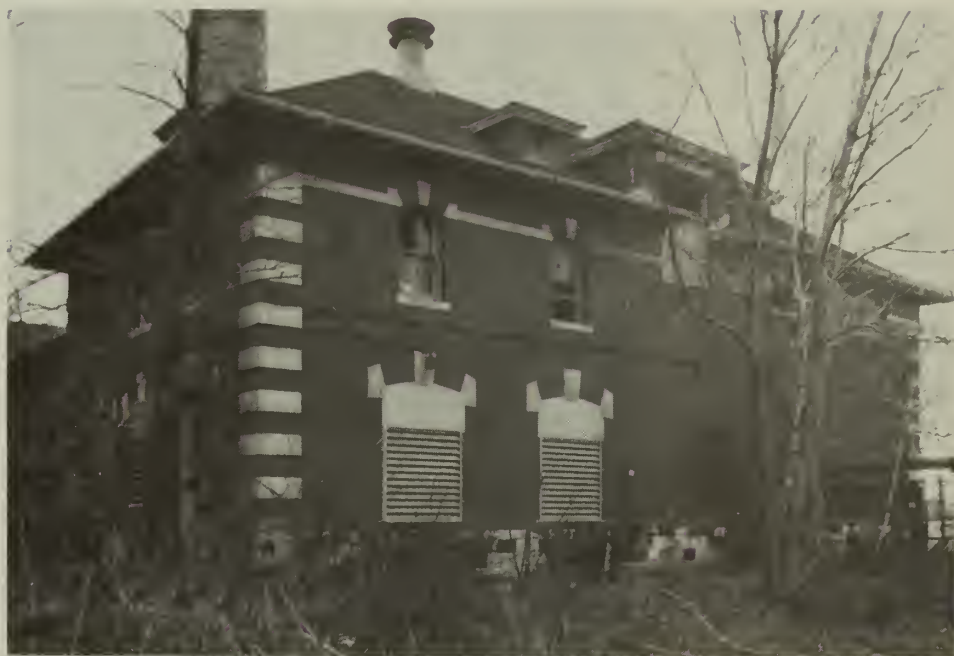
4. North elevation, view southwest.

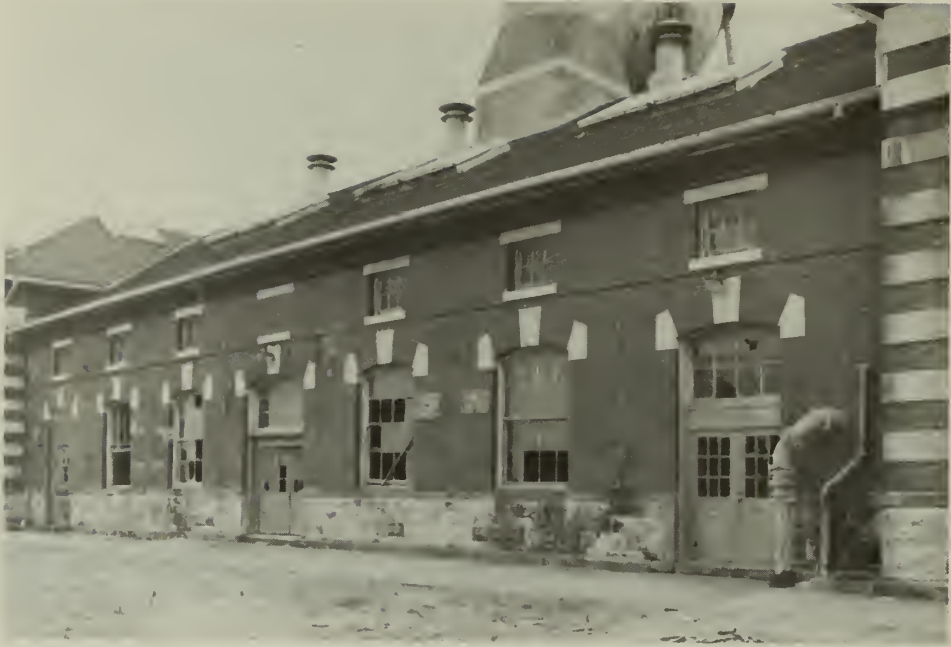
7. West elevation, view northeast.

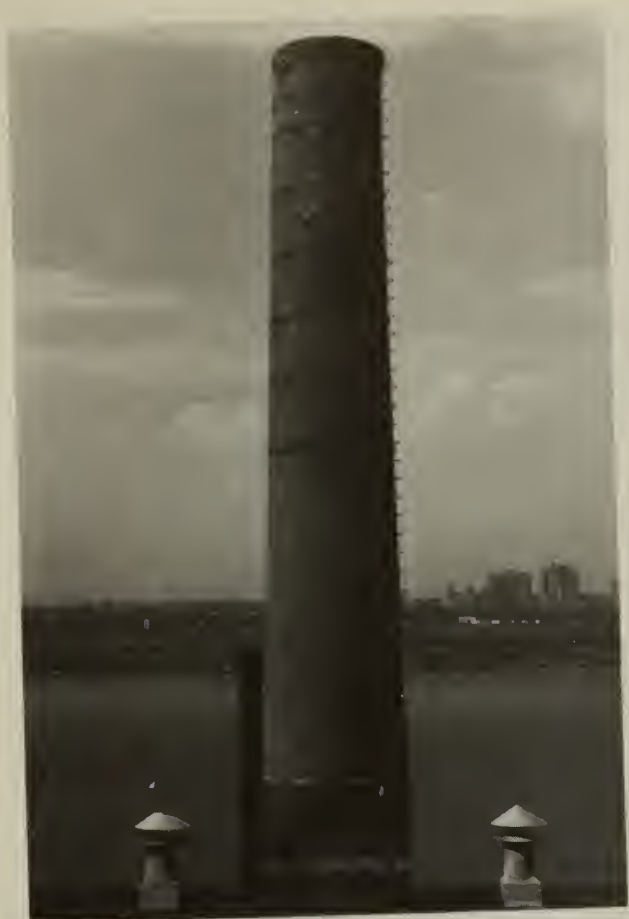
Two major problems were observed: The northwest wall and the chimney, both of which have historically been problem areas, continue to be in extremely poor condition. The chimney is structurally unsound. The mortar is crumbling, the brickwork is buckling, and the chimney is keeling towards the north (photo 13). The stepirons are severely corroded. The brick walls at the northwest corner are heaving. The mortar is deteriorated and several courses appear to be separating from the wall (photo 22). See Chapter II.G., Structural System, for detailed information on the chimney and the northwest wall.

13. Chimney, view west.

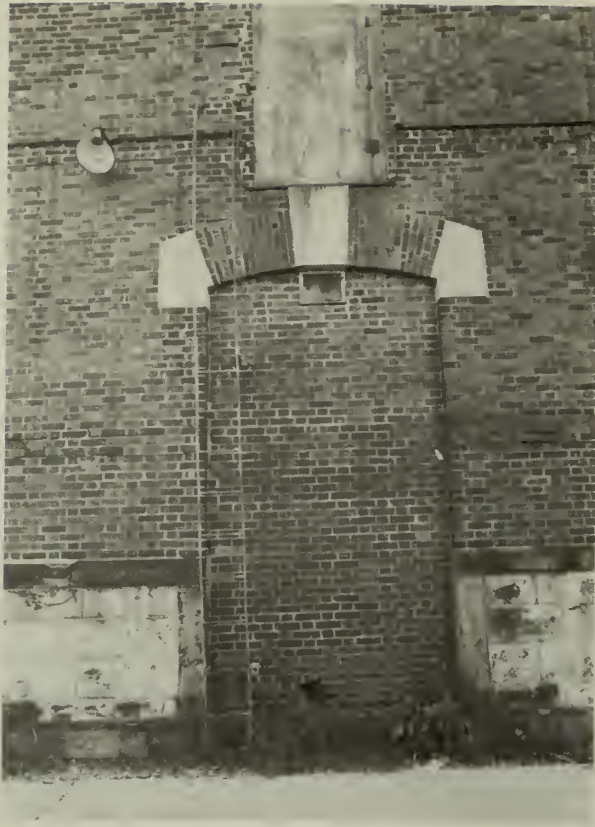
19. North pavilion entrance filled in with brick, west elevation.

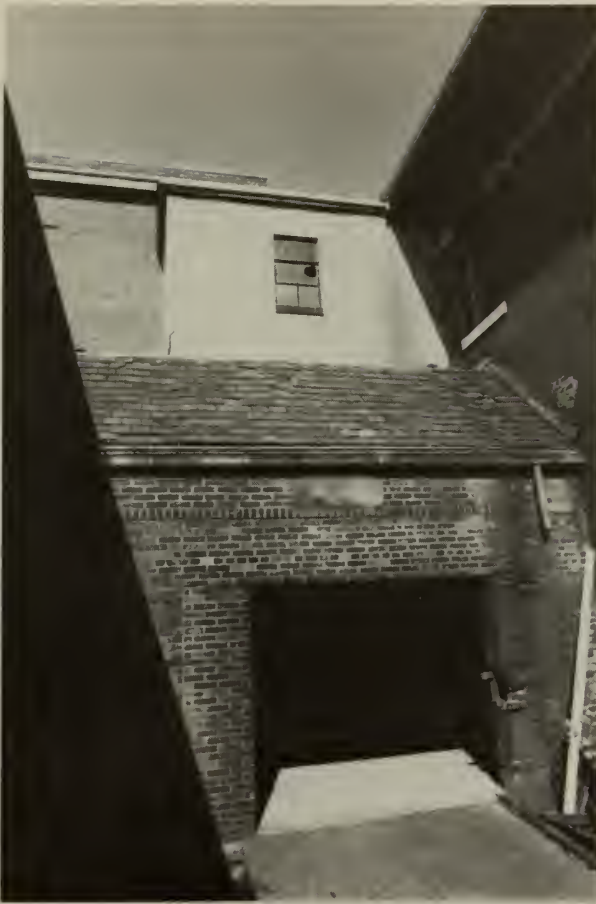
21. Covered way 5 and connector between the powerhouse and the Bakery and Carpentry Building, view west.

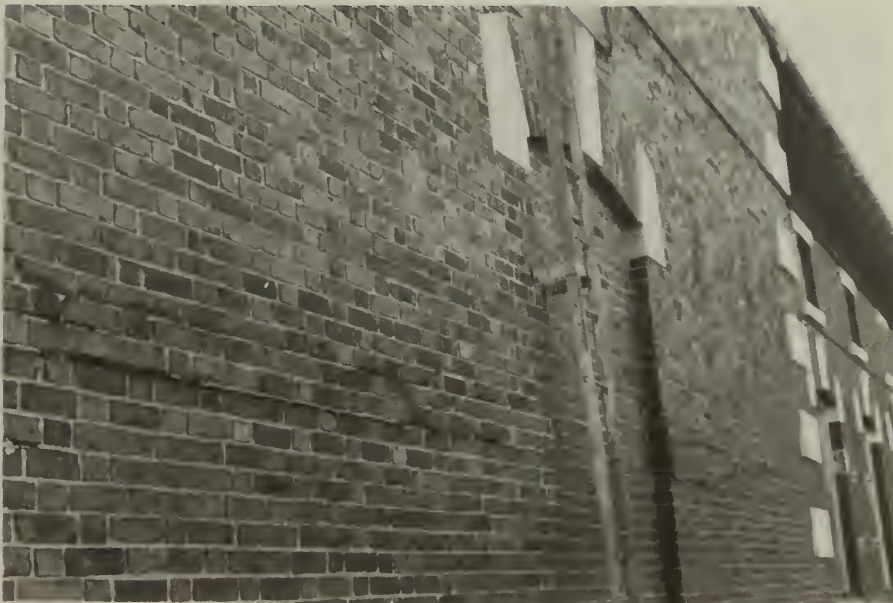
22. Heaving brick courses at northwest corner.

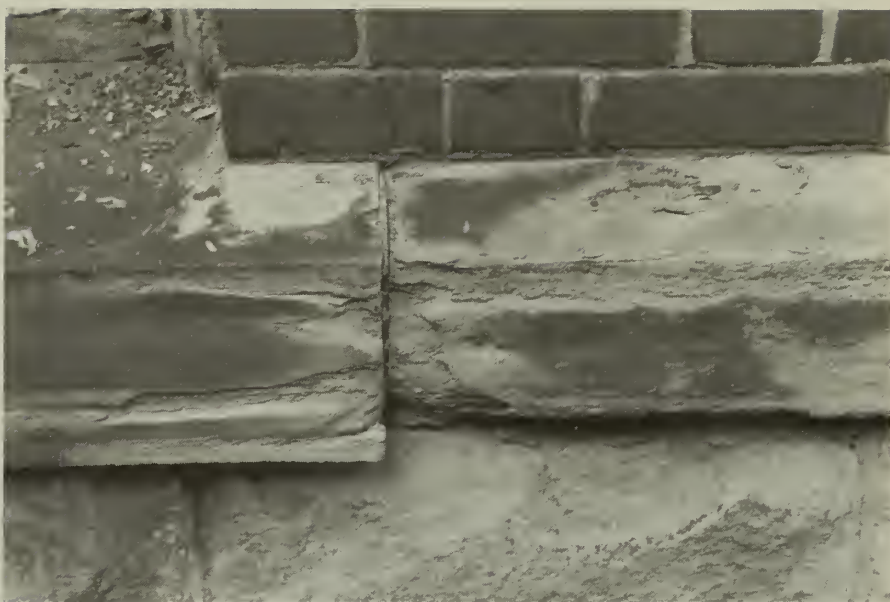
23. Exfoliation, bluestone water table, east elevation.

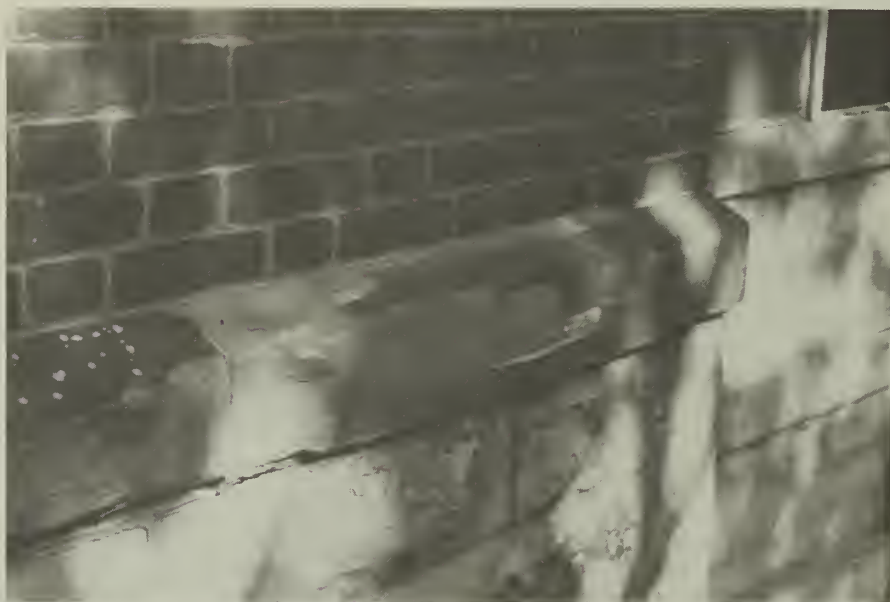
24. Exfoliation, bluestone water table, east elevation.

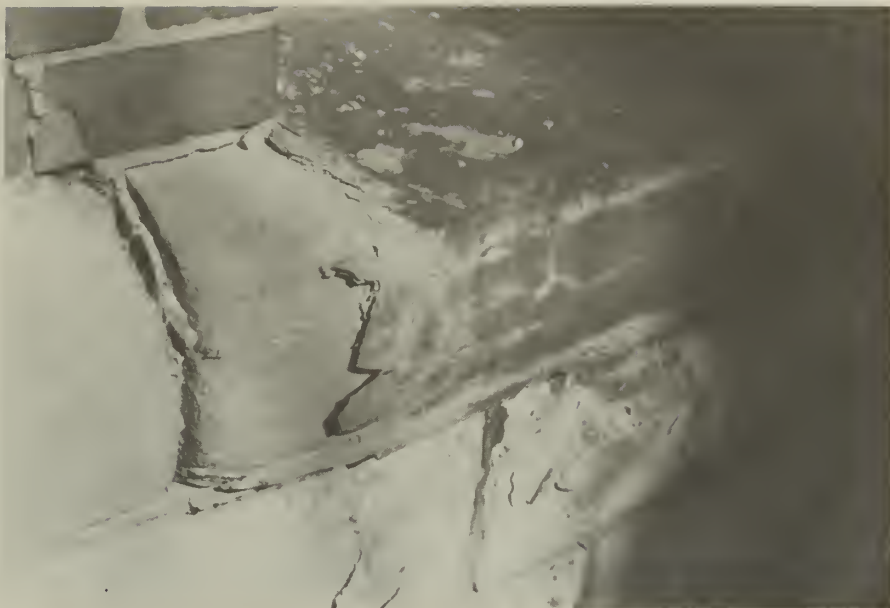
25. Exfoliation, bluestone water table, east elevation.

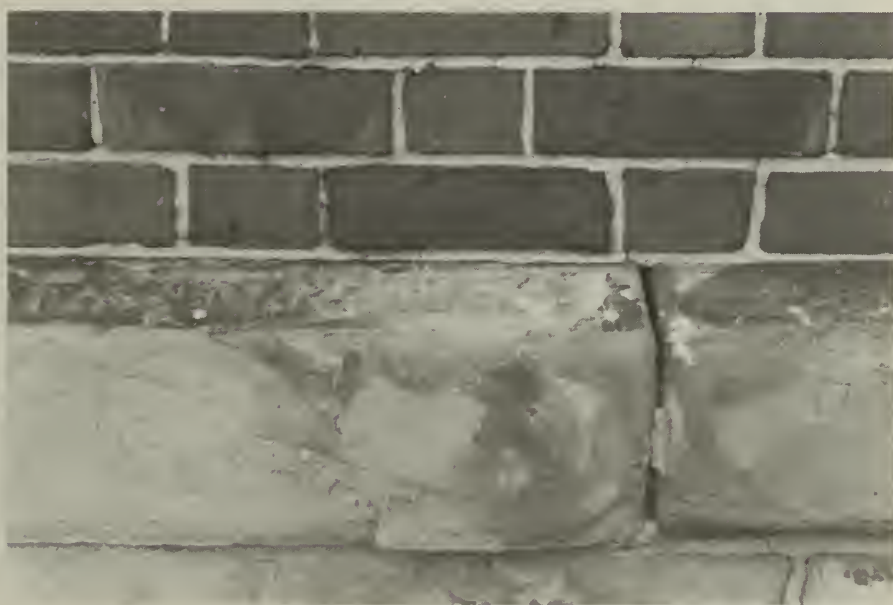
26. Exfoliation, bluestone water table, west elevation.

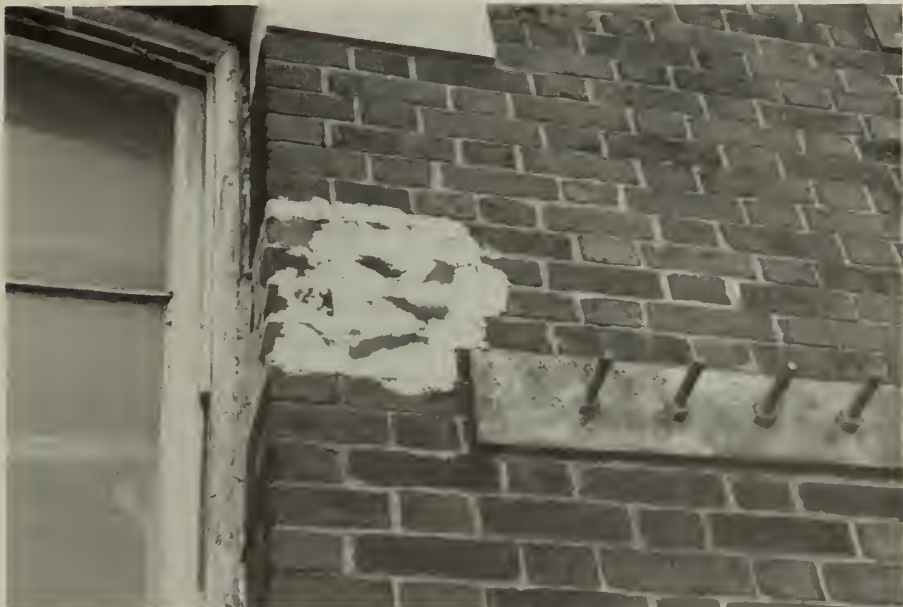
34. Patching, west elevation.

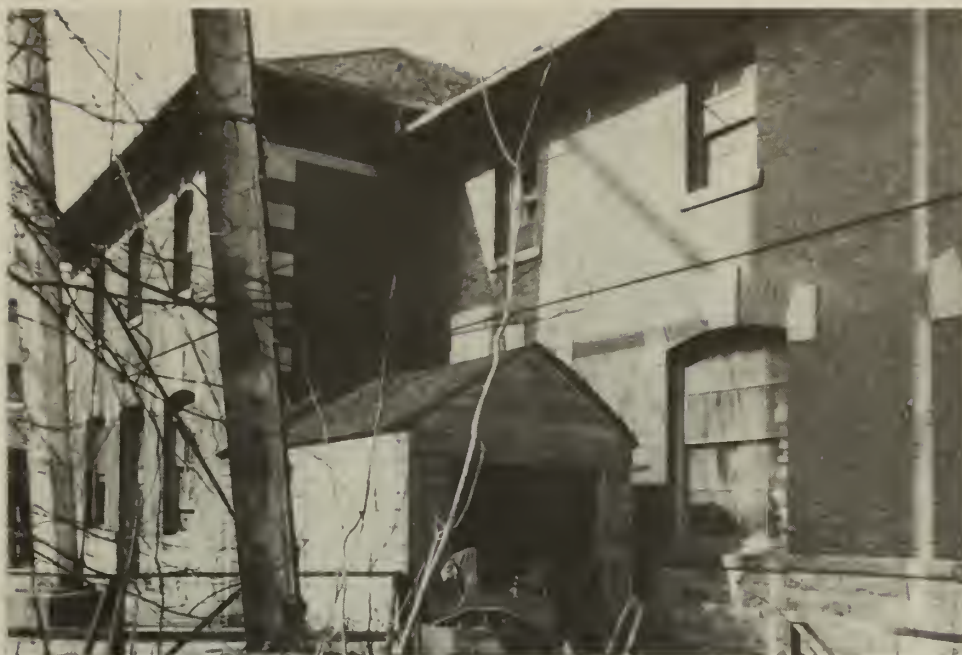
37. Shed on the east side of the powerhouse, view southwest.

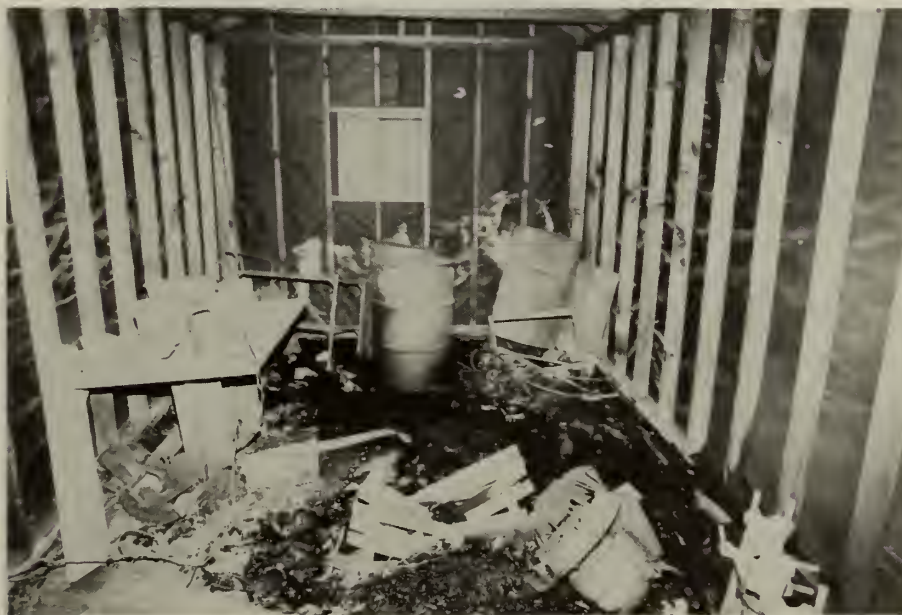
38. Interior of shed, wood frame structure built directly on top of concrete walk, view south.

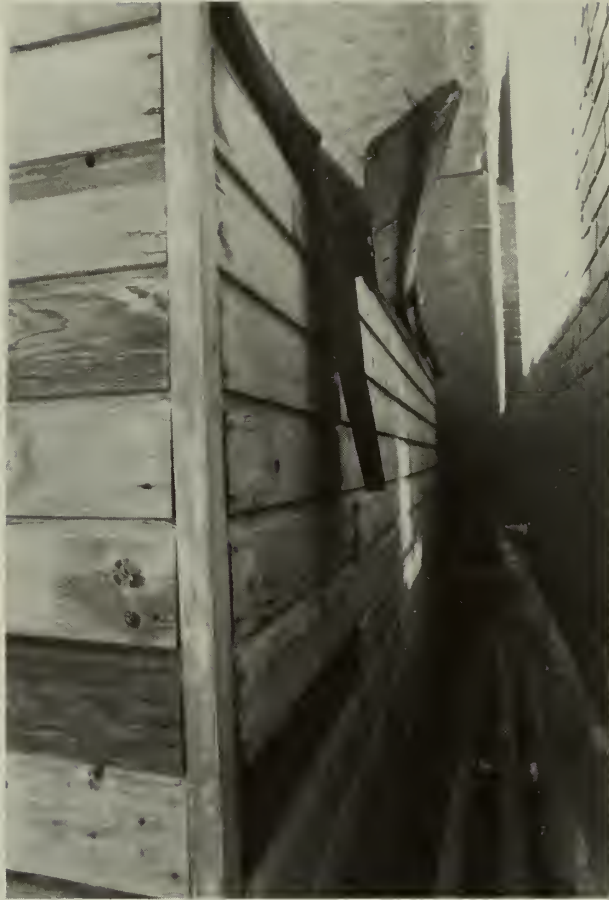
39. Wood siding separating, west elevation of shed, view south.

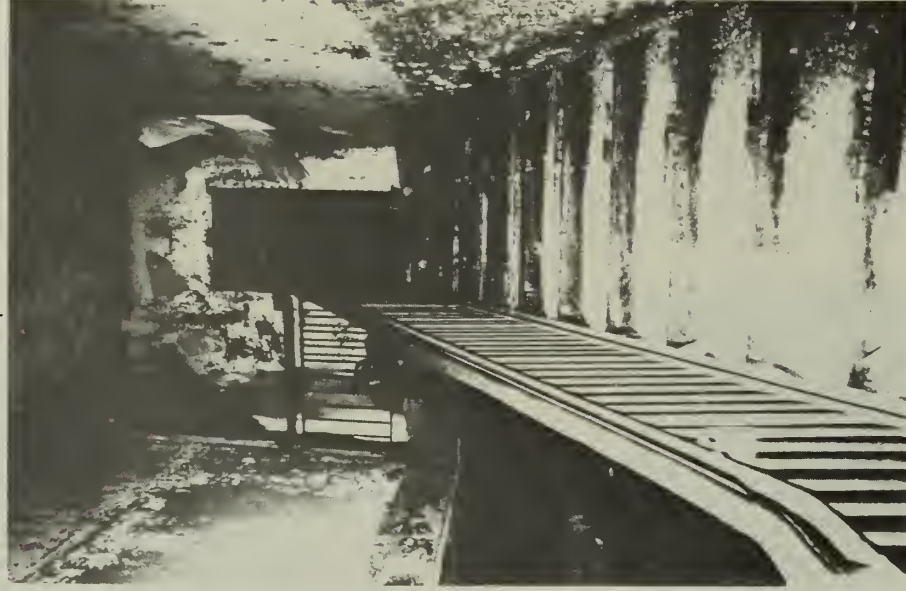
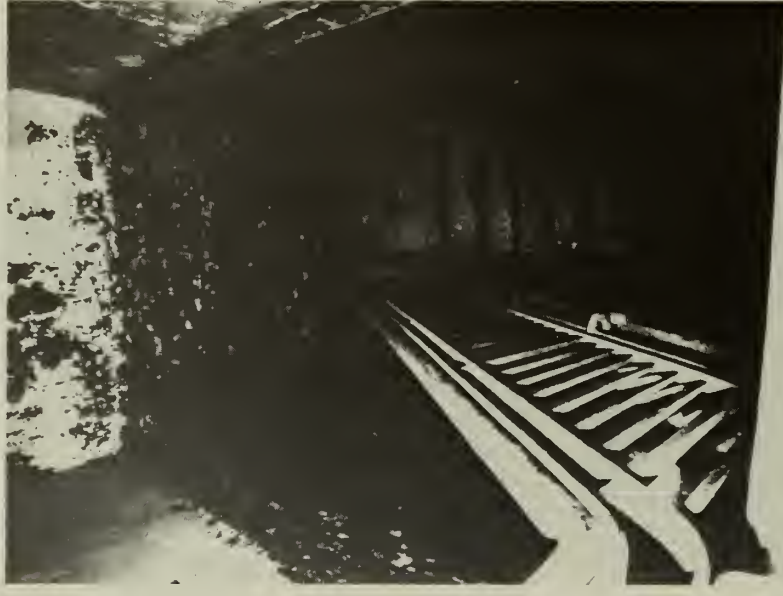
PHOTOGRAPHS: (1) FROM FIRST FLOOR LANDING (2) FROM PLATFORM (3) FROM TOP LANDING ROOM NO. 501

General: All ironwork, surface corroded. Balustrade corroding at bases. All metal surfaces badly flaking paint and corroded.

Floor: Generally good. First floor landing tile cracked and floor sagged at center.

Ceiling: Fair. Peeling paint and plaster spalling. Exposed lath in northern corner.

Lighting: Missing shades.

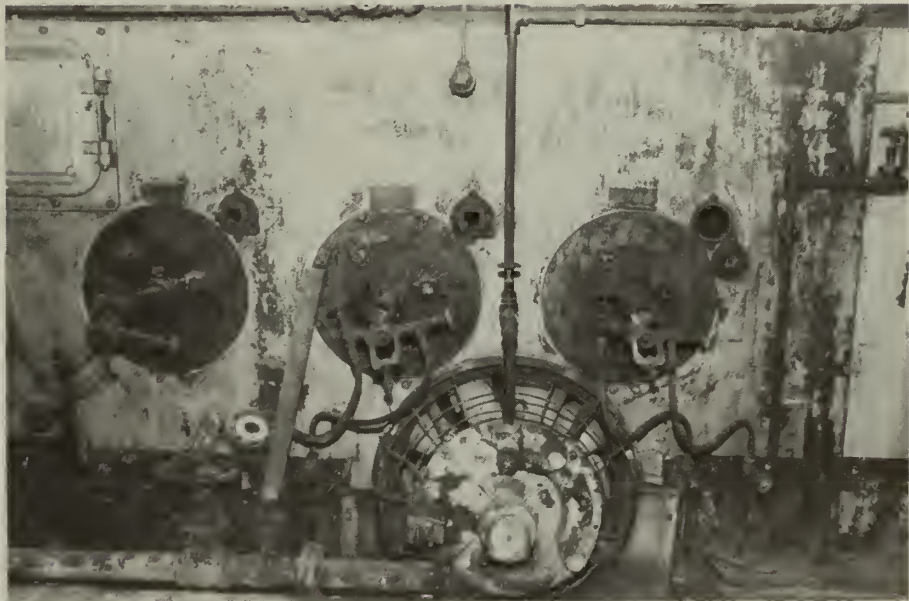
The structural steel and exterior steel casings on all boilers are extensively corroded. All oil-firing equipment is missing and gauges are either missing or broken. Furnace wall firebrick and the outside brick setting are badly deteriorated. Boiler auxiliaries such as feedwater heaters, regulators, and pumps are in poor condition and not reusable.

4. Room 105- Boiler #1.

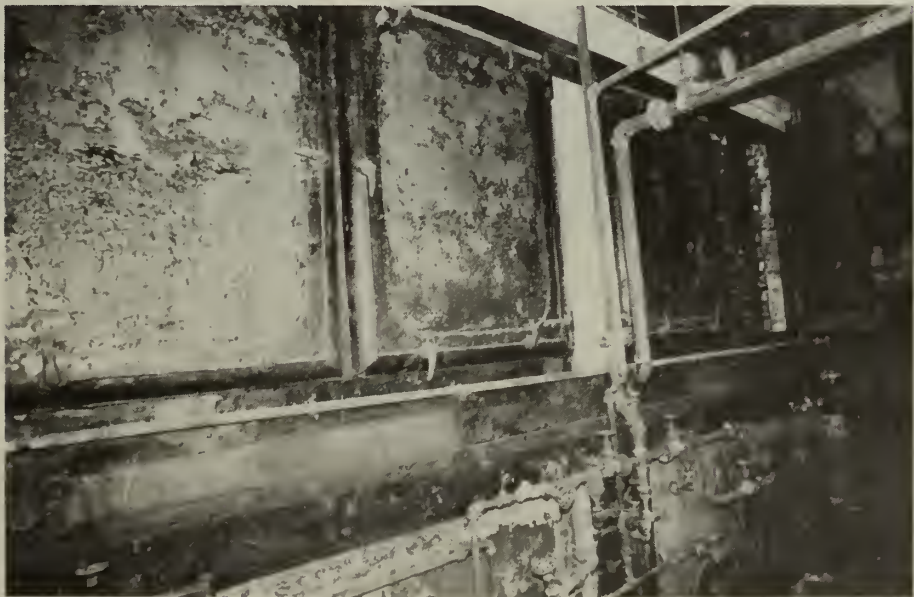
9. Room #105- boiler #4 and 5.

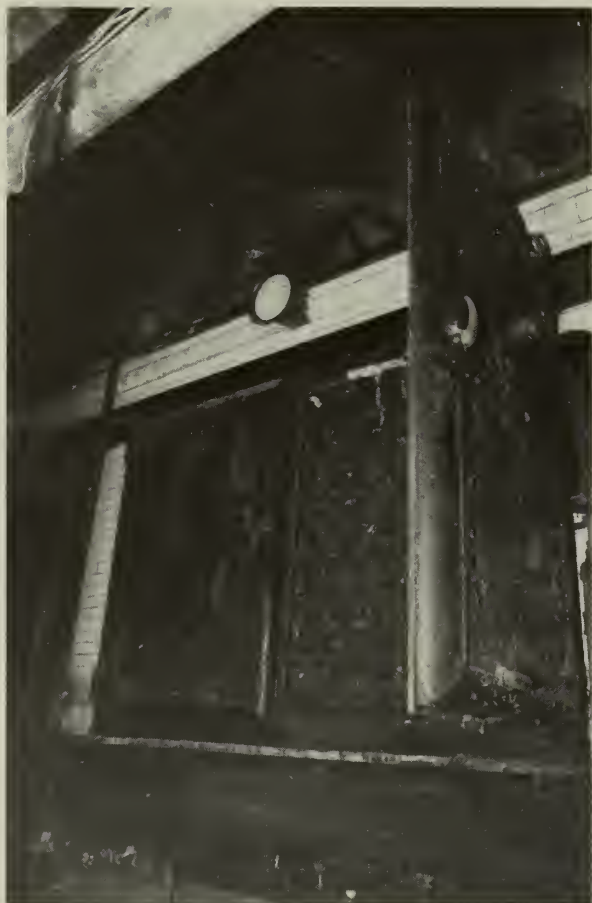
10. Room 105, boiler #5
Upper doors, flame plate

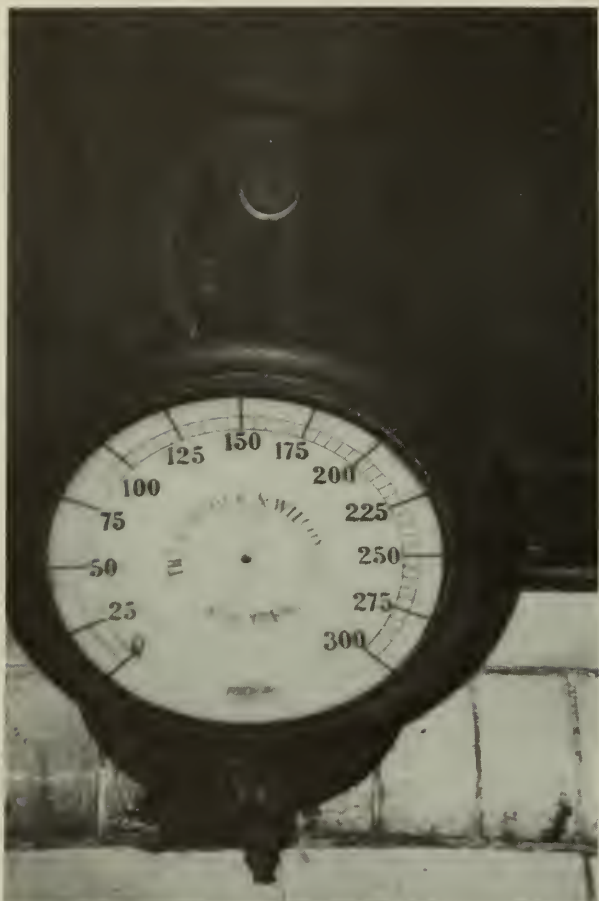
13. Room 105, boiler #5, pressure gauge.

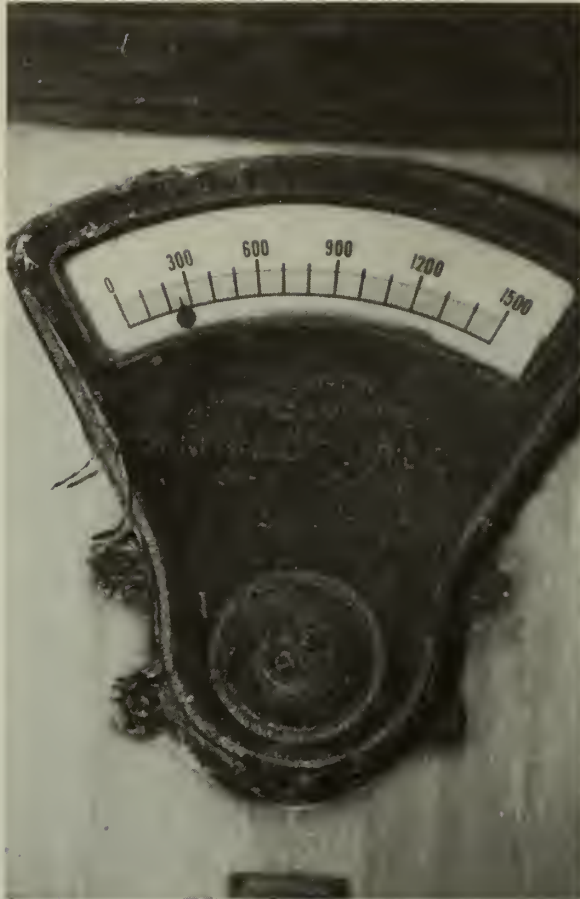
The marble switchboard panel has been destroyed below the top row panels of astatic ammeters (photos 23-24). The wire grating extending from the top of the switchboard to the ceiling and the enclosing end grate door are intact but surface corroded.

23. Room 104- Top surviving panel of marble switchboard, "Thomson Astatic Ammeter" General Electric Co.

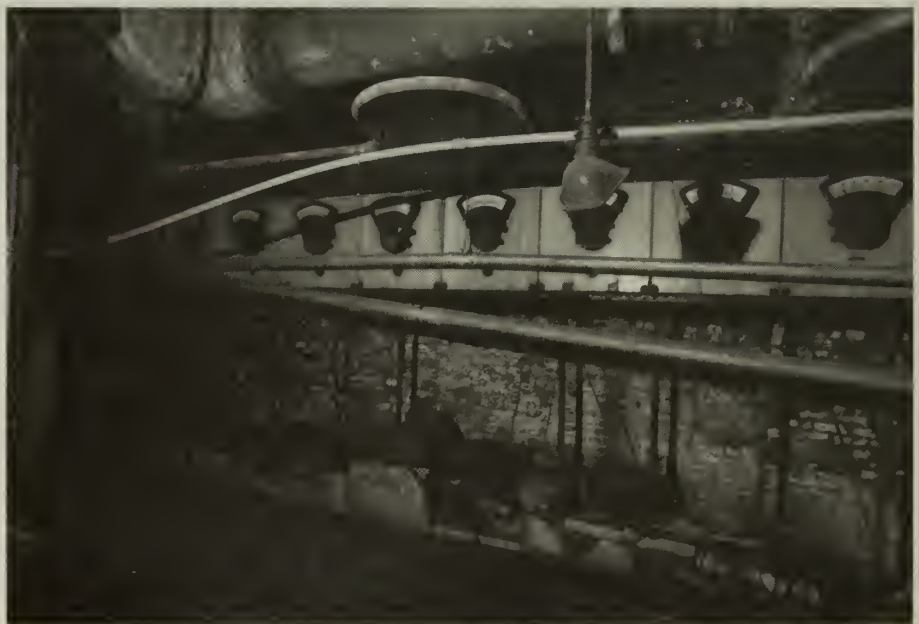
24. Room 104- north wall, main switchboard.

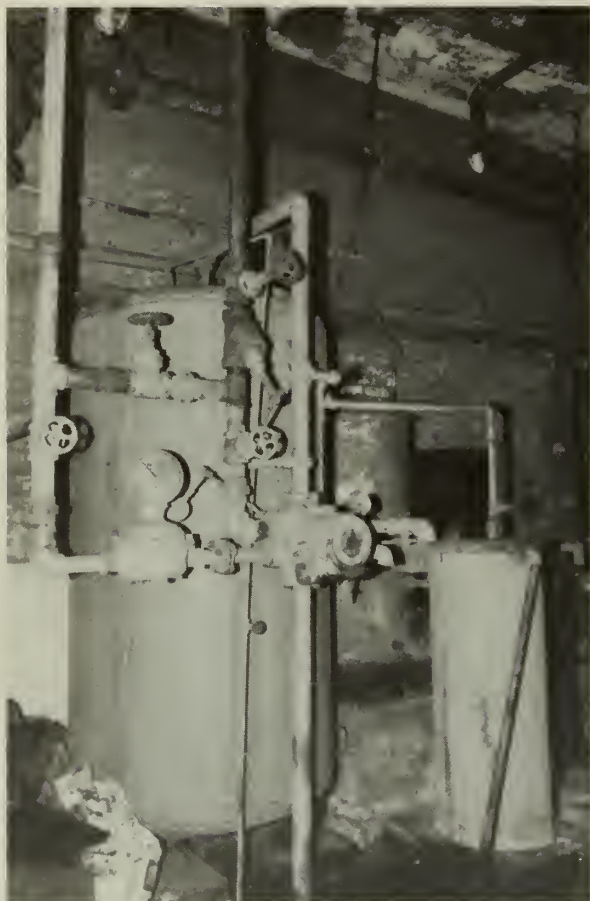
63. Room 106- water softener, west wall. 64. Room 106- west wall.
 "Permutit"- brine rinse.

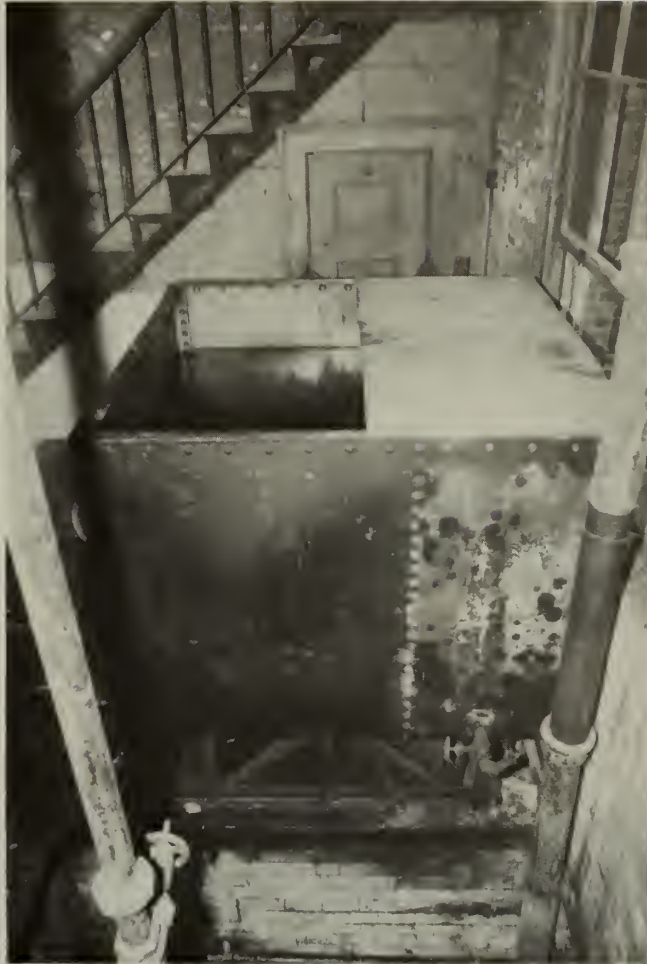
65. Room 106- holding tank , northeast corner

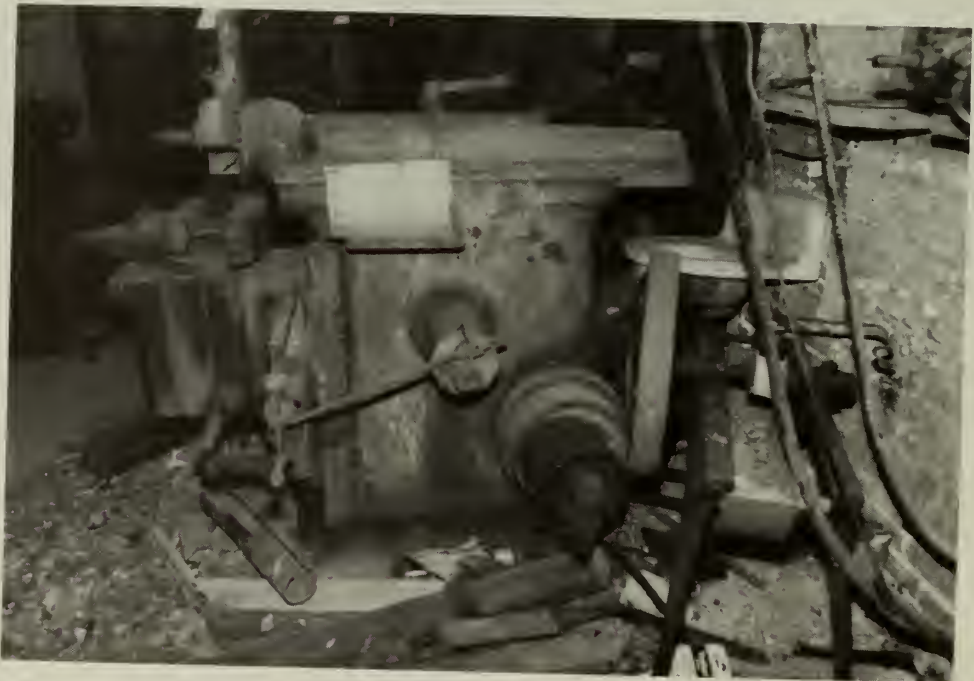
67. Room 108- Unidentified, (#3)

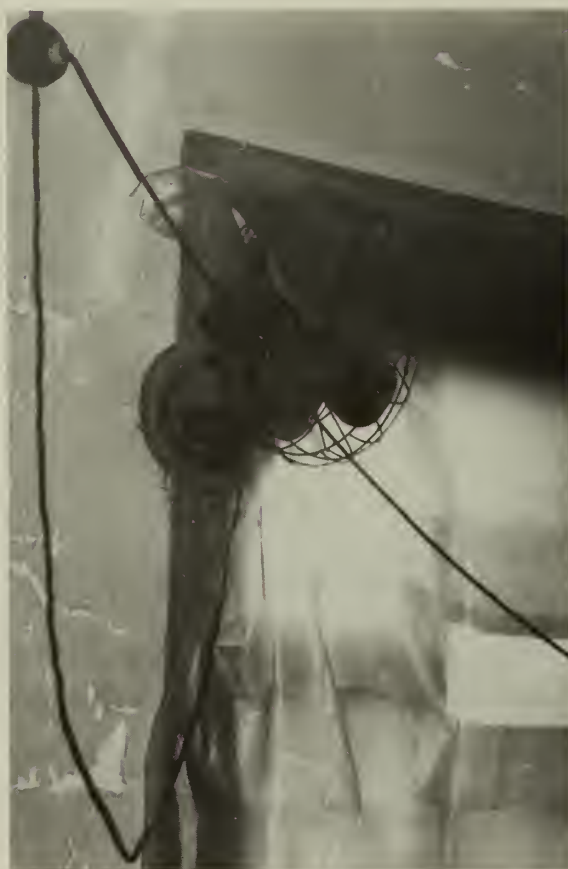
There are no radiators on the first floor, but sectional cast-iron radiators are found in almost every room on the second floor. Ventilation fans have been placed in door transoms and circular holes exist in two rooms where ceiling fans to the attic were once installed (photos 1 and 2).

2. Room 211, rotary wall-mounted fan.

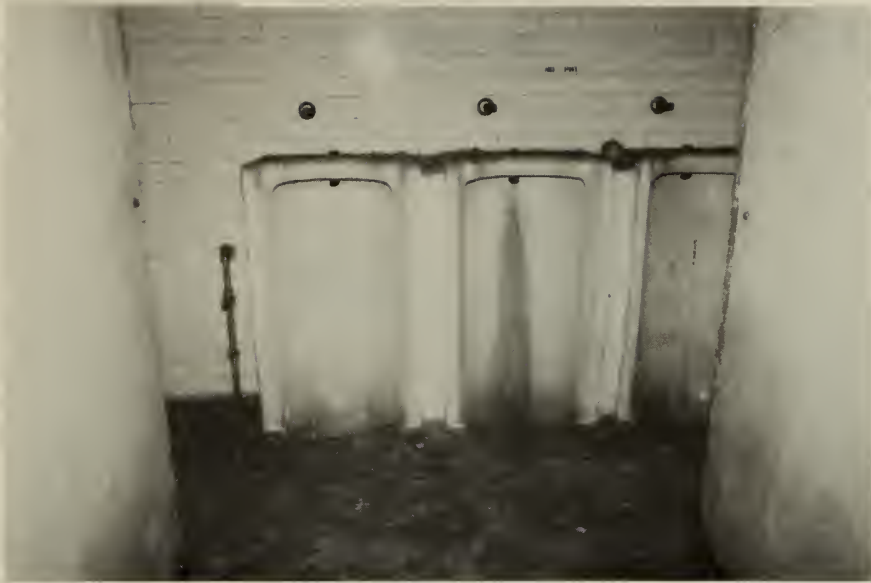
The fixtures in the powerhouse are primarily limited to the second floor. On the first floor, there is only one slop sink located at the west wall of the boiler room. On the second floor, there are three toilets, one shower/wash room, two room sinks, and two aluminum enclosed showers. All fixtures date from the 1930's or later (photos 3-6).

3. Room 212, floor-type urinal.

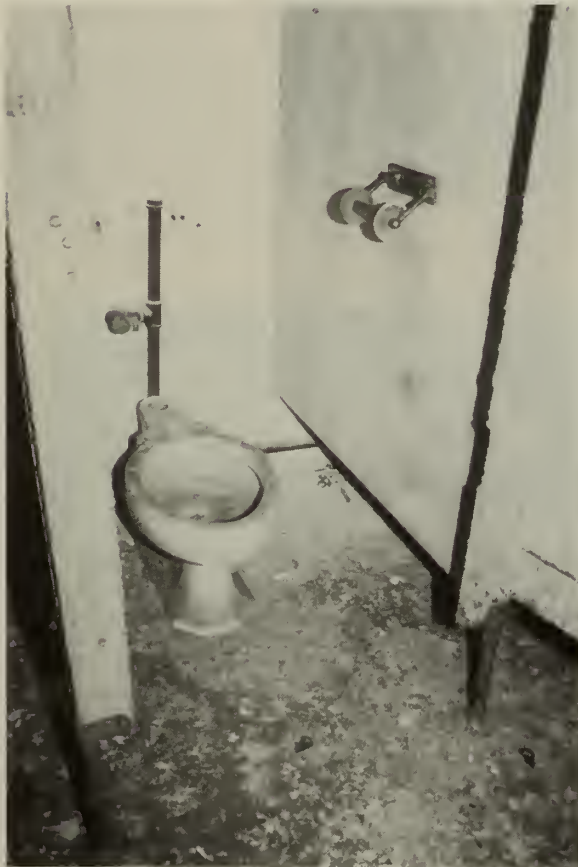
4. Room 212, toilet.

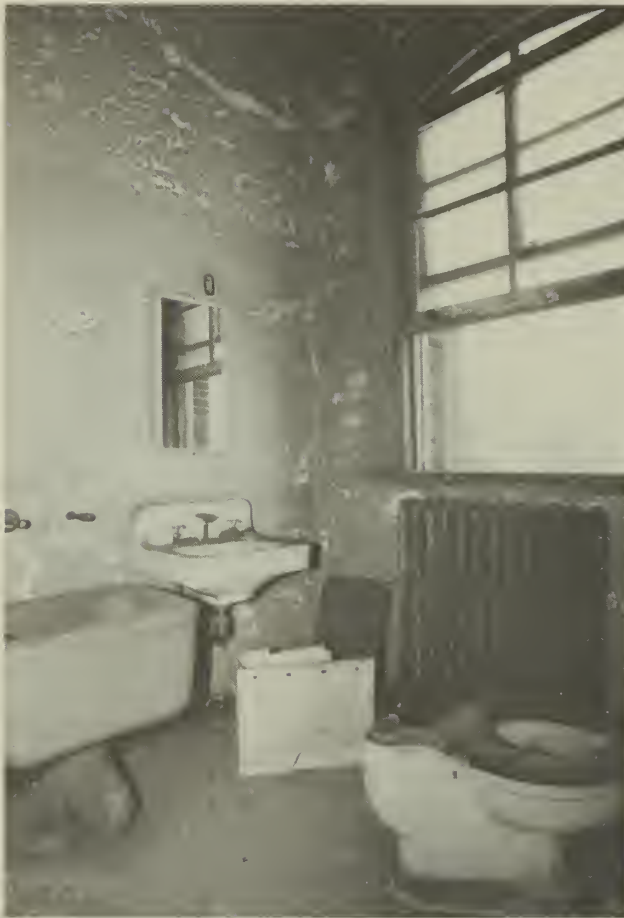
5. Room 201, sink, slop sink and toilet.

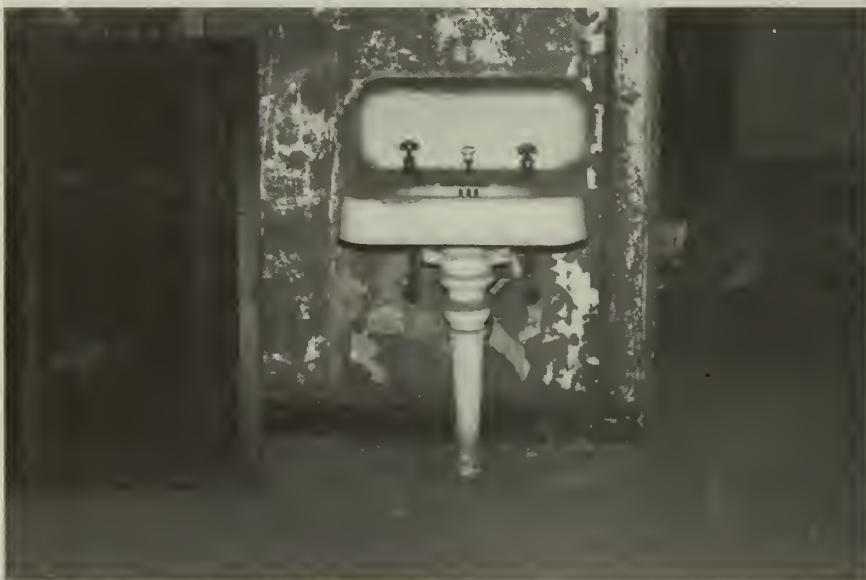
6. Room 202, round pedestal sink, c. 1920's.
