historic structure report architectural data section volume 2: appendixes

#### HISTORIC STRUCTURE REPORT

#### LINDENWALD

## MARTIN VAN BUREN NATIONAL HISTORIC SITE

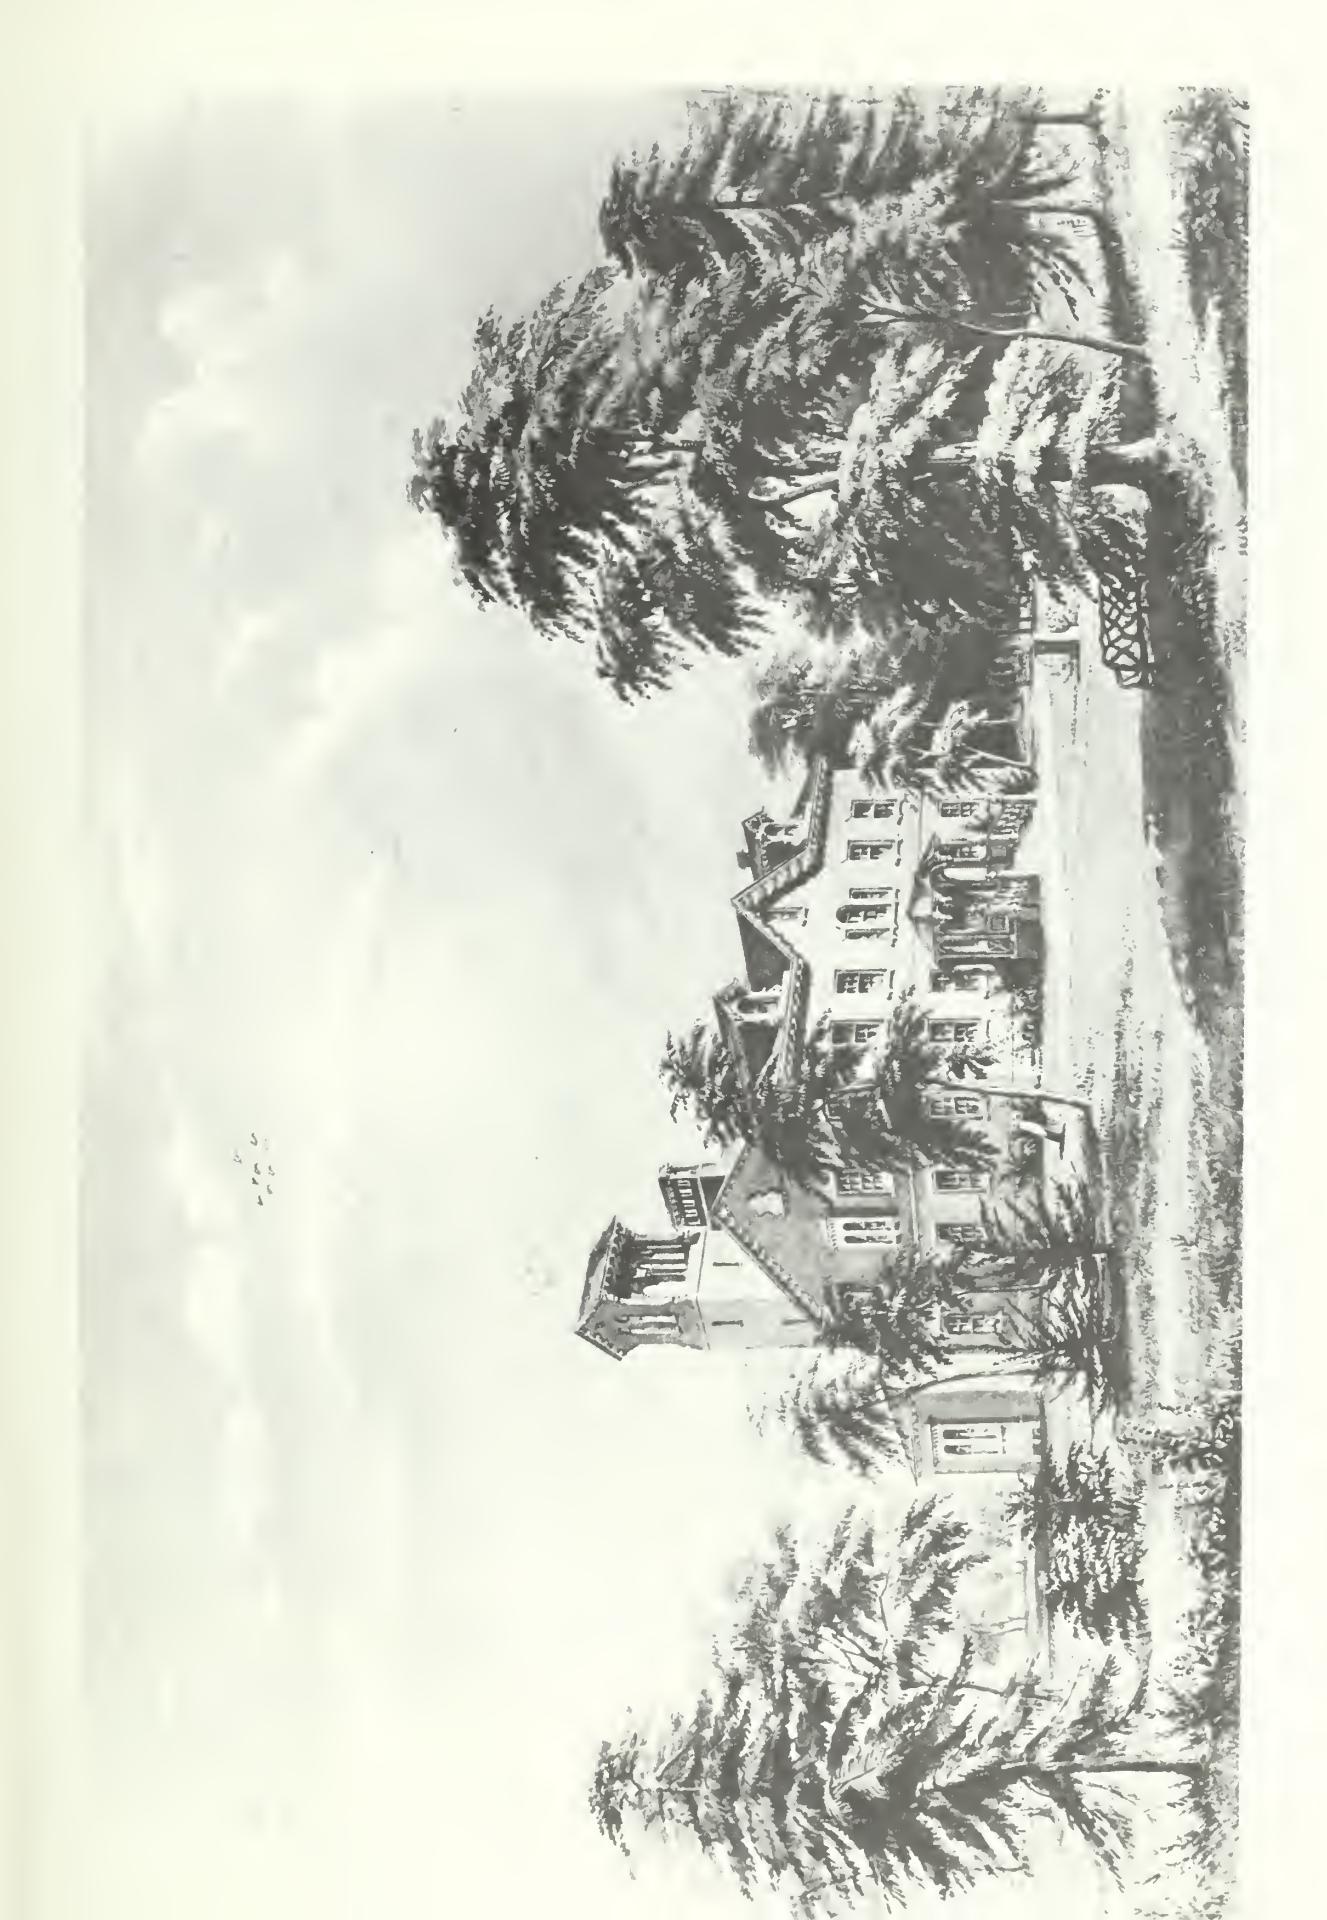
The the This photograph of the south and sides is dated ca. 1890-1900 on the basis of recollections of donor, Hazel Whitbeck, a long-time resident in the vicinity. Lindenwald, ca. 1890-1900. following details should be noted: HP5. east

The chimney base and cap are a dark tone--either dark paint or unpainted brick. There is a return at the south end of the south dormer sill box.

been The southeast corner of the foundation appears to have repointed.

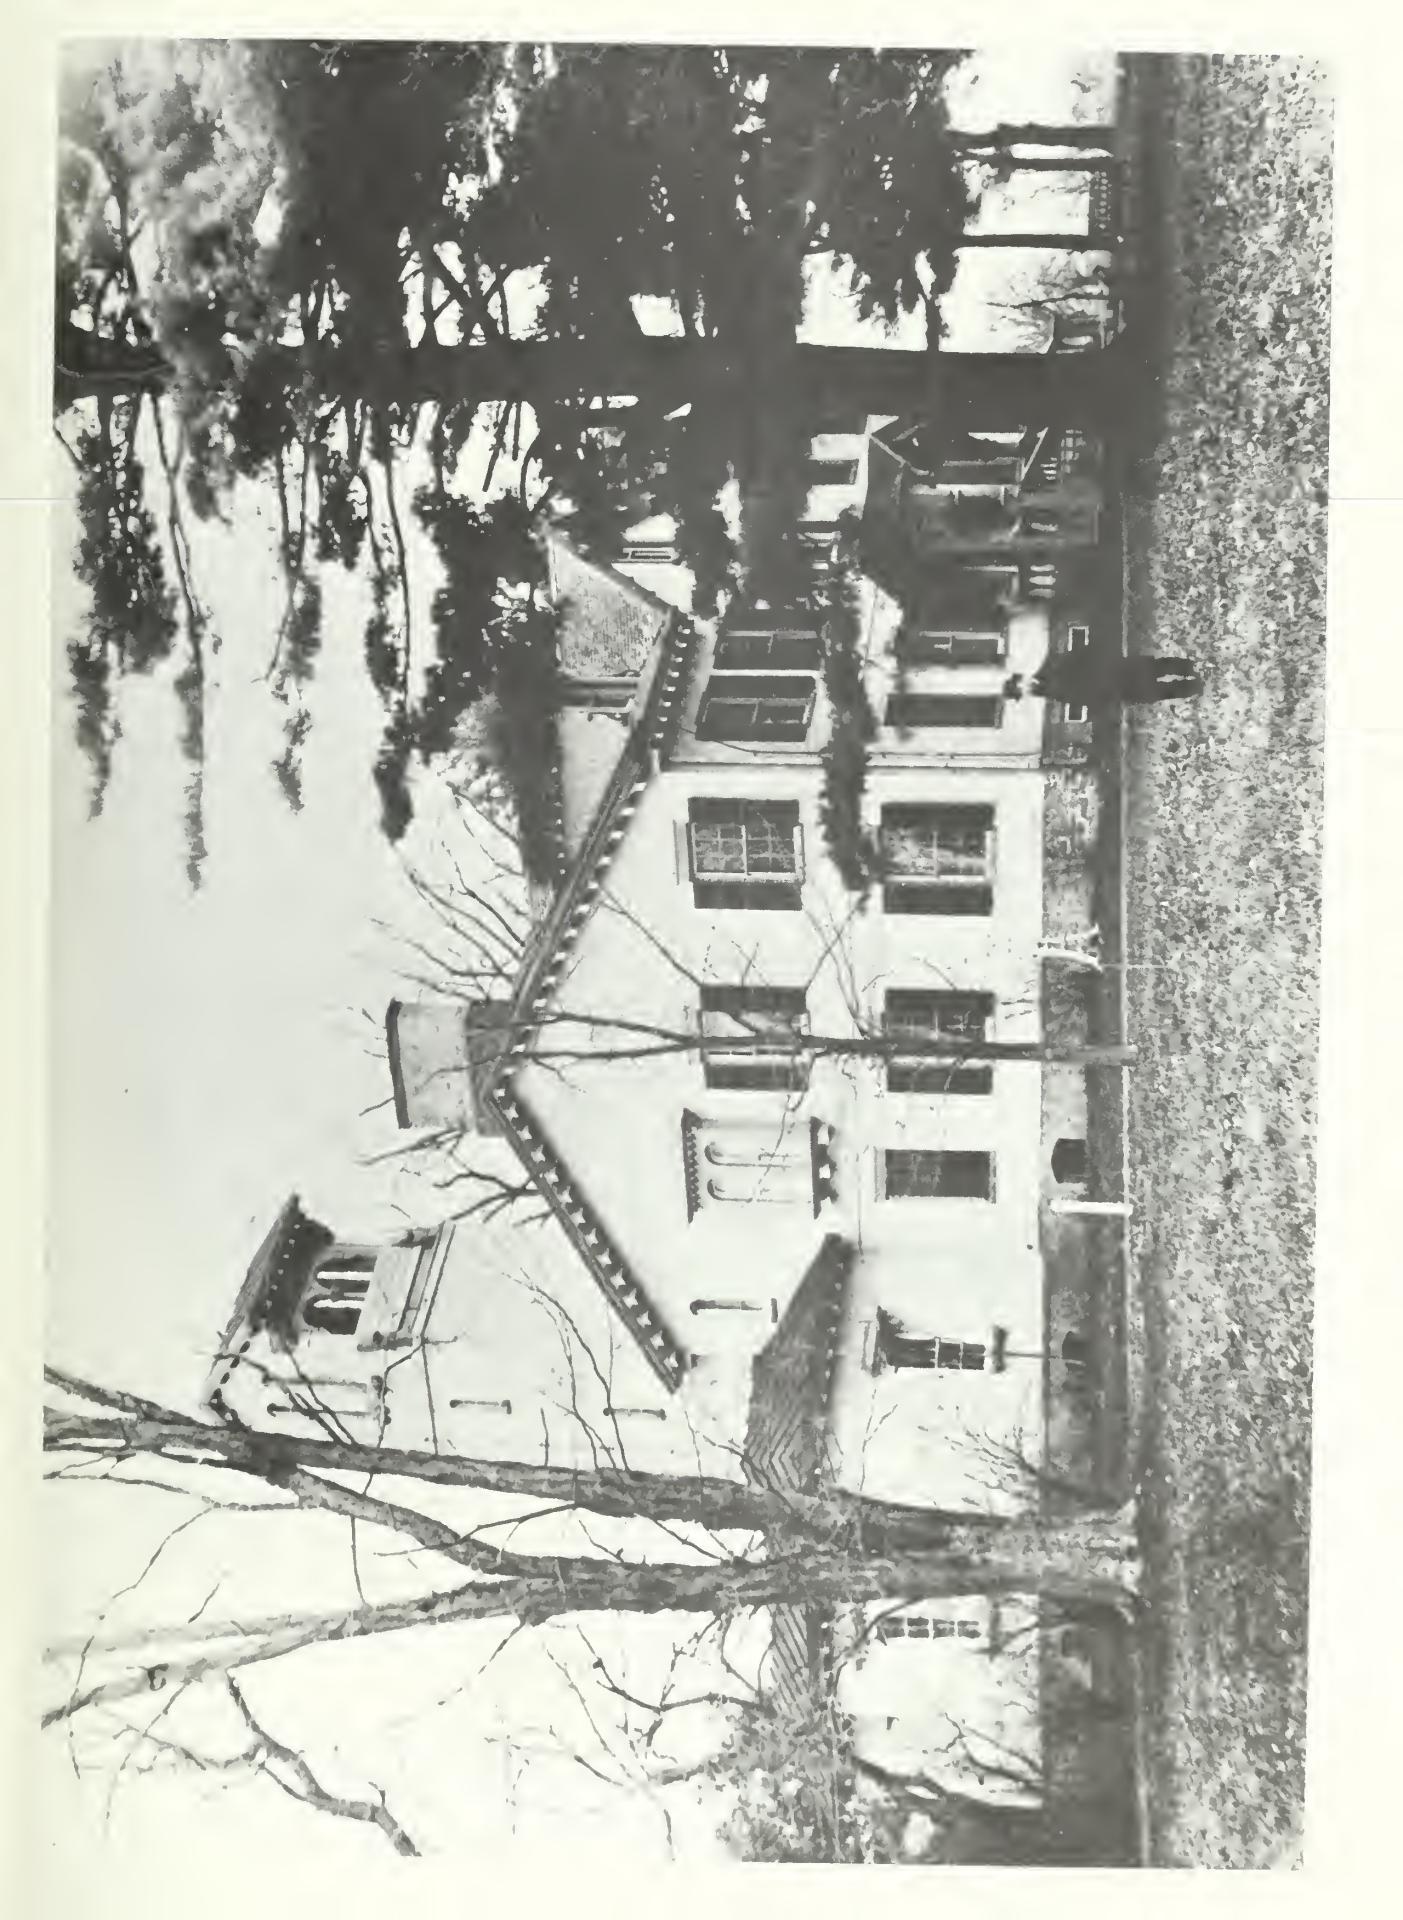
approximate because it is based on the growth of the small tree in the compared to its size in HP5. The following details should date of this photograph is The 1900. Ca. Lindenwald, foreground be noted: HP6.

The dormer sill return is missing.

constitute the visible items of lawn furniture. The tripod trellis tree in the A rustic chair on the front porch, a glider, and a hitching post seen in HP5 may be hidden behind the small foreground.

There is a row of small bushes or ferns along the cheek of the front porch (not present in HP5).

Basement window frames are painted a dark tone.

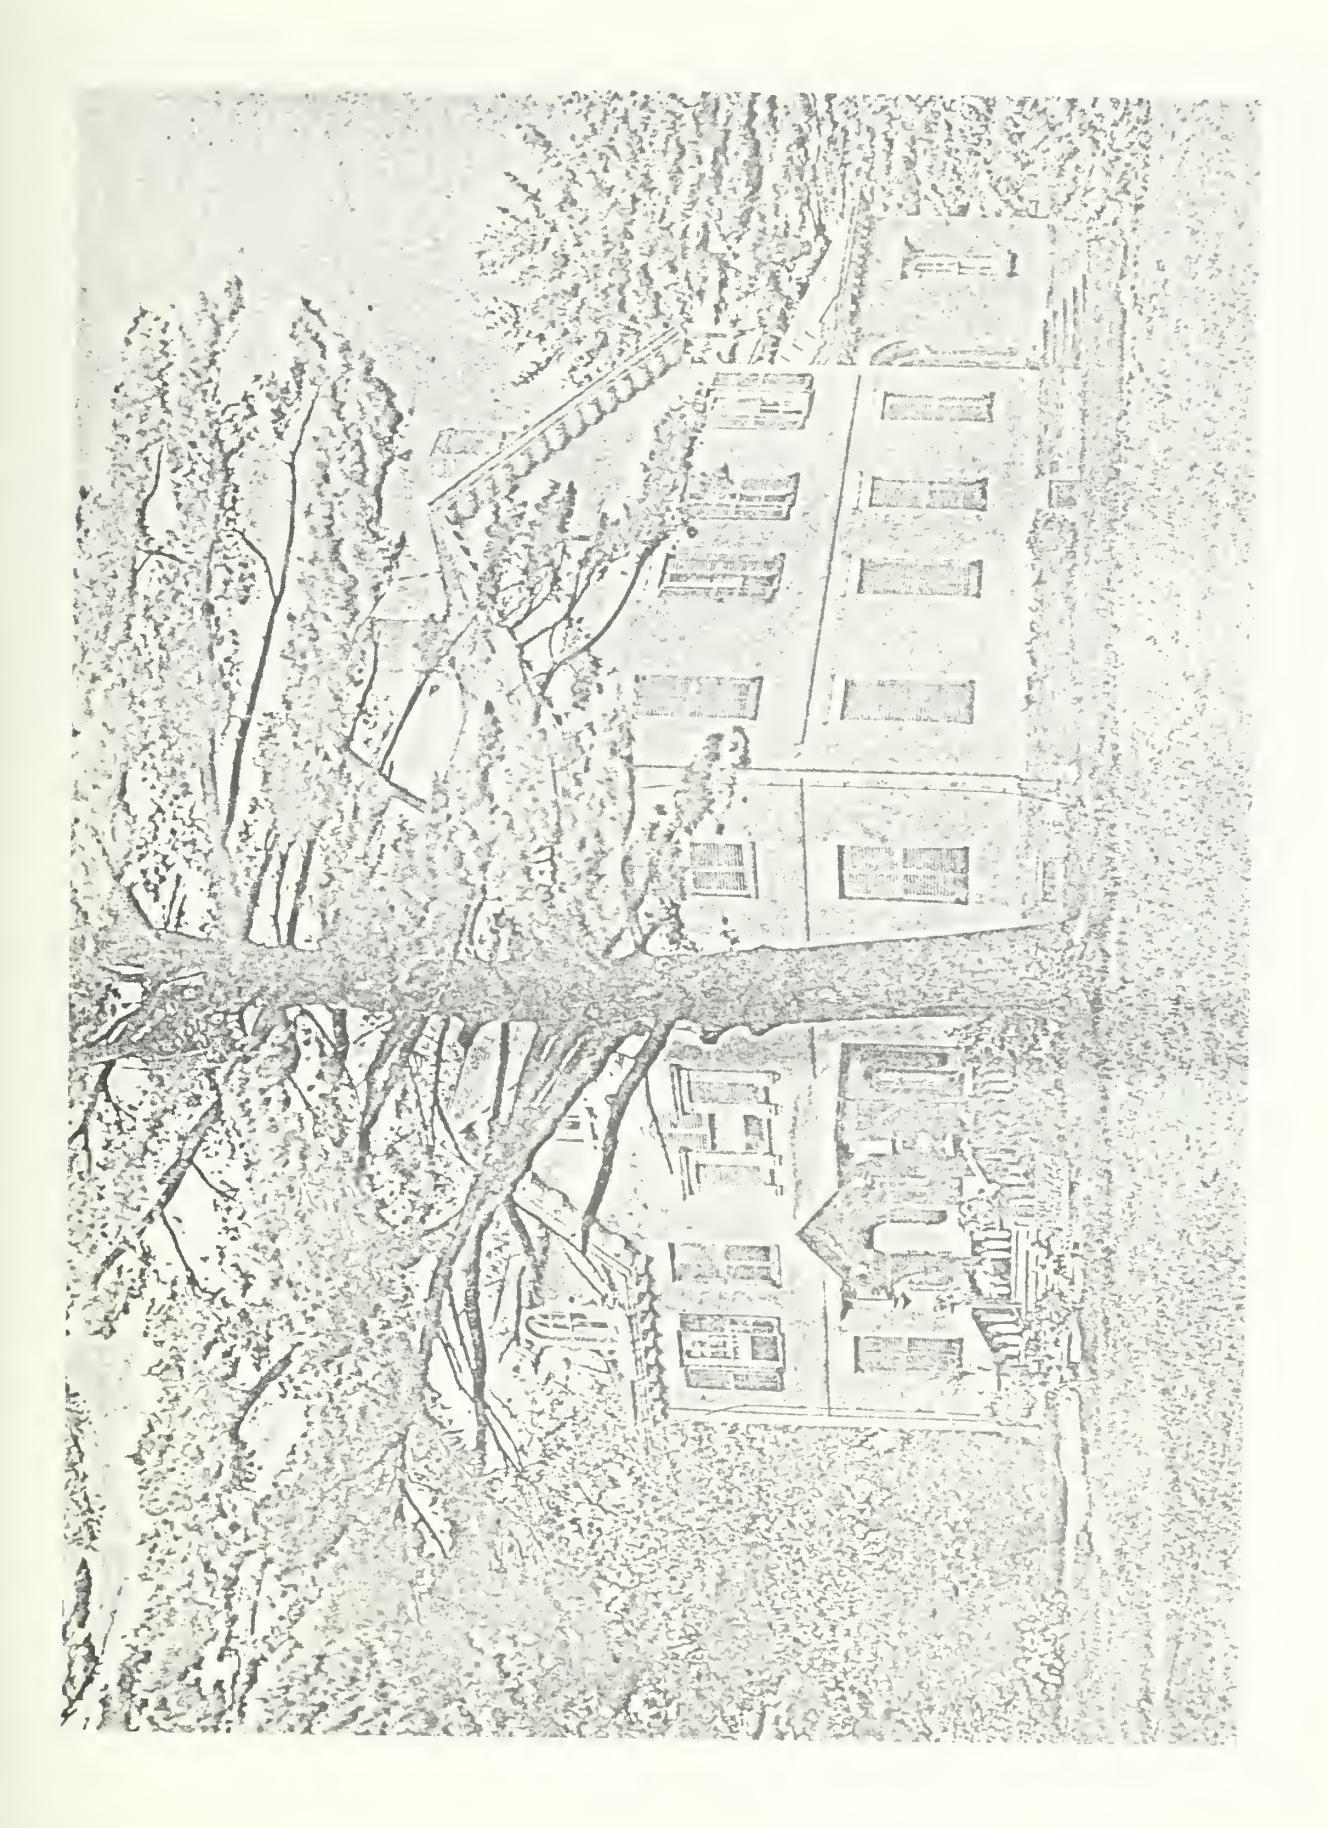
visible on the glass plate, but not included in this print, are the farm office, partially visible at the extreme left (south) side, an adjacent fence, the hitching post, the glider, a cauldron (cast iron?) at the This photograph is from the New York State Archives, glass plate number 82, negative number 10643. The glass plate is dated 1913. The print presented here is an enlargement of the central part of the glass plate. Landscape features base of the south pine tree, another cast-iron bench near the south an outbuilding northwest of the house, and an extensive awn with trees and shrubs. Within the area of this print, the Lindenwald, East Elevation, ca. 1913. following details should be noted: pine tree, HP10.

Lightning rods and conductors are present.

a cast-iron bench There are two rustic chairs on the porch and under the north pine tree. The north hydrangea appears to be 6' to 7' tall and the south one 4' to 5' tall. The foundation, window frames, shutters, and front porch seem to be painted a dark tone. Sash, bricks, and cornice appear to be painted a lighter tone.

The dark area at the base of the north foundation may be the ferns present in HP9.

The north end of the north The south dormer sill box is askew. dormer sill box is detached.

the Sheet-metal gutters have been added to the level eaves of south dormer.

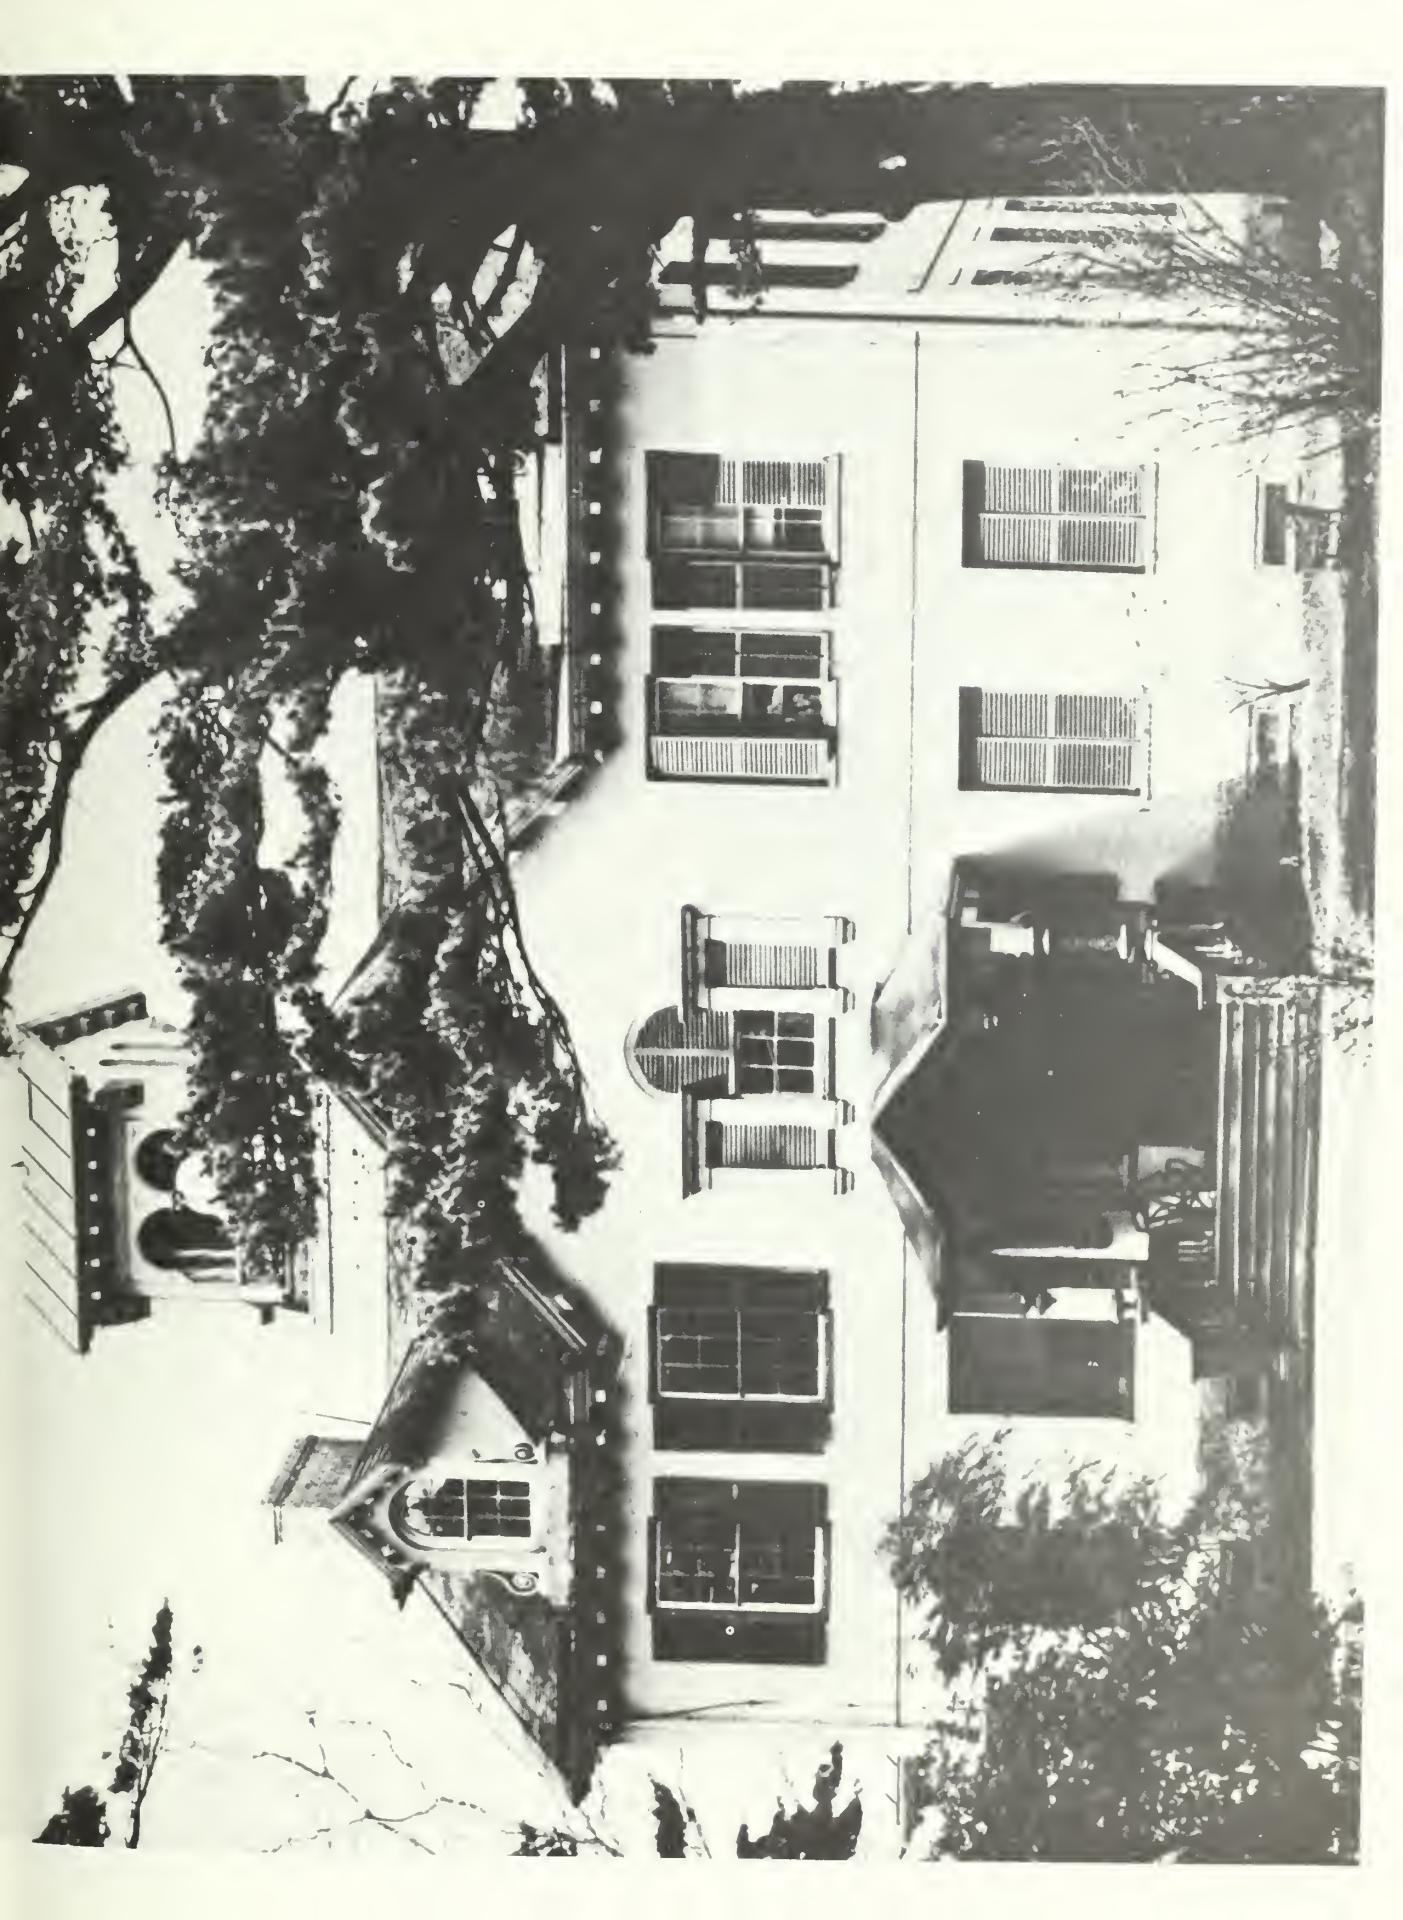
The on similarities with HP10, the fact that the hydrangeas are slightly This date is based larger, the state of deterioration of the dormer sill boxes, continued presence of lightning rods, and the wood shingle roof. East Elevation, ca. 1913-1917. following details should be noted: Lindenwald, HP11.

to be painted a darker tone. Sash, bricks, and cornice appear to The foundation window frames, shutters, and front porch appear be painted a lighter tone.

Two rustic chairs and a wicker rocker can be seen on the front porch. Two cast-iron benches are placed in the shade of the north and south pine trees. A row of potted plants lines a A cluster of similar potted plants is to the east of this line and on axis with the front door. What may be a cast-iron cauldron appears in the The north hydrangea is 7' to 8' tall and the south one 4' to 5' path or drive parallel to the front of the house. left foreground under the south pine tree. tall.

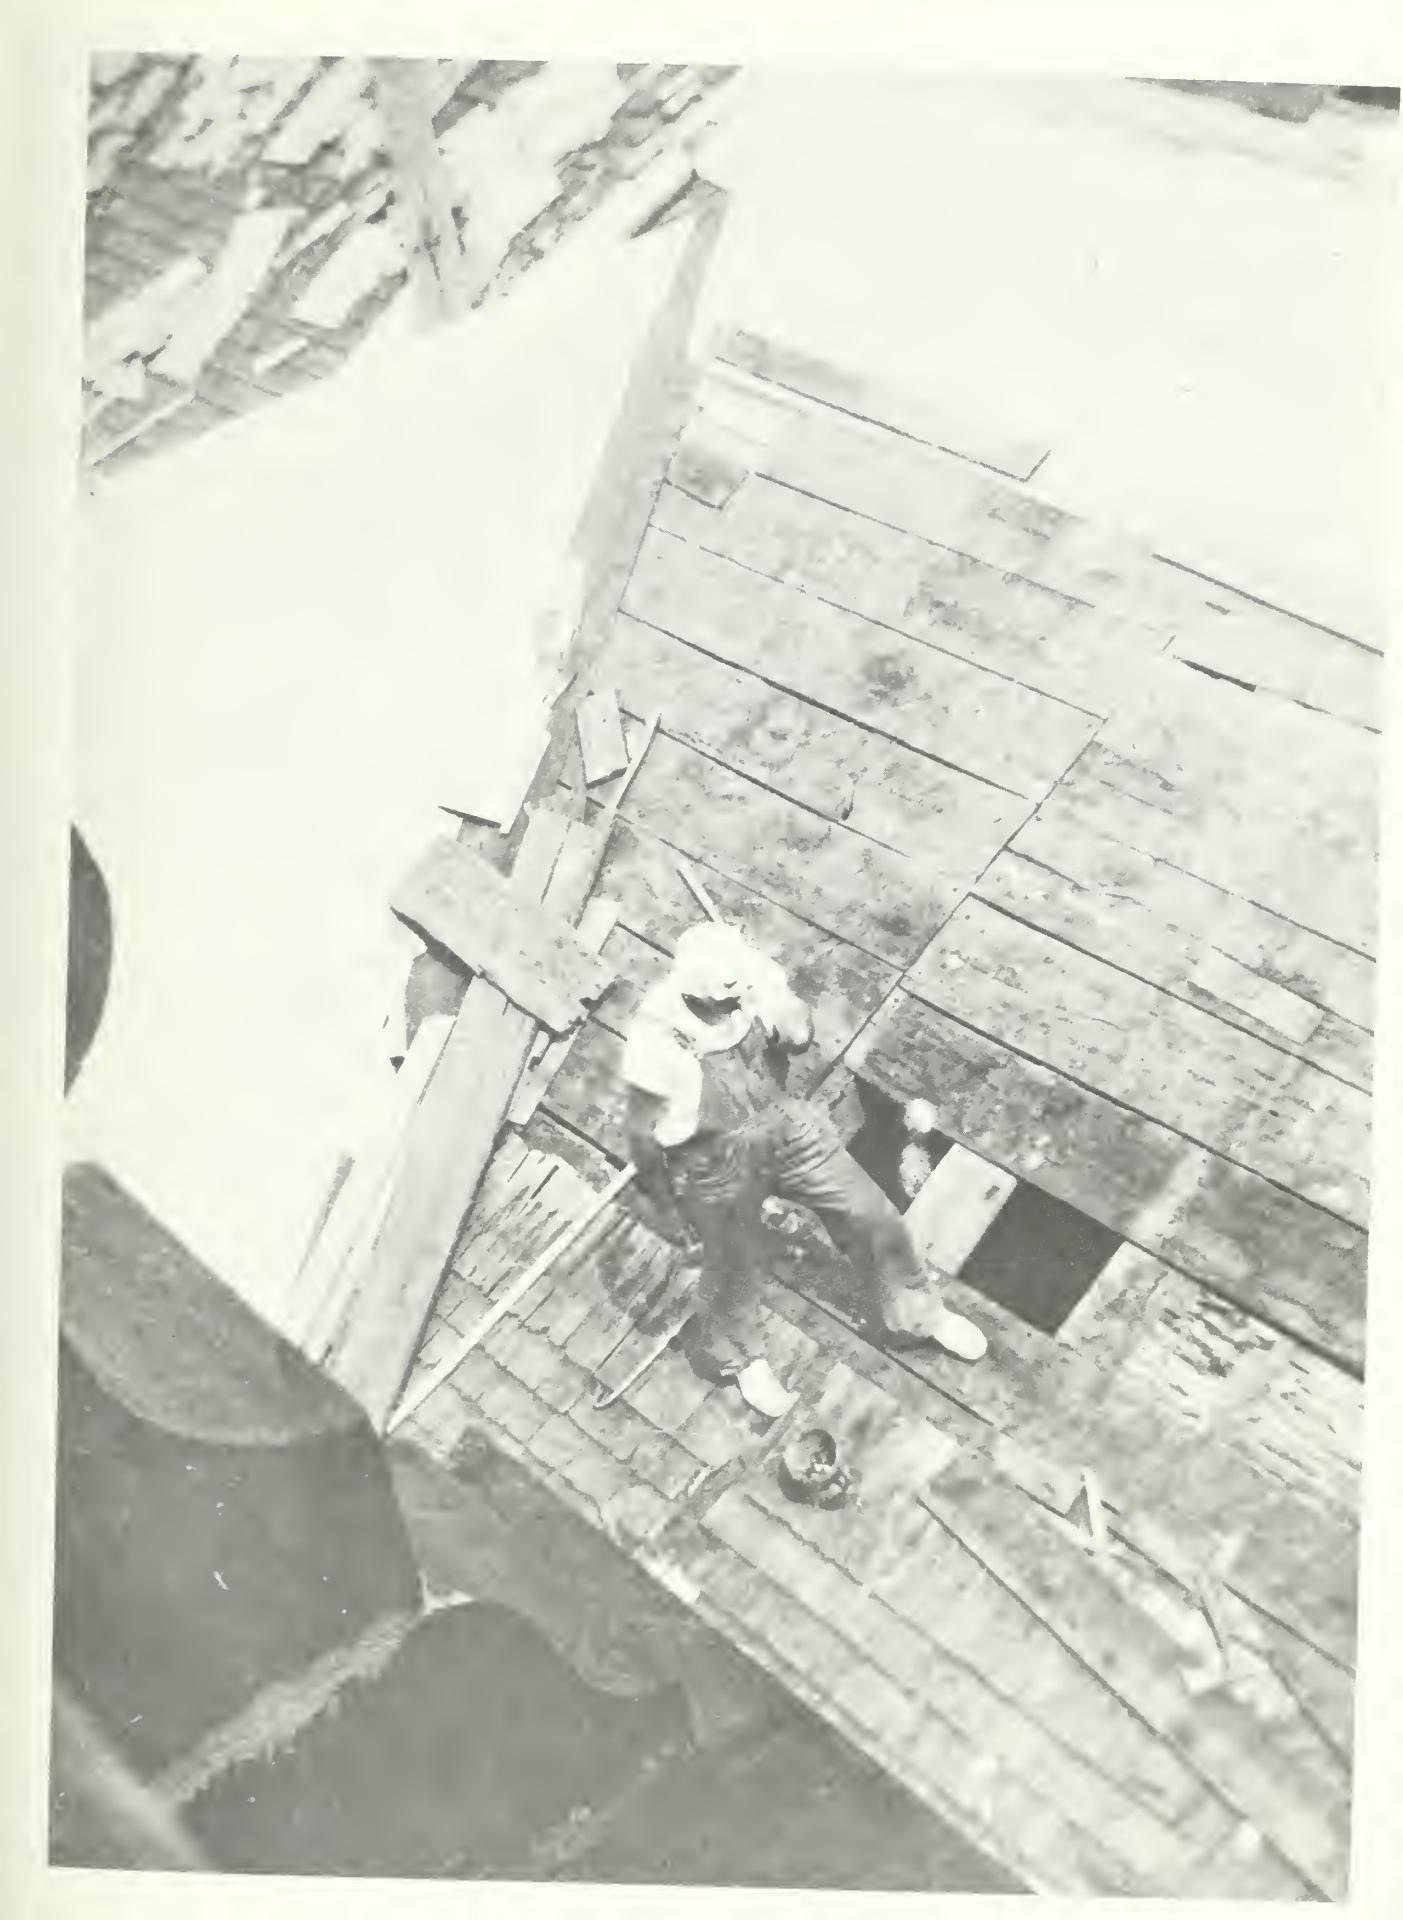
Note HP15. This photograph again shows Dr. Bascom Birney in the process of removing shingles from the west slope of the ca. 1797 roof. Note the roofing bracket near the top right corner of the photograph.

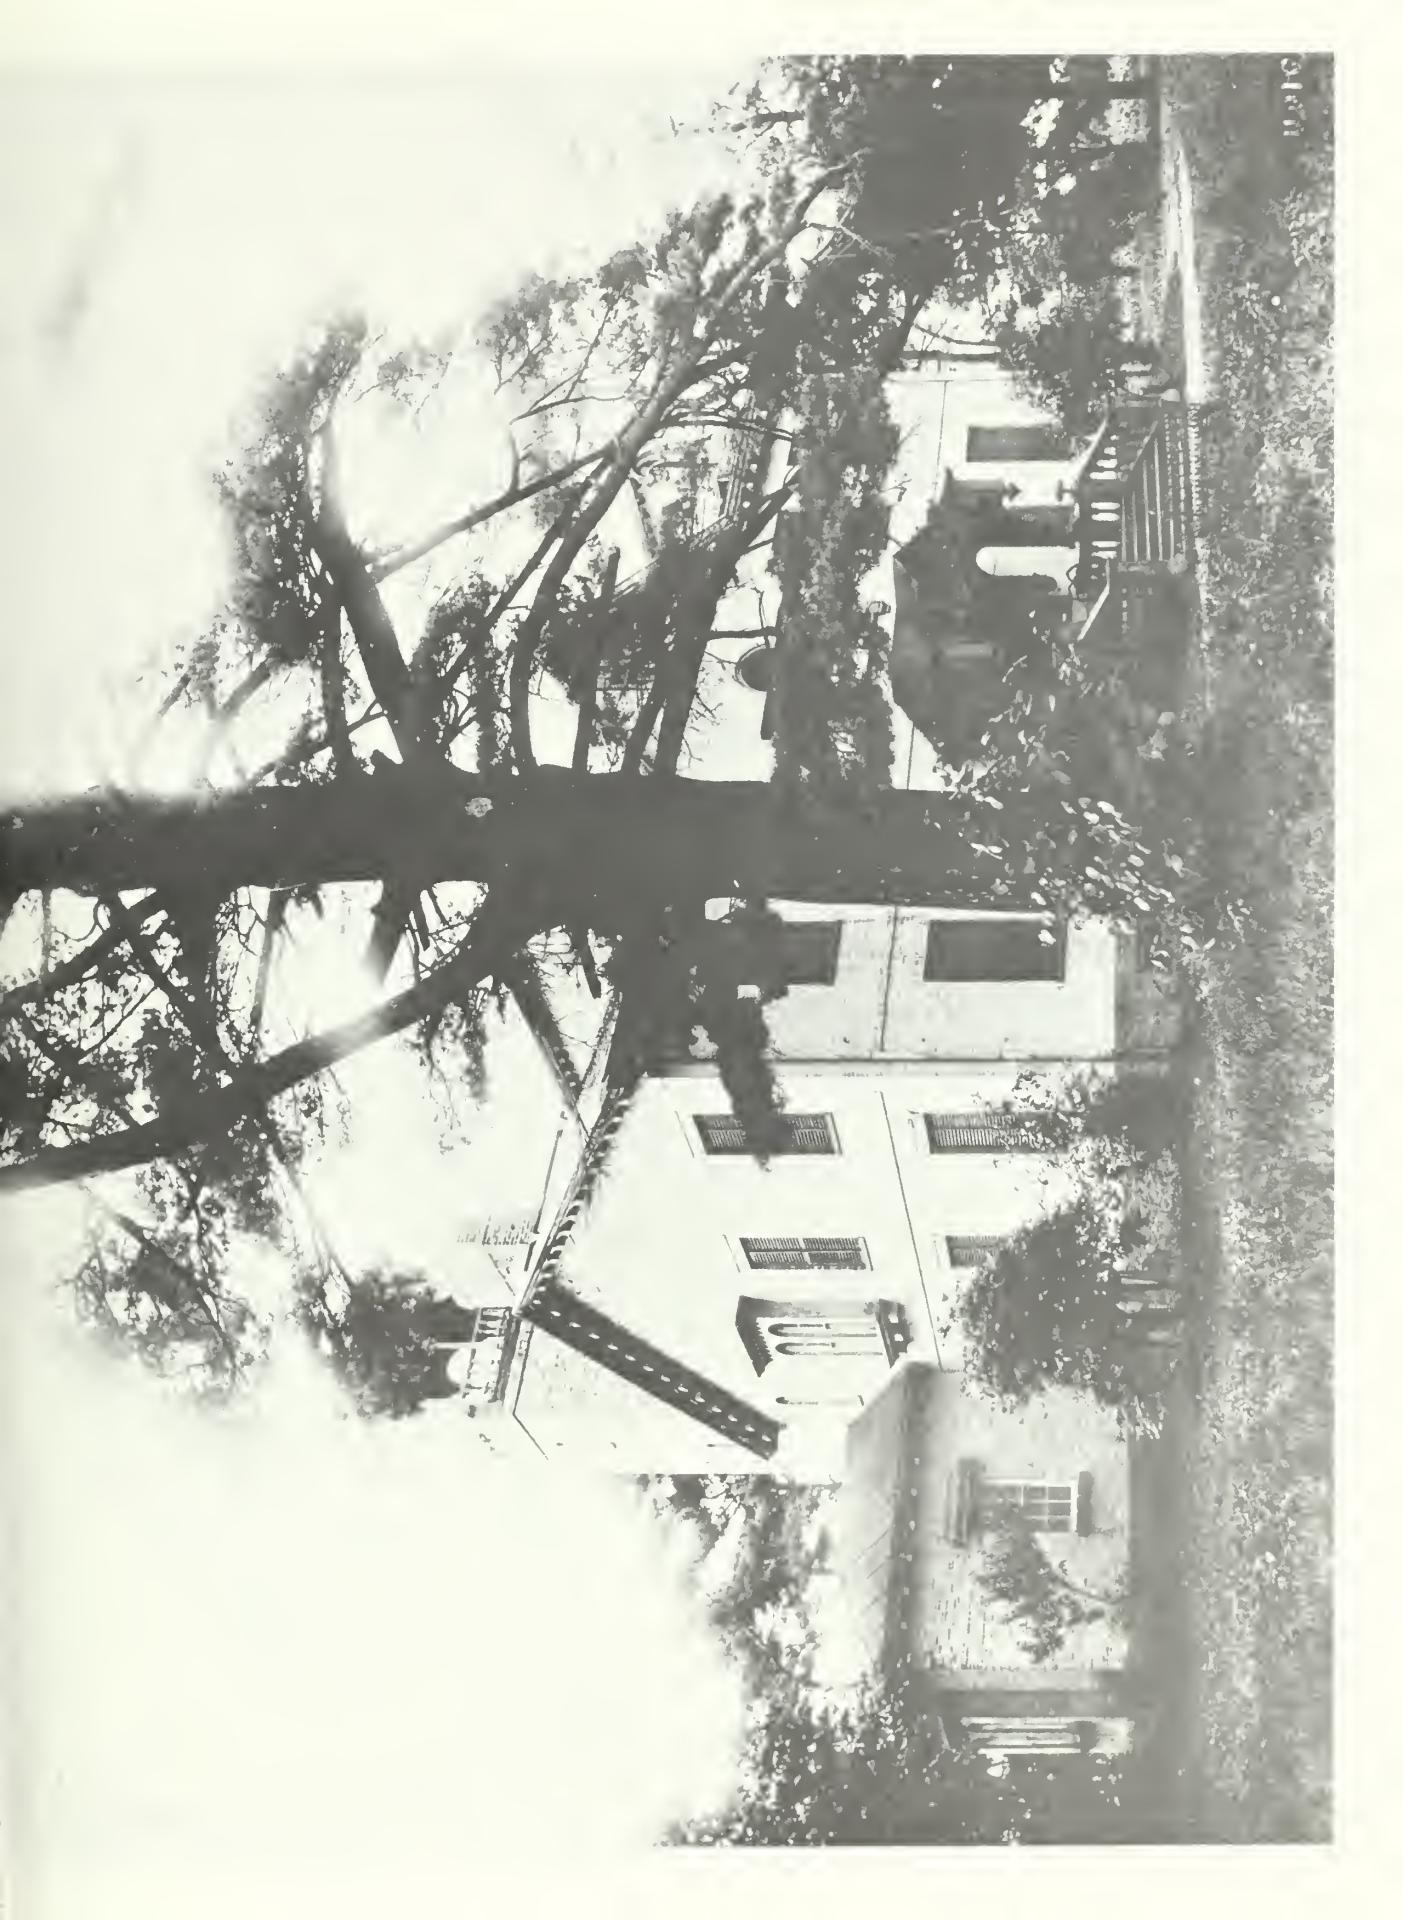
HP19. This photograph is a detail of HP18.

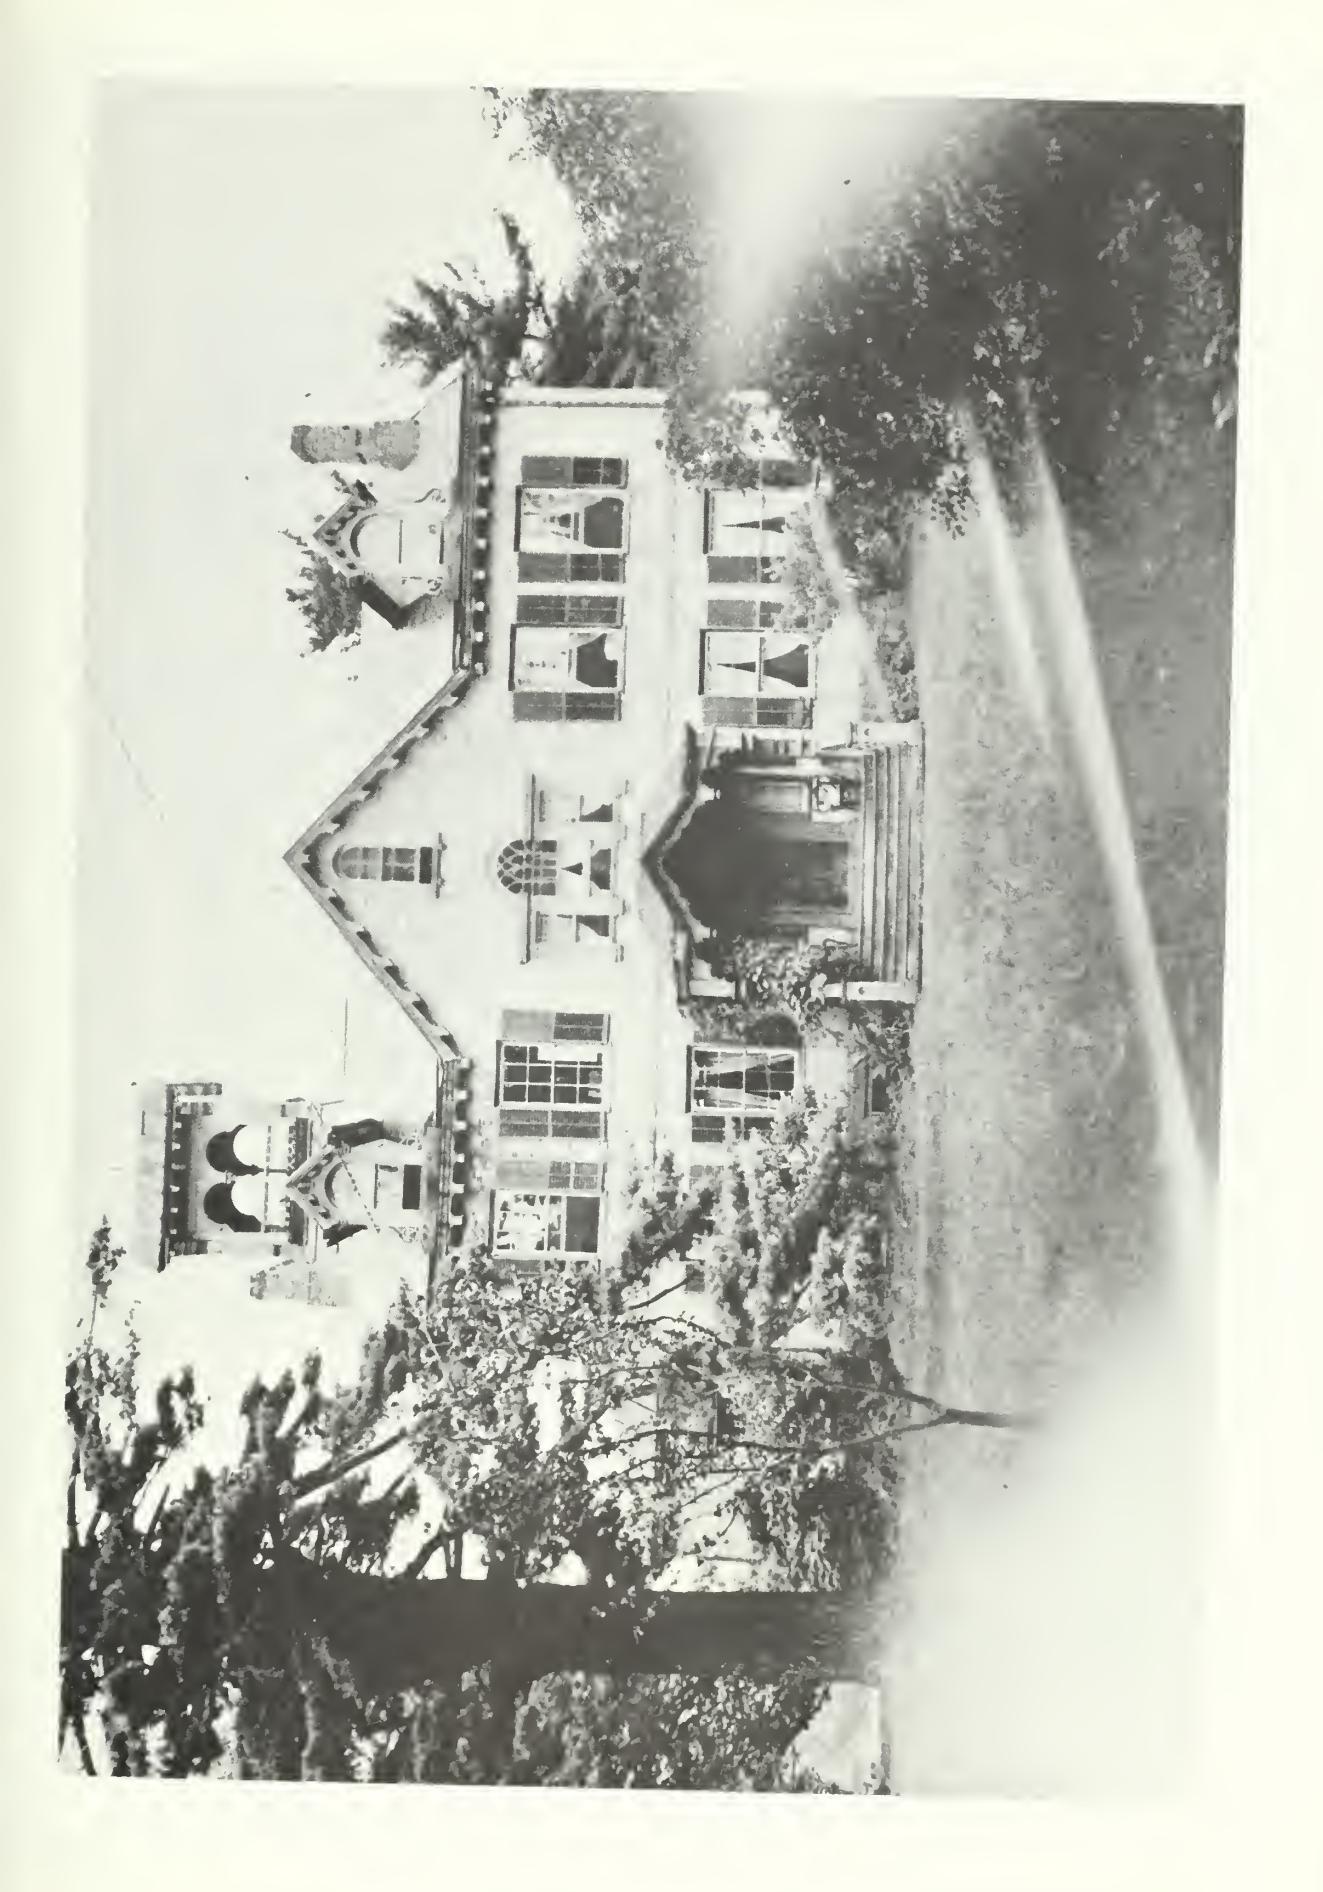
HP25. Ca. 1850 Front Porch, 1936. This photograph was taken by Melvin Weig on August 3, 1936. The following details should be noted:

pattern of seams in sheet-metal roofing

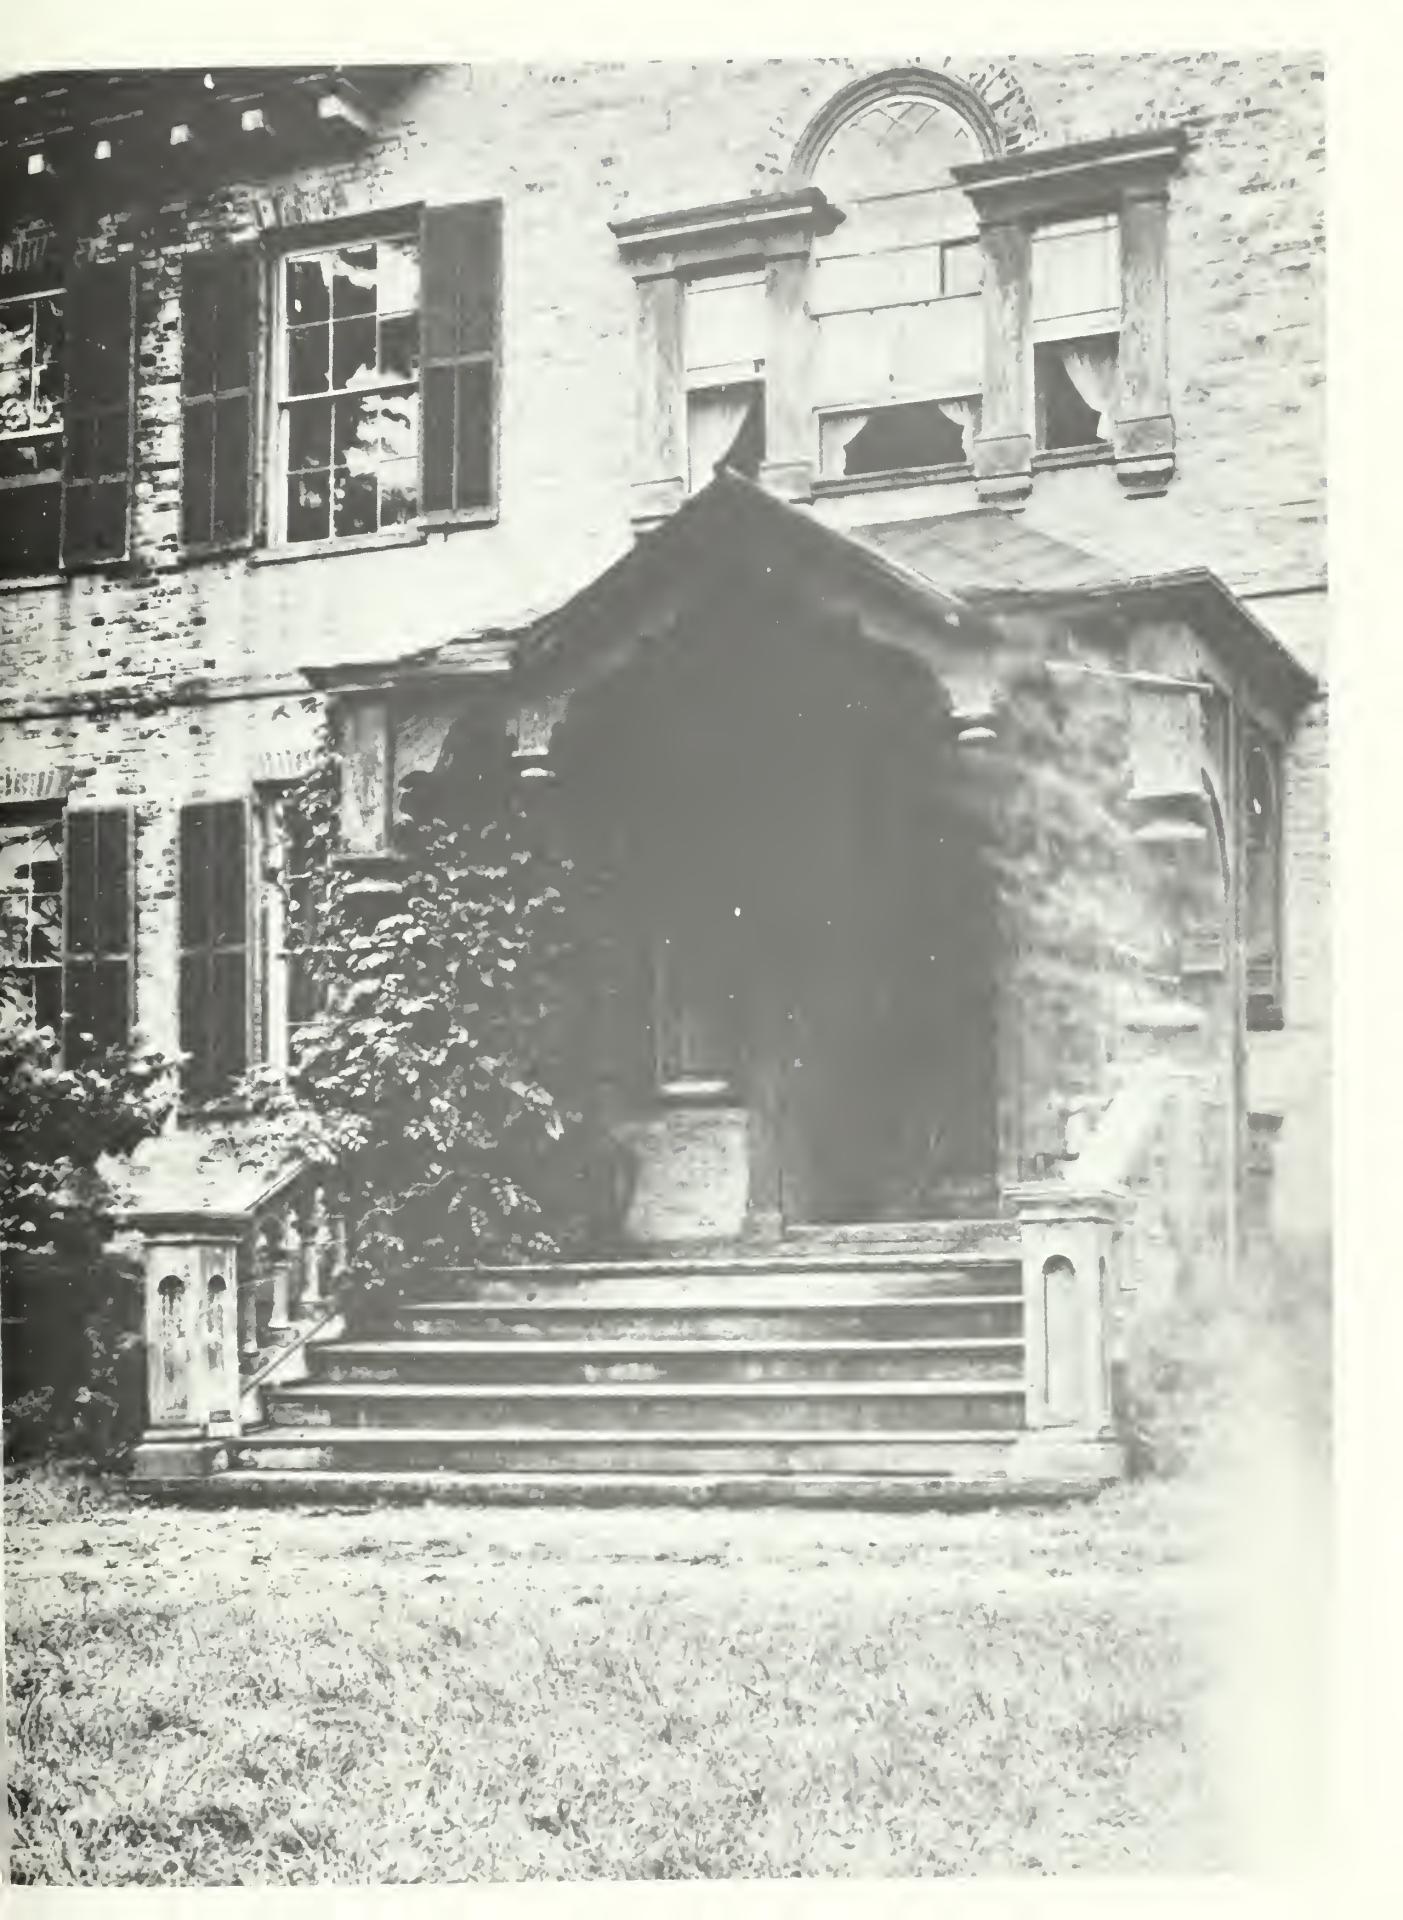
North Side of Lindenwald, 1936. This photograph was taken by Melvin Weig on August 3, 1936. The following details should be noted: HP26.

σ There is new flashing on the north gable capping board and rainwater diverter at east end.

The paint scheme is the same as that observed in HP23.
