historic structure report architectural data section volume 2: appendixes

#### HISTORIC STRUCTURE REPORT

#### LINDENWALD

## MARTIN VAN BUREN NATIONAL HISTORIC SITE

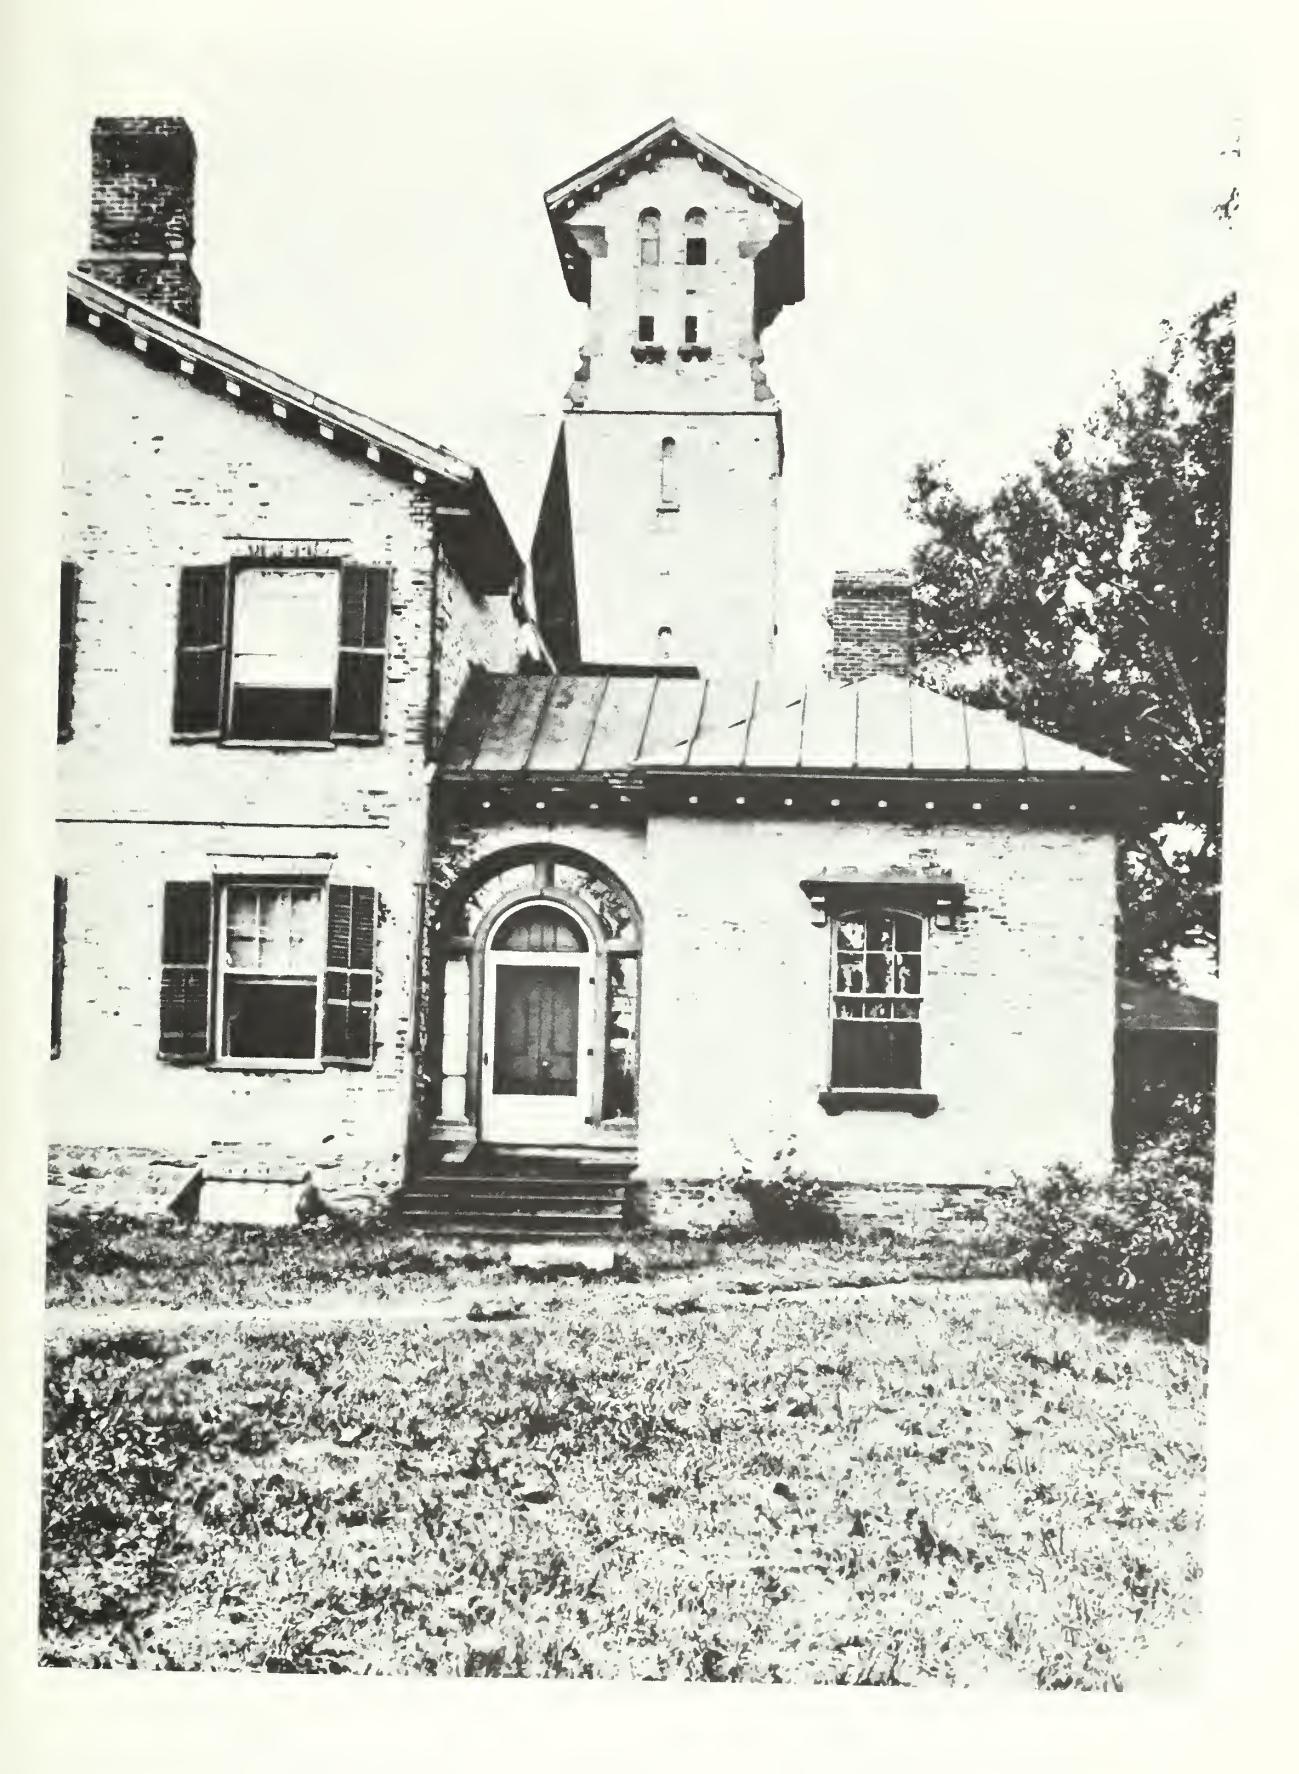
HP28. Lindenwald, West Elevation, 1936. This photograph was taken by Melvin Weig on August 3, 1936. The following details should be noted:

An early 20th century porch is attached to rooms II2 and II4.

There are modillions on the skylight cornice.

There are steps at door 112.

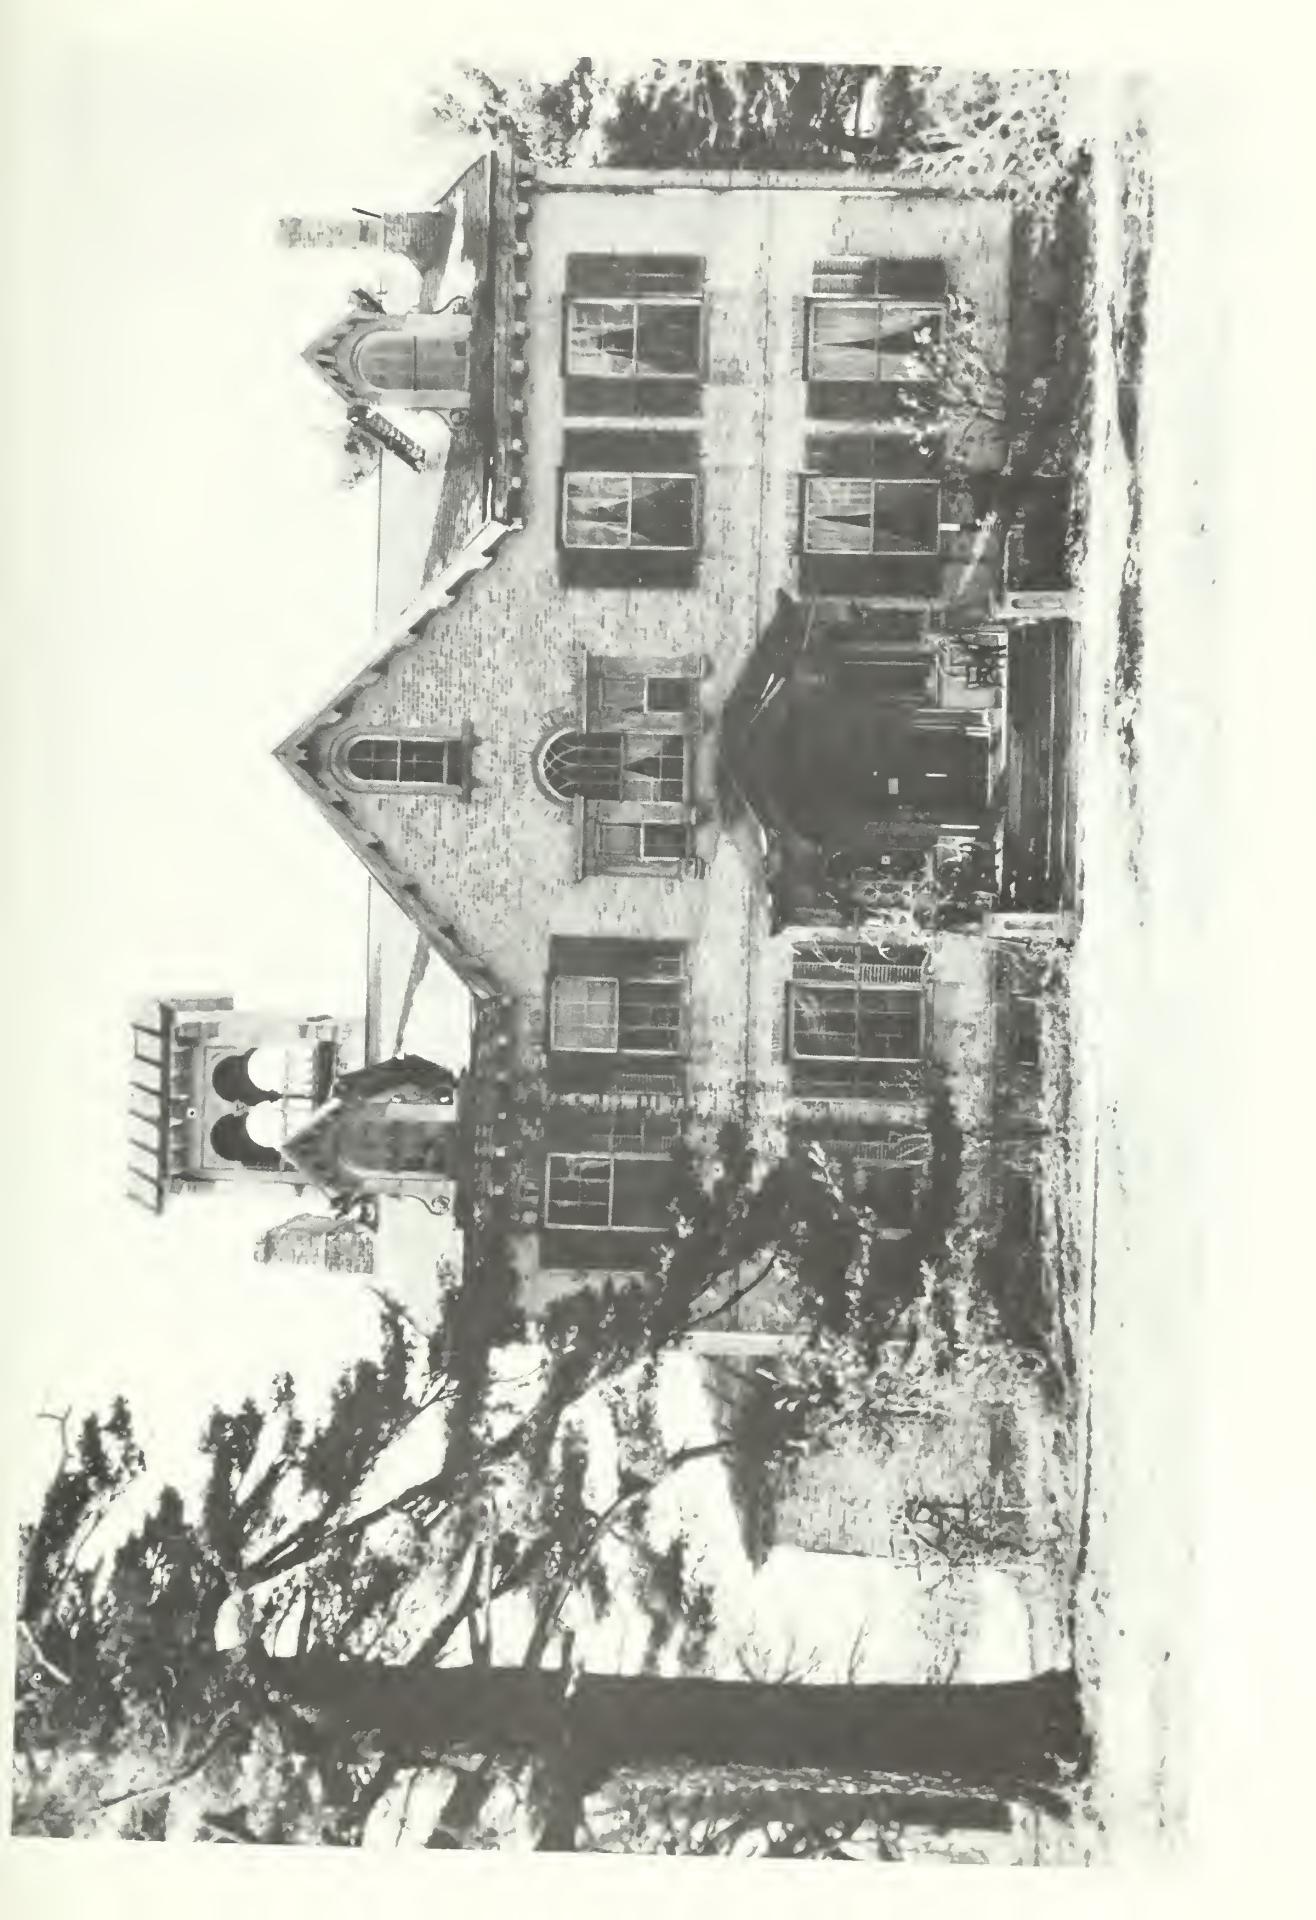
HP35. Front Door of Lindenwald (Door 101), 1937. This photograph was taken by Nelson Baldwin in January 1937. The following details should be noted:

The front door is painted an even darker tone. The porch rafters and ceiling (sheathing boards) appear to match the brickwork. The sash are painted a lighter tone than the brickwork. Door and window trim and the porch elements are painted a darker tone.

There are stuccoed areas over windows 103 and 104.

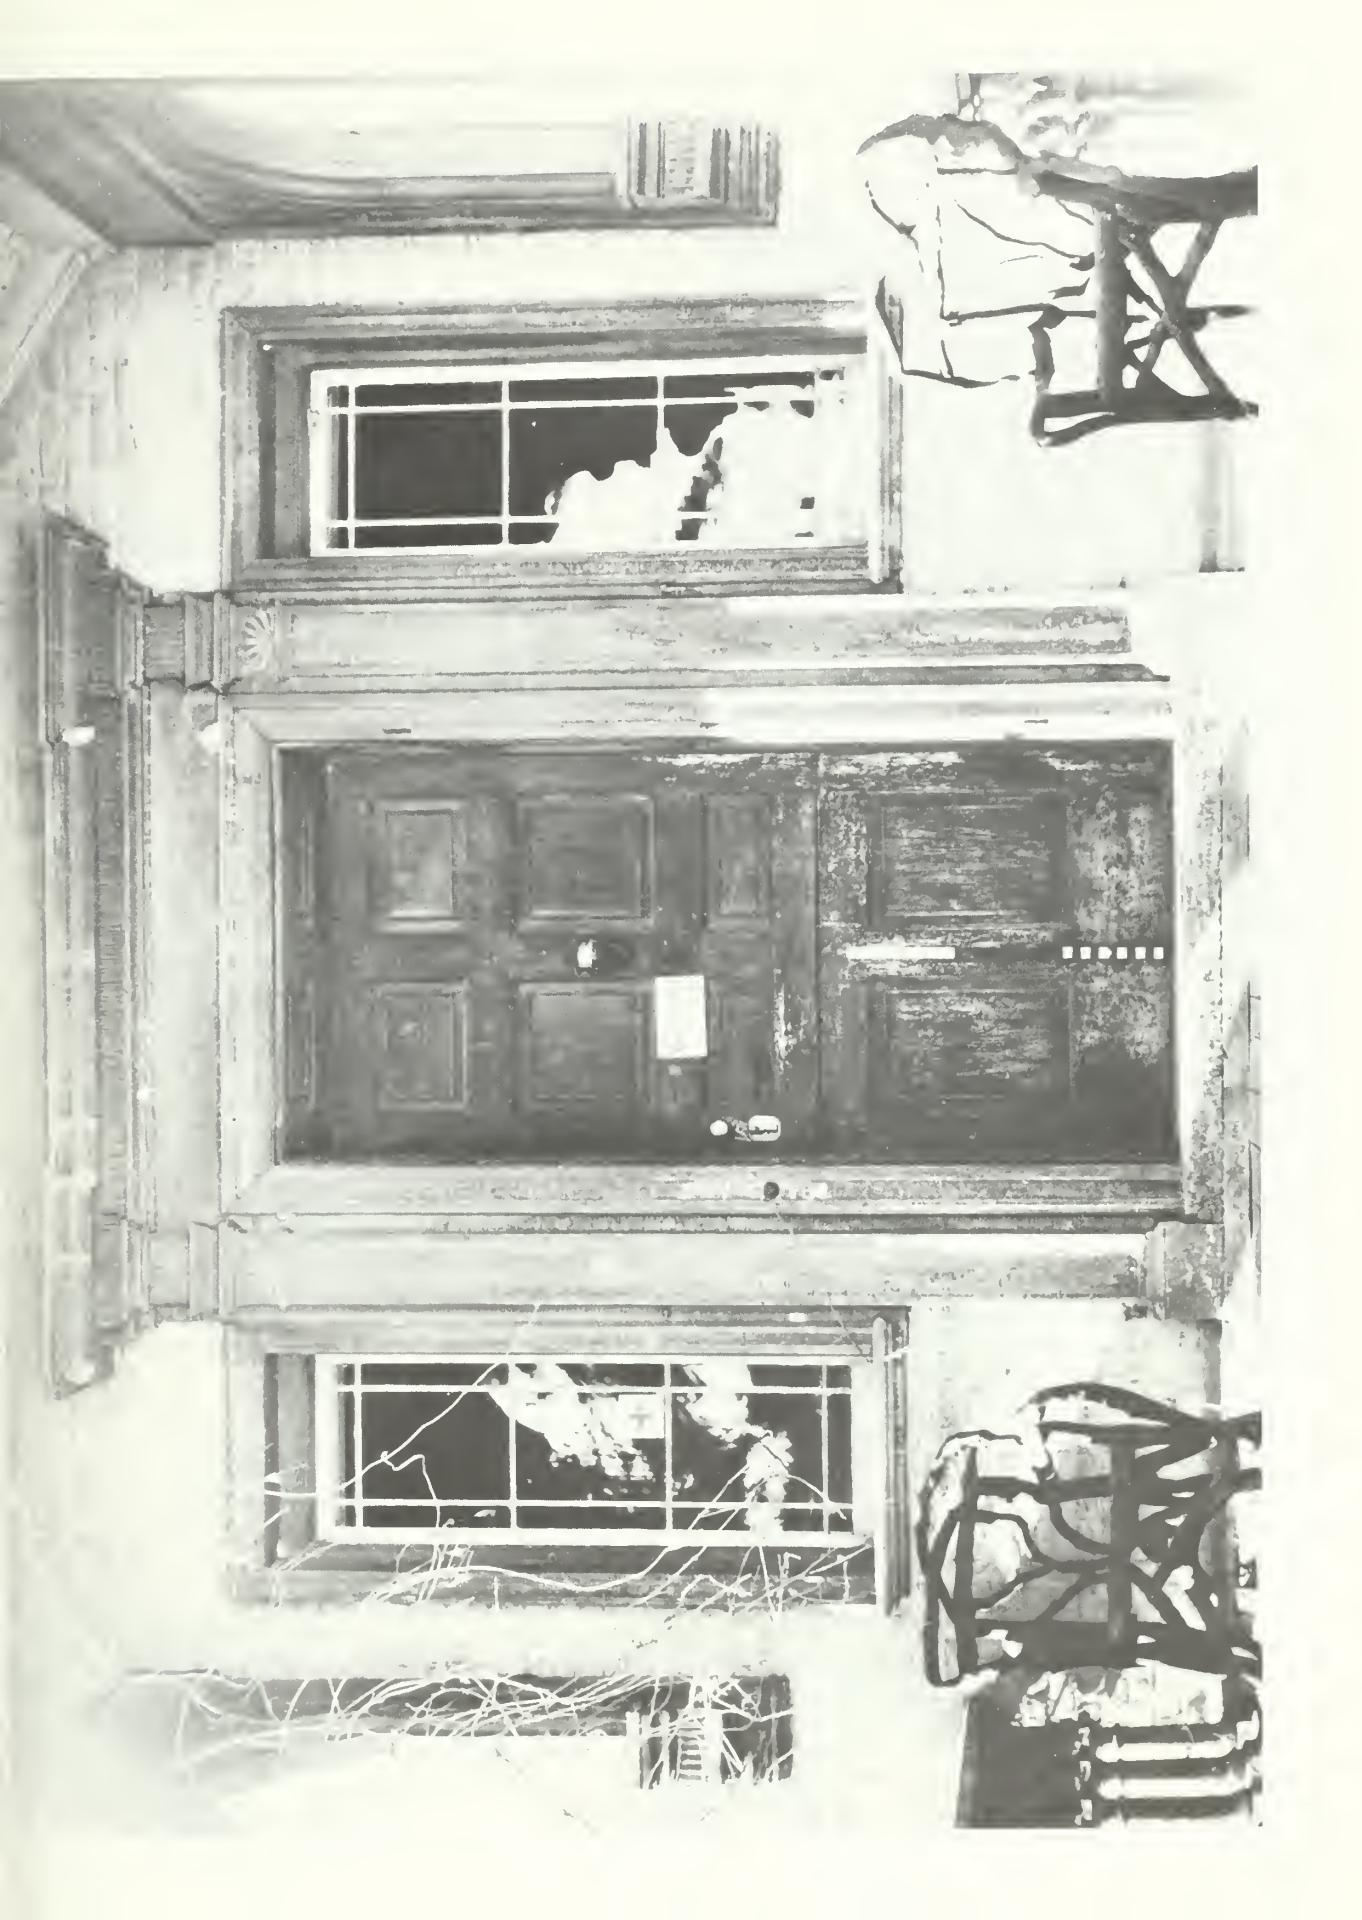
North Elevation of Lindenwald, 1937. This photograph was taken by Nelson Baldwin in January 1937. The following details should be noted: HP36.

The paint scheme is the same as in HP33.

Remnants of ferns are present at the east end of the north foundation wall.

There is a cover over window 007.

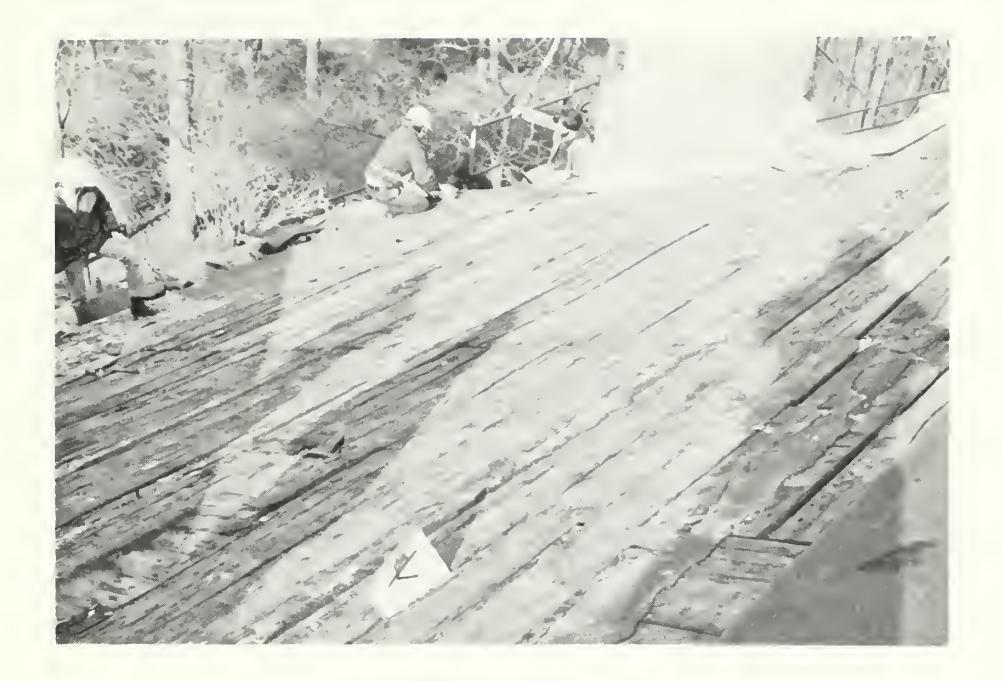
IP003, N039-01. Main roof, northwest corner looking northwest. Note hatch infill in foreground.

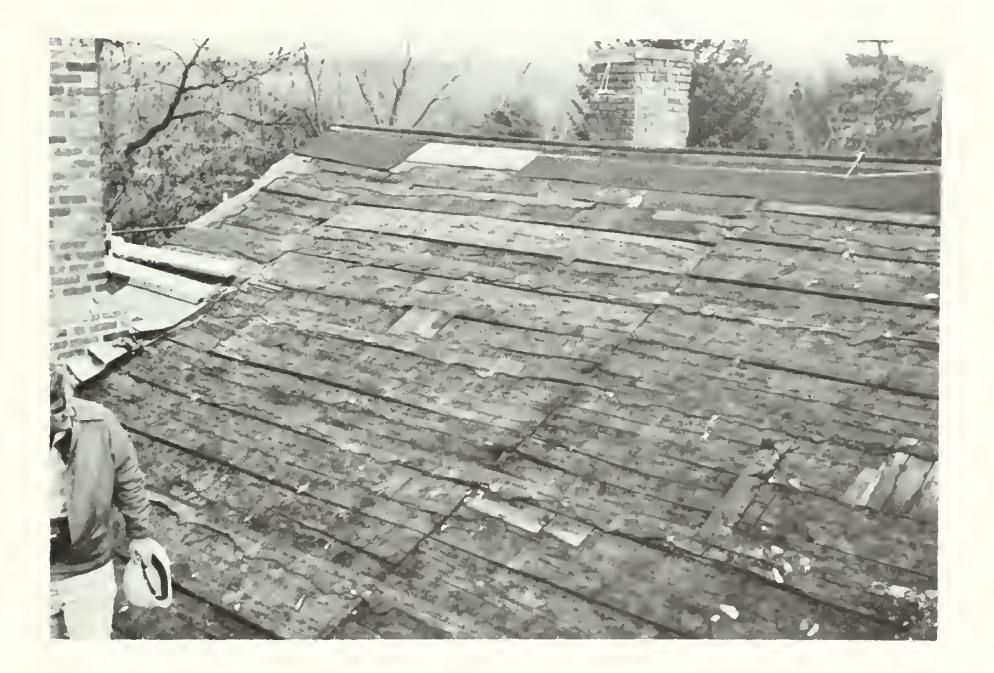
IP004, N039-07. Main roof, northwest corner looking northeast. Note shingle shims.

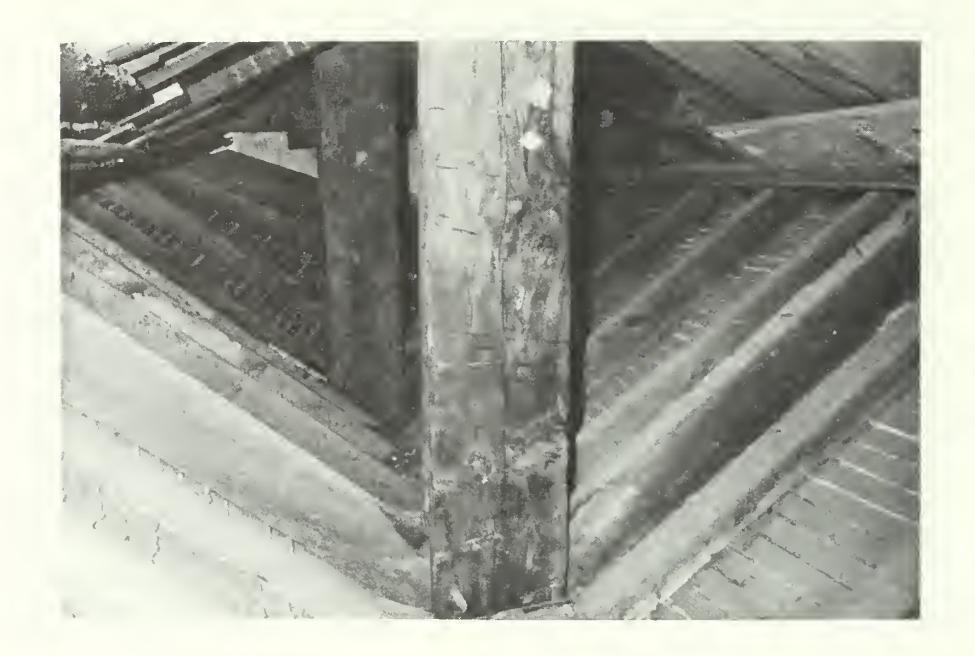
IP005, N002-11. Kingposts above ca. 1849 ceiling. Note plaster on end wall.

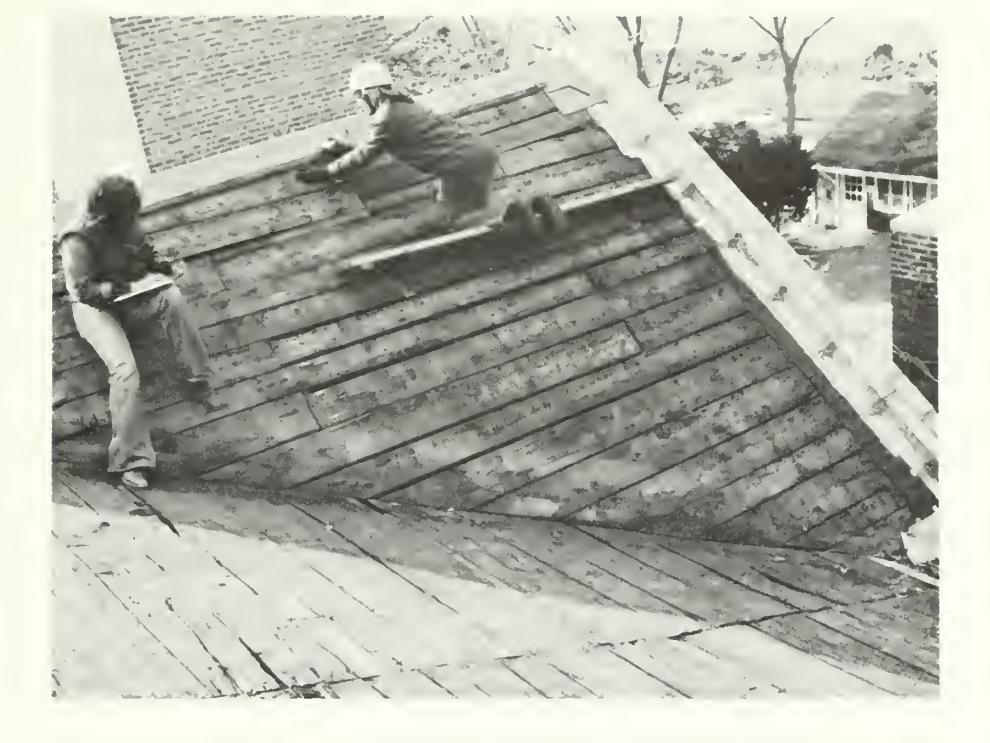
IP007, N039-14. Gable sheathing.

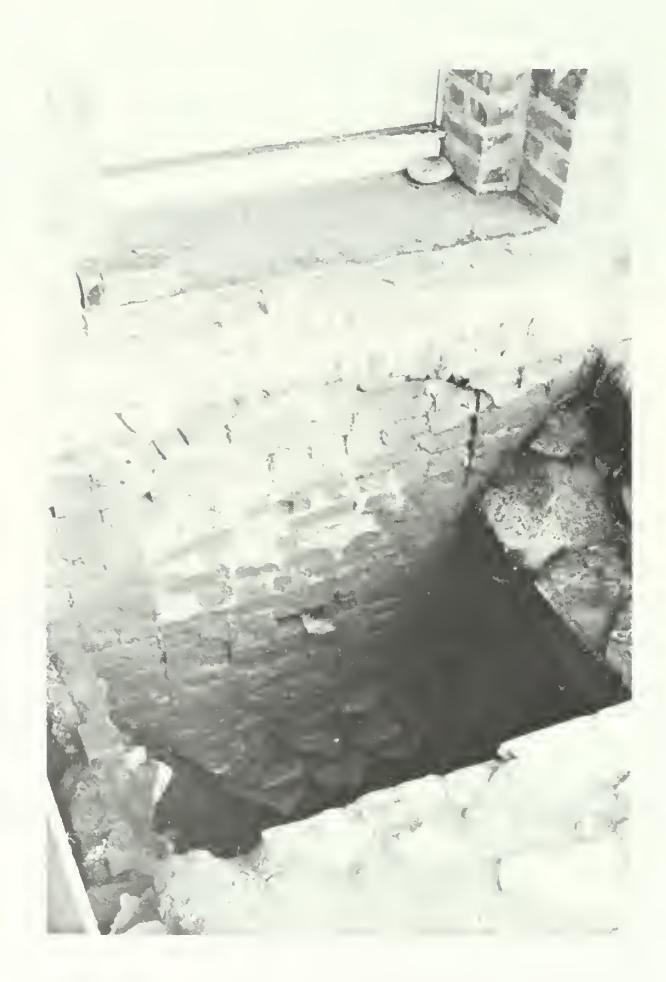
IP009, N004-19. Exterior view of door 010, probable entrance to cold storage area.

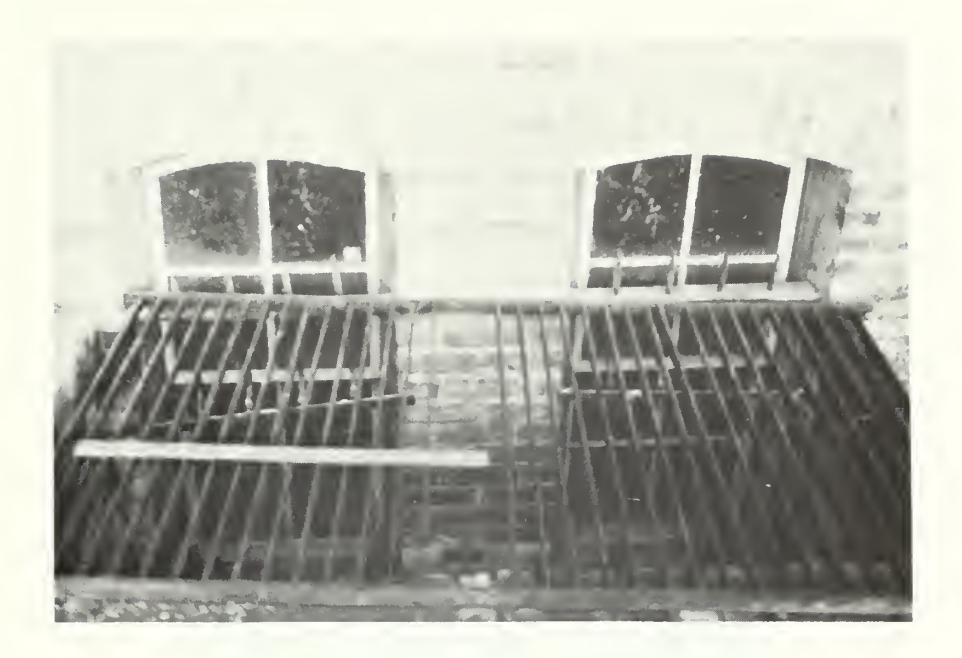
IP010, N019-14. Window well 012-13.

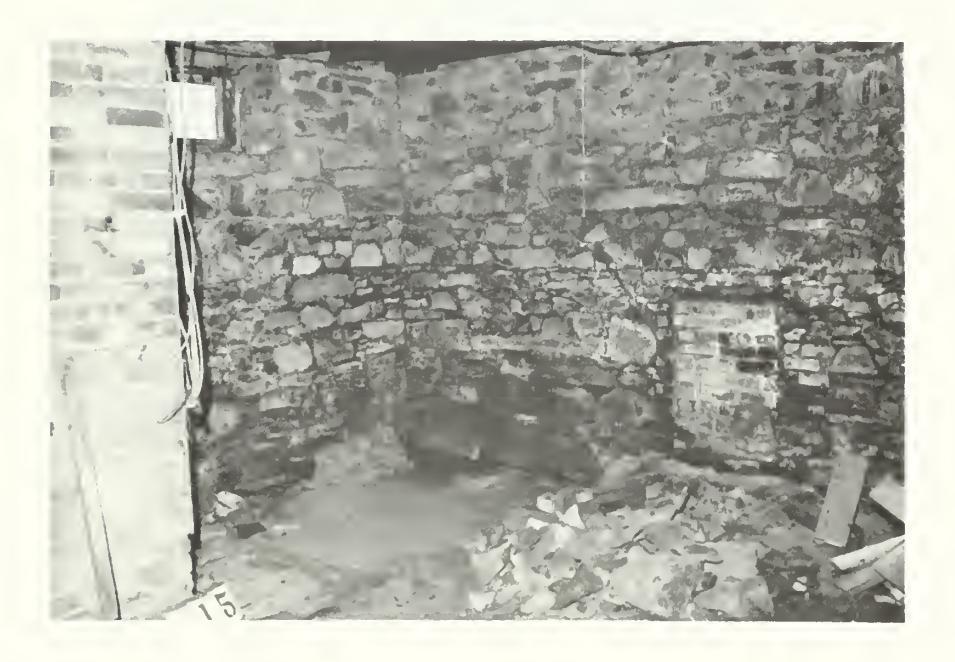
IP011, N016-12. Room 015. Note bricked-in coal chute opening.

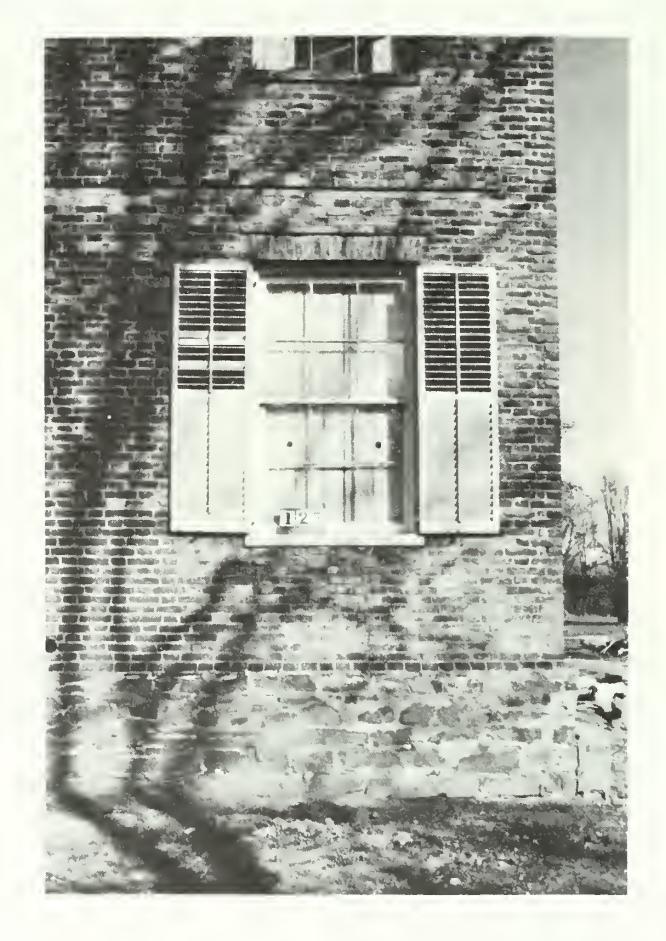
IP012, N012-08. Window 127, typical ca. 1797 window with ca. 1840 sash and shutter blinds.

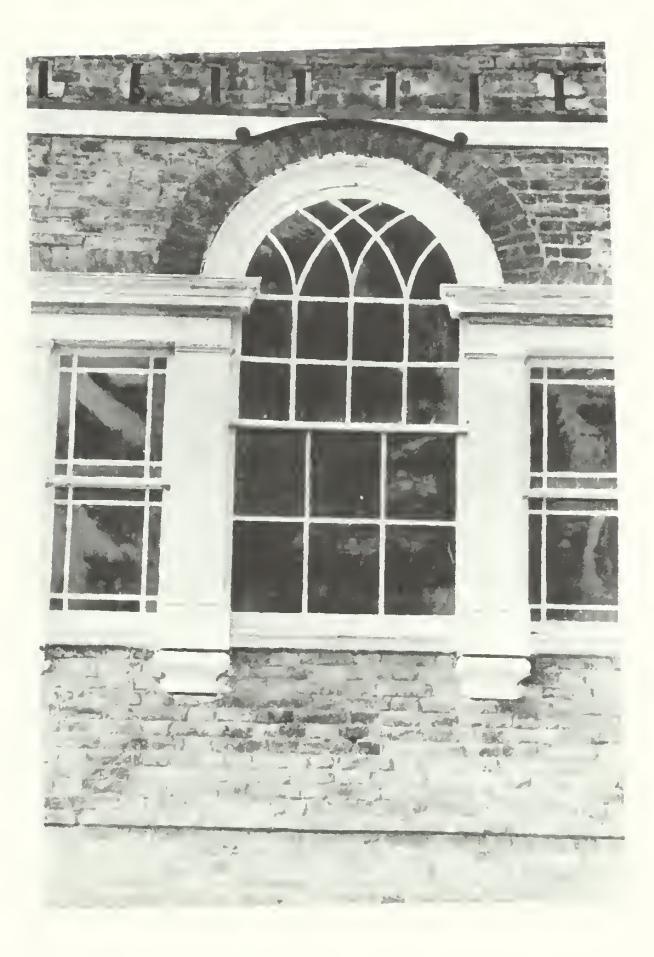
IP013, N013-05. Window 204, ca. 1797 "Gothick" sash above ca. 1840 six-light sash.

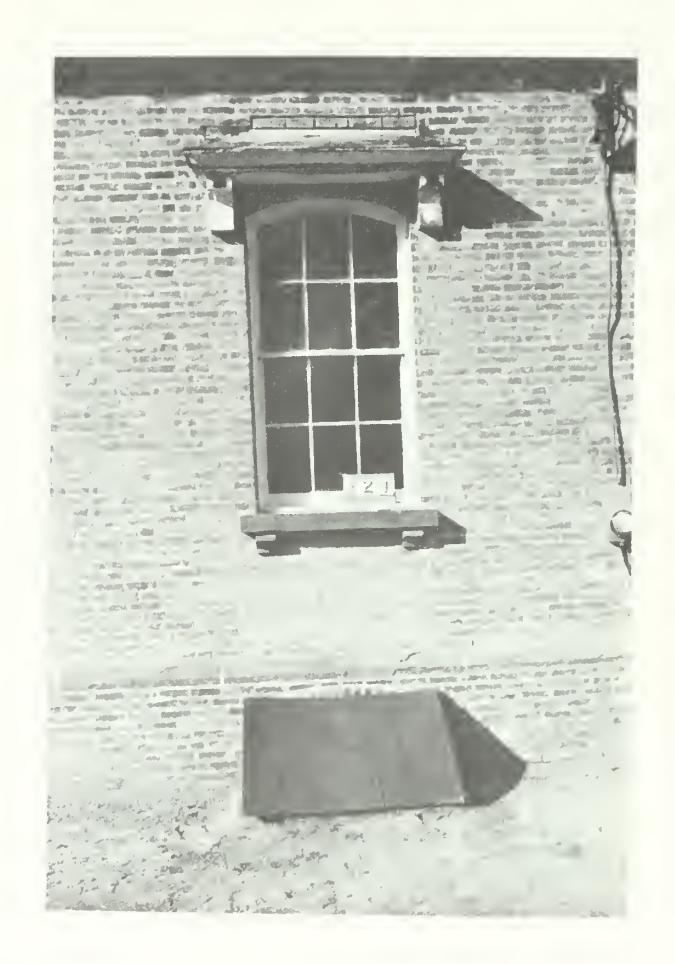
IP014, N012-05. Window 124, typical ca. 1850 sash.

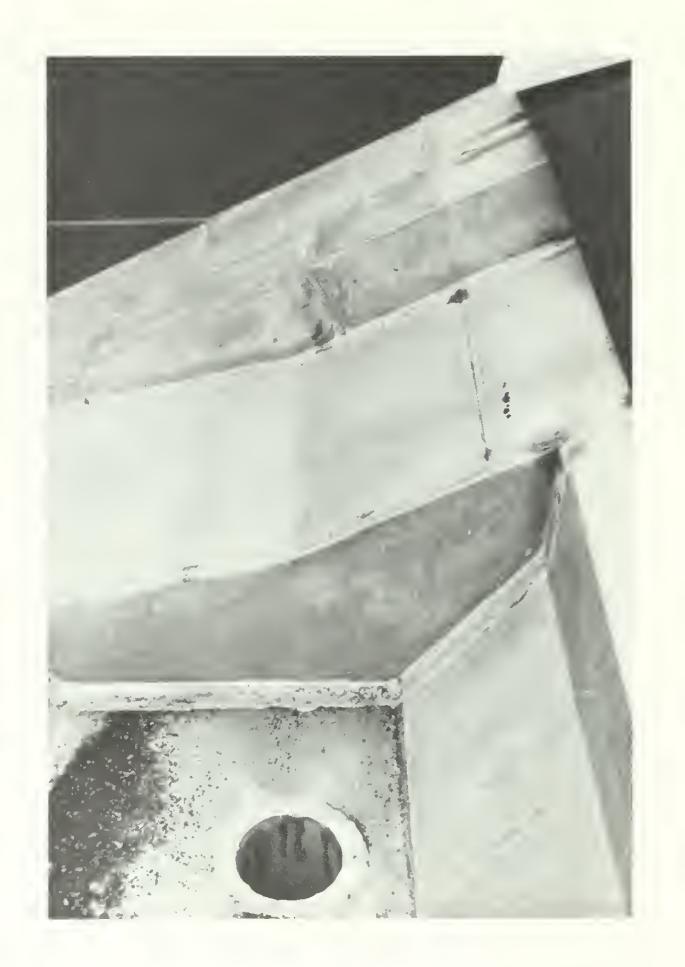
IP016. Gutter liner, rake capping board, and downspout at northwest corner, main roof.

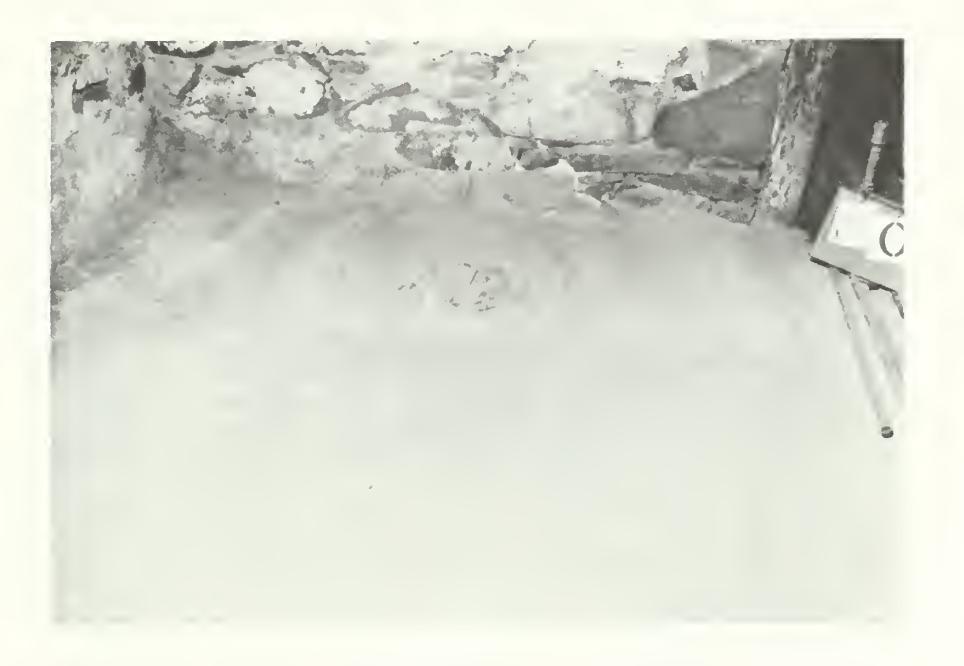
IP018, N008-37. Unidentified feature in floor of room 002.

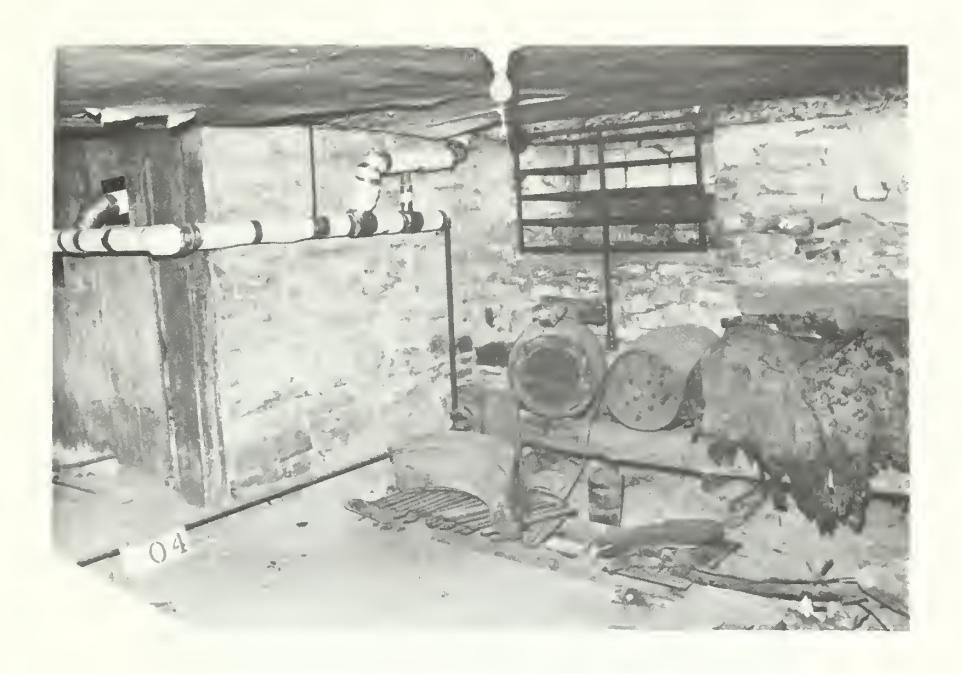
IP021, N007-30. Room 004, northeast corner. Note barrels on rack and porch pieces on floor.

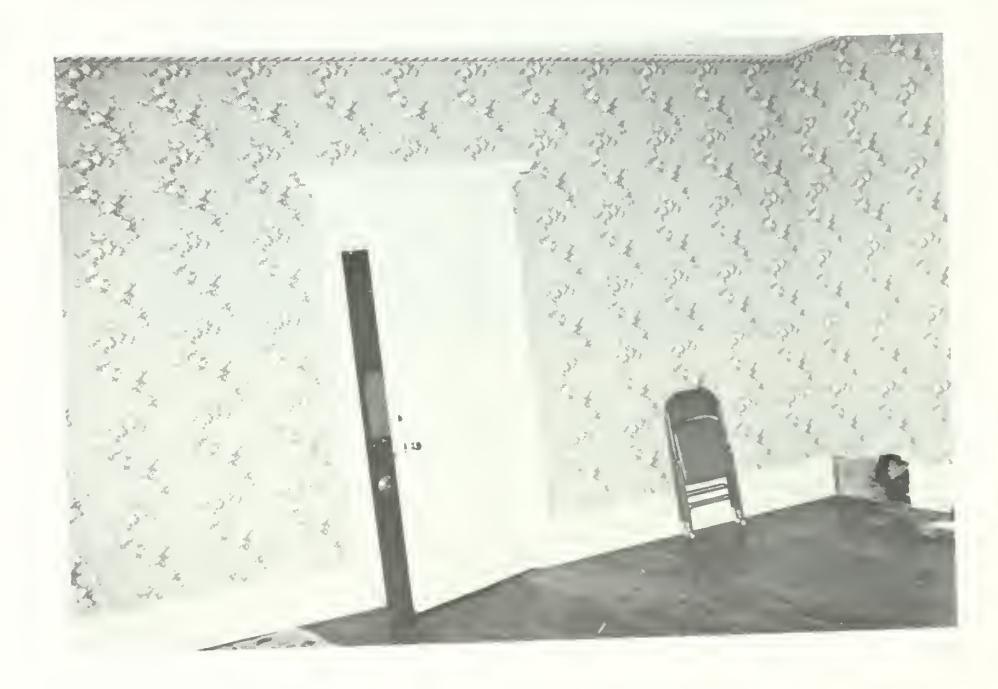
IP026, N022-29. Room 104, south wall and door 102. Note register opening in southwest corner.

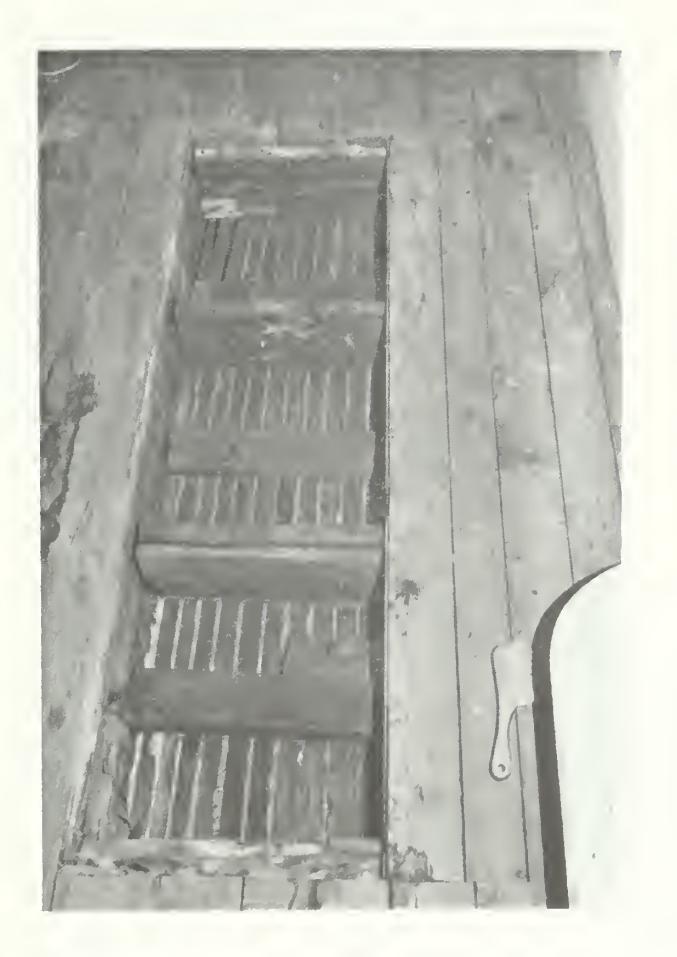
IP027, N017-32. Former basement stair opening in floor of room 105.

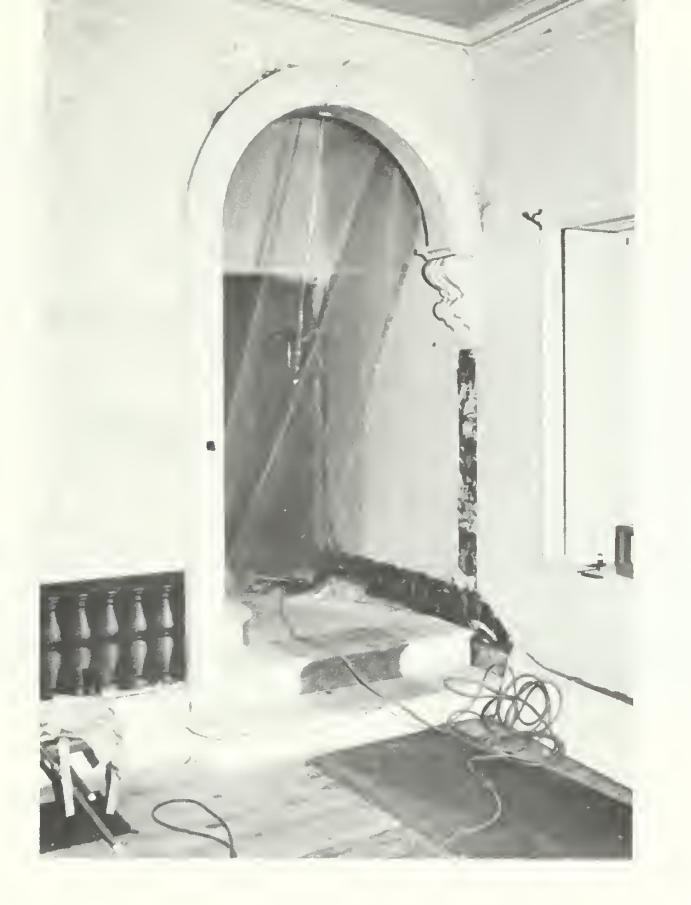
IP029, N022-12. Door 130 ca. 1849 alteration to room 105. Note patch in west wall about 8" above bracket.

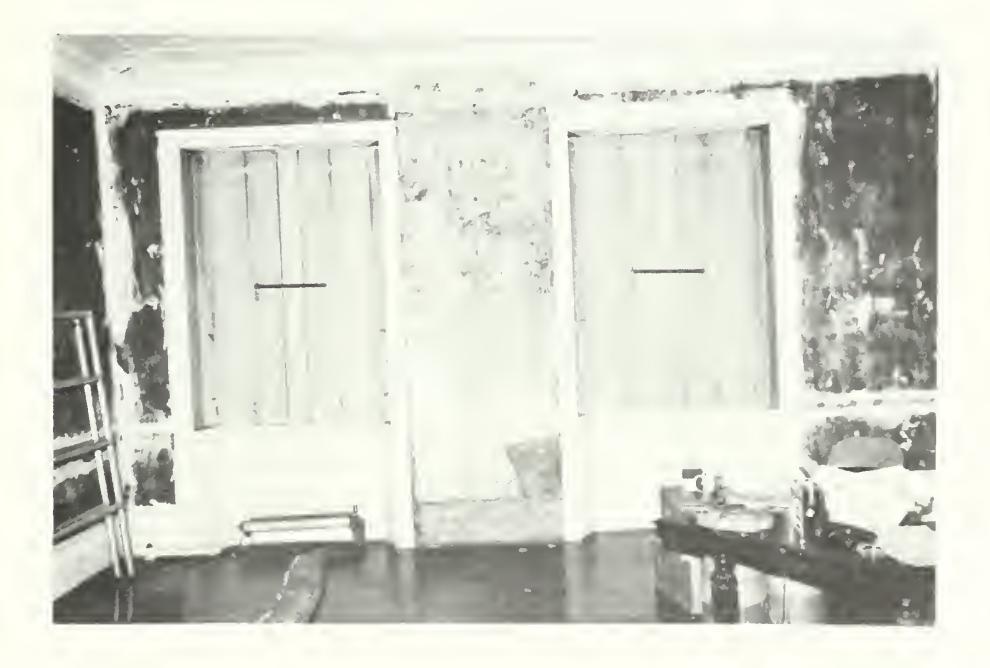
IP030, N023-24. Room 106, east wall. Note historic wallpaper revealed by removal of mirror between windows 101 and 102.

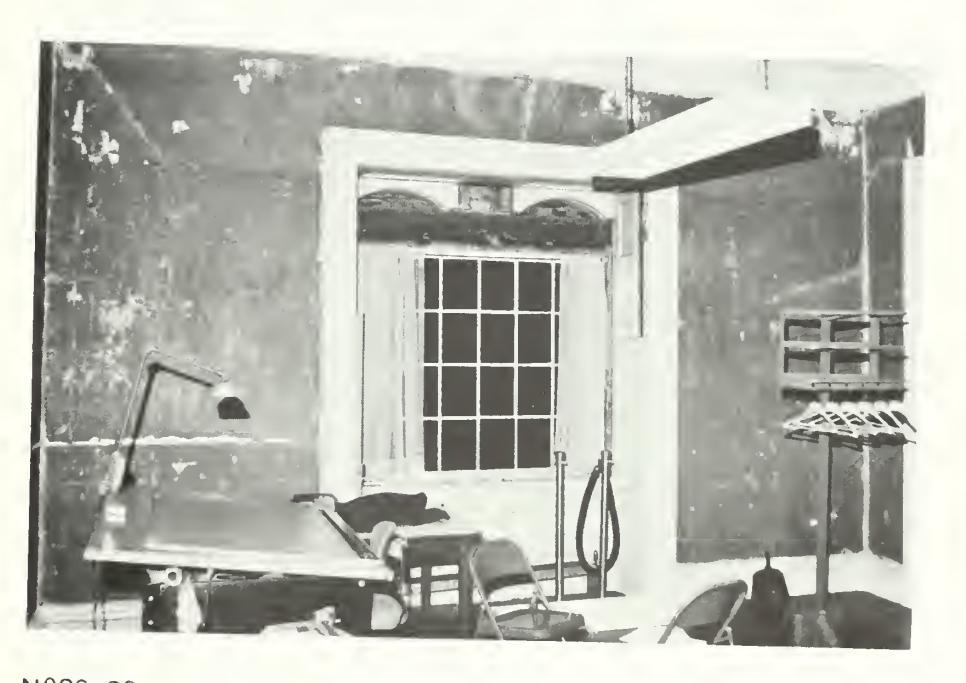
IP034, N023-29. Room 111, south wall, windows 122 and 123. Note arched window heads.

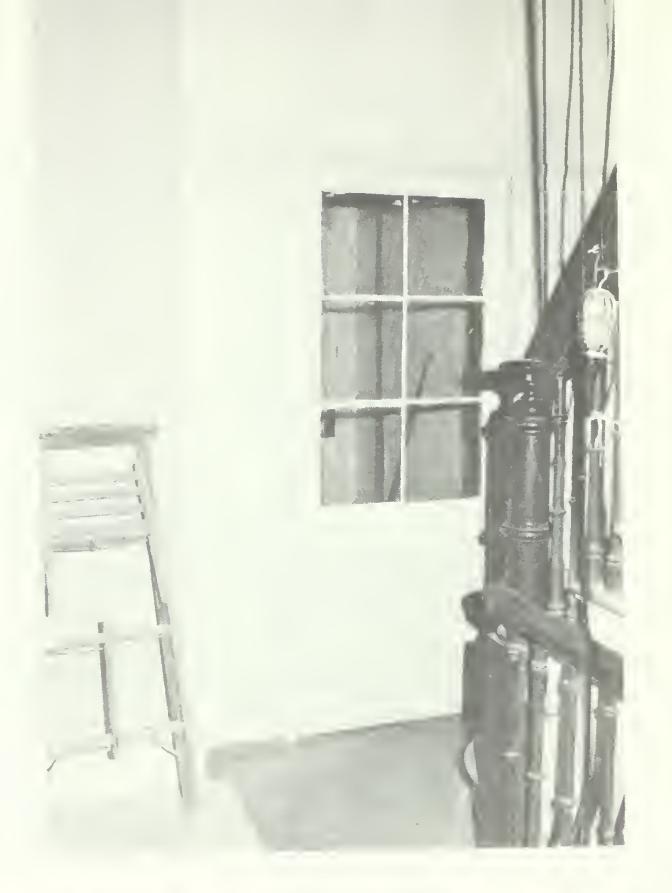
IP035, N025-35. Room 113, north wall. Note board partition and door 121.

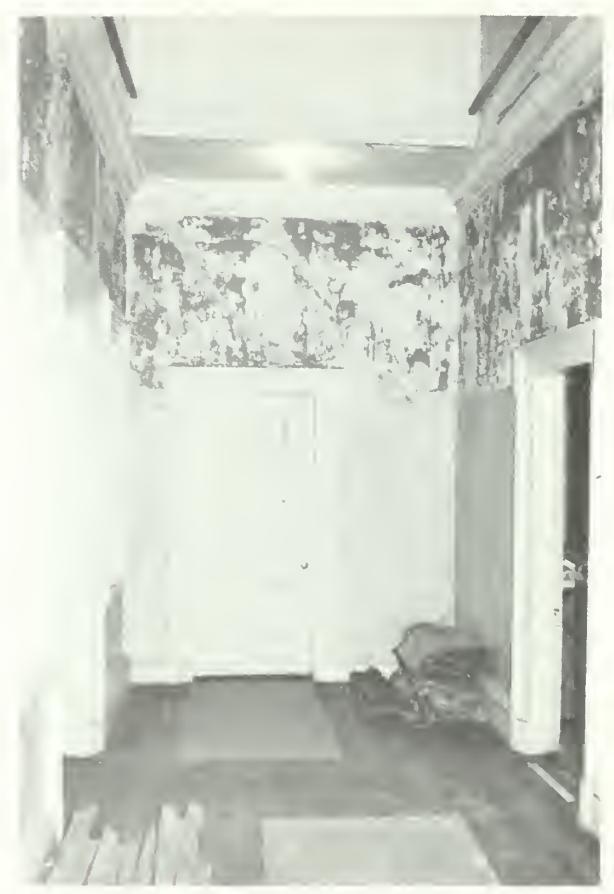
IP040, N021-15. Room 119, looking south to door 118, door 115 to the right and door 108 to the left. Note skylight opening above.

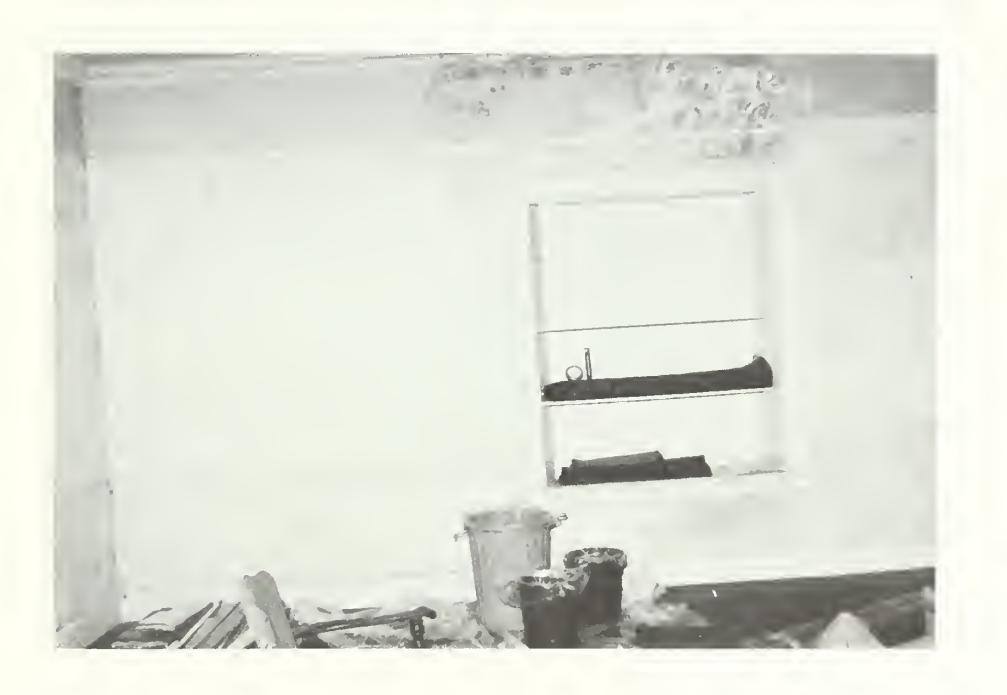
IP042, N030-37. Room 201 west wall. Note shelves in former window opening.

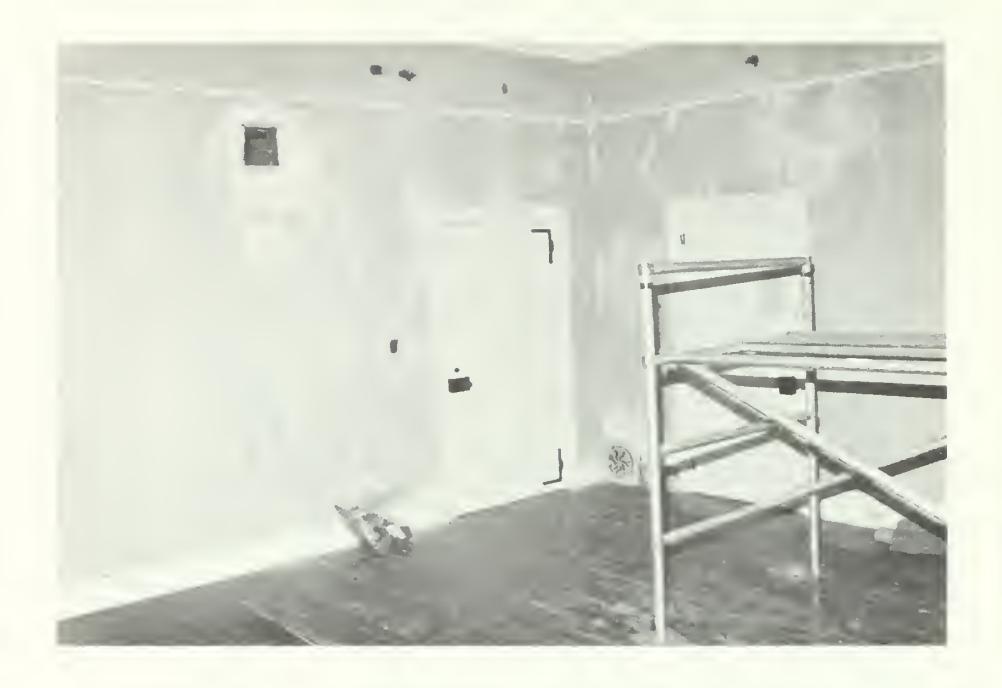
IP043, N030-31. Room 205, south and west walls. Note outline of former door opening (door 219) on south wall and ventilation opening above.

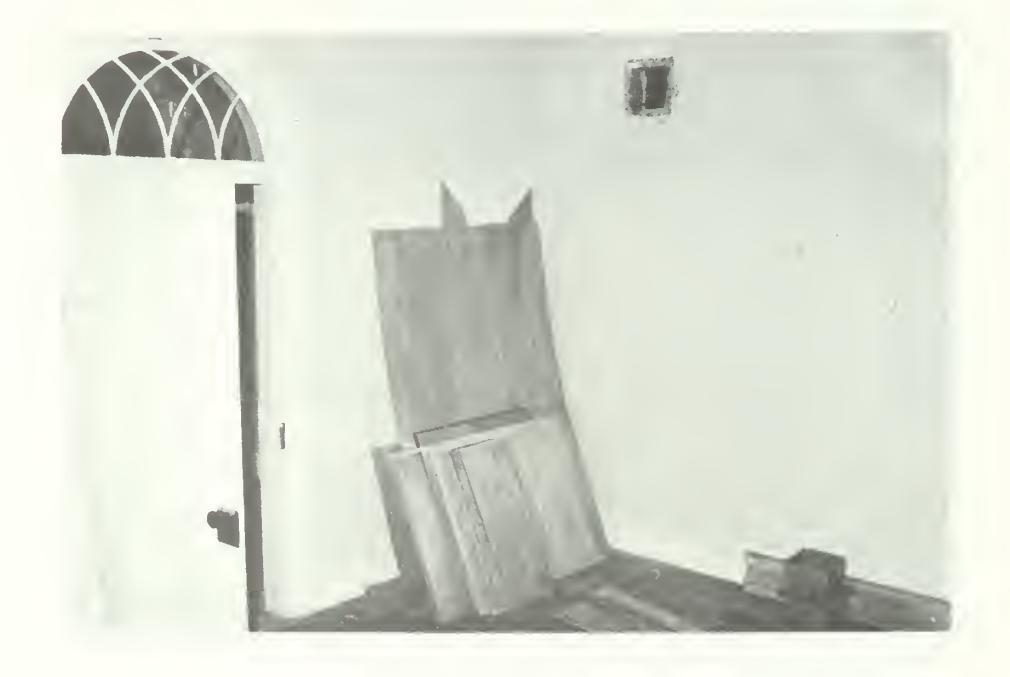
IP044, N030-23. Room 208, northwest corner. Note faint outline of former door opening (door 219) on north wall below ventilation opening and patch of chair rail across door opening.
