historic structure report architectural data section volume 2: appendixes

#### HISTORIC STRUCTURE REPORT

#### LINDENWALD

## MARTIN VAN BUREN NATIONAL HISTORIC SITE

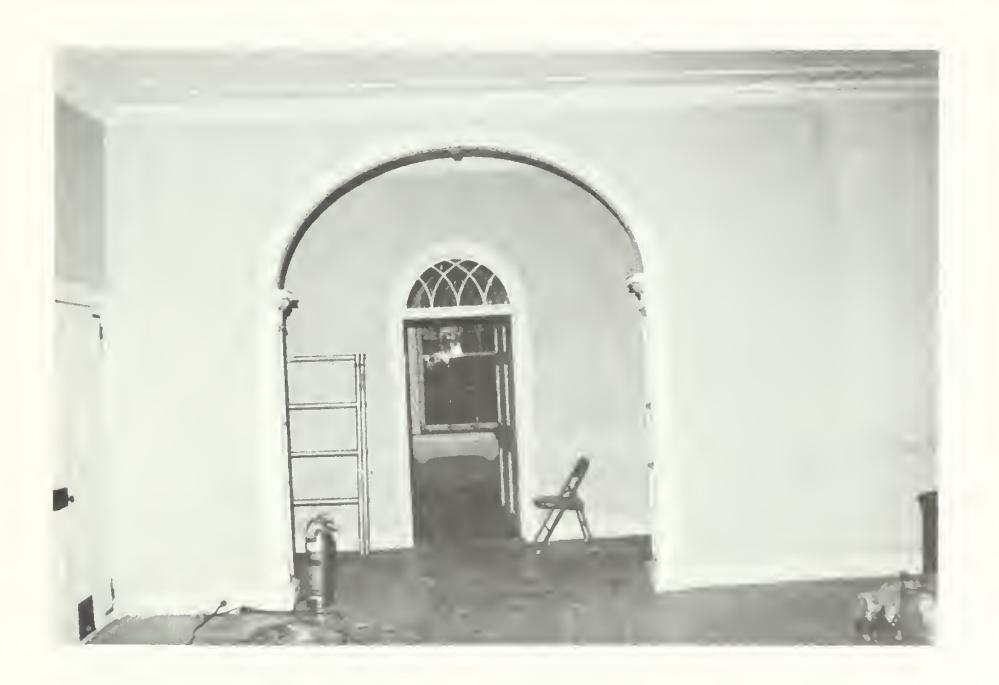
IP046, N030-03. Room 206, looking east into rooms 207 and 208 through doors 218 and 202. Note vertical line at former location of south wall near right edge.

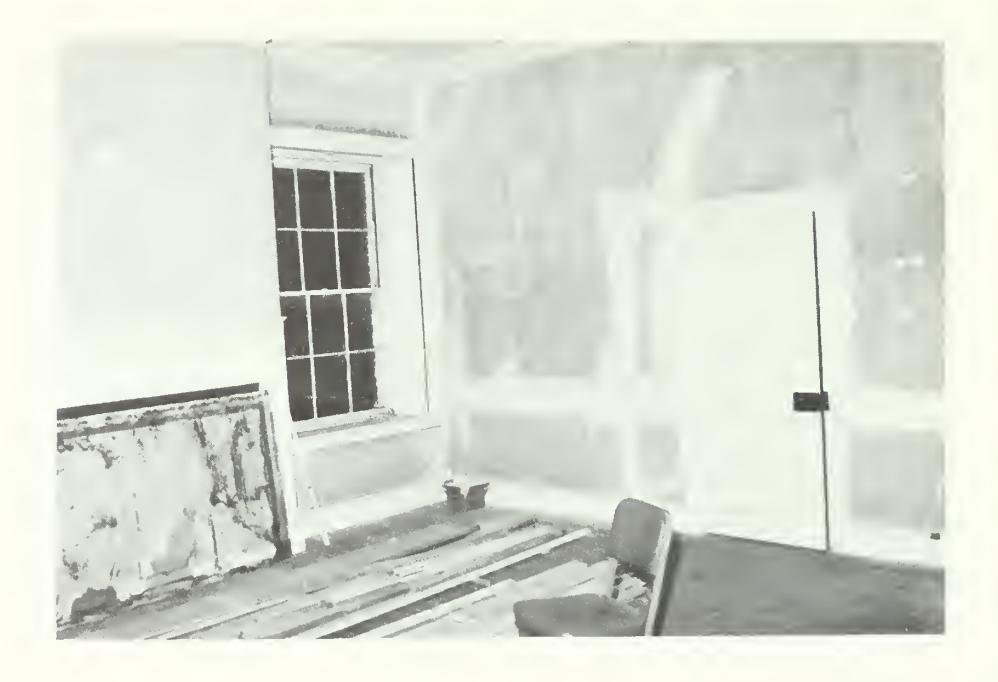
IP047, N030-15. Room 209, south and west walls. Note door 216 and its former location.

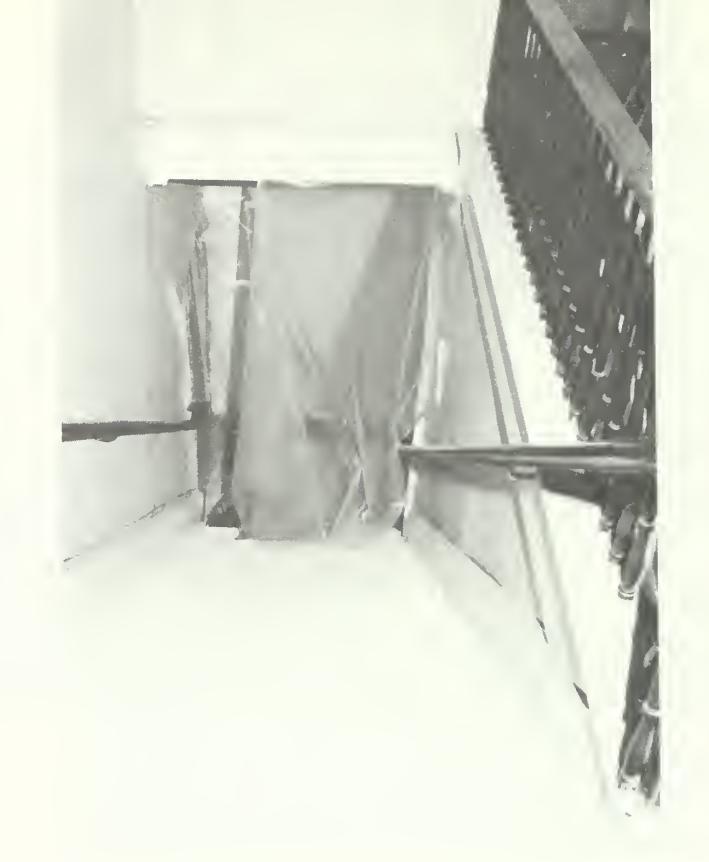
IP050, N030-17. Room 209 north and east walls, door 201 and window 202.

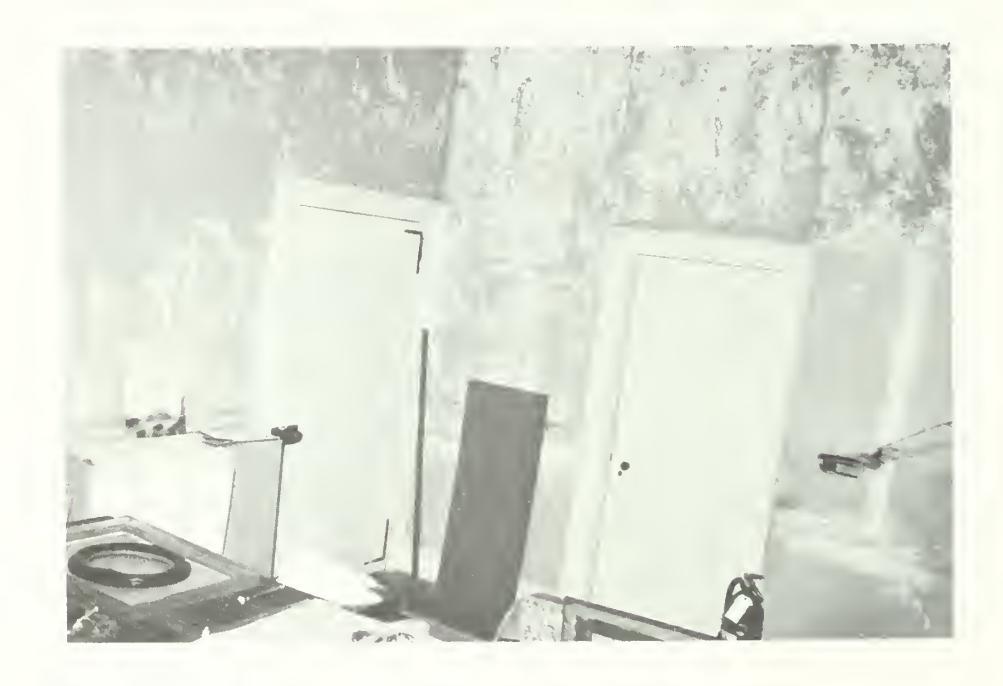
1P051, N029-34. Rooms 206 and 110, looking west down stair.

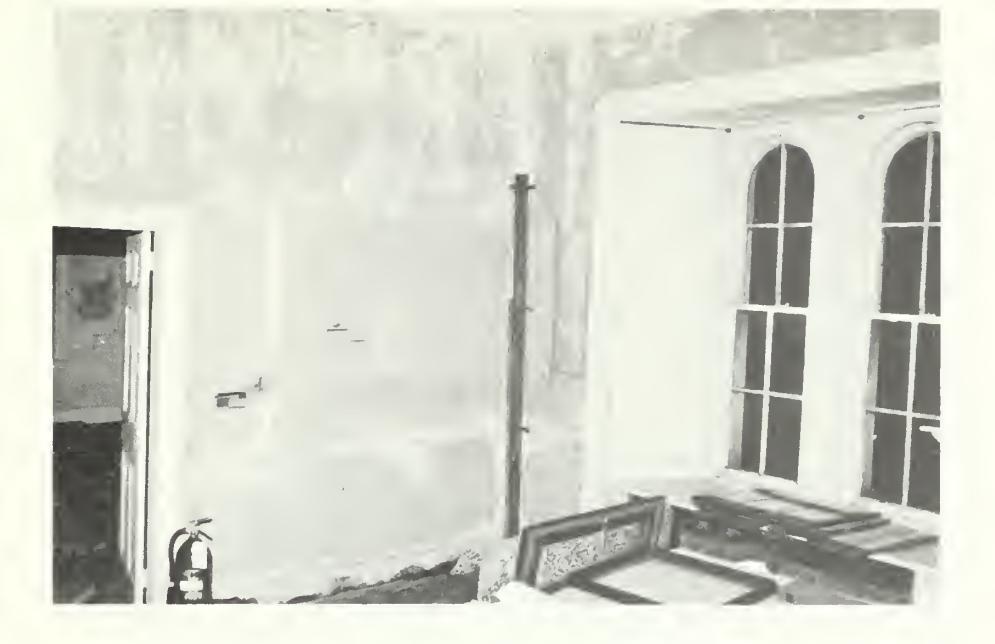
IP052, N030-11. Room 210 north and east walls, doors 215 and 216.

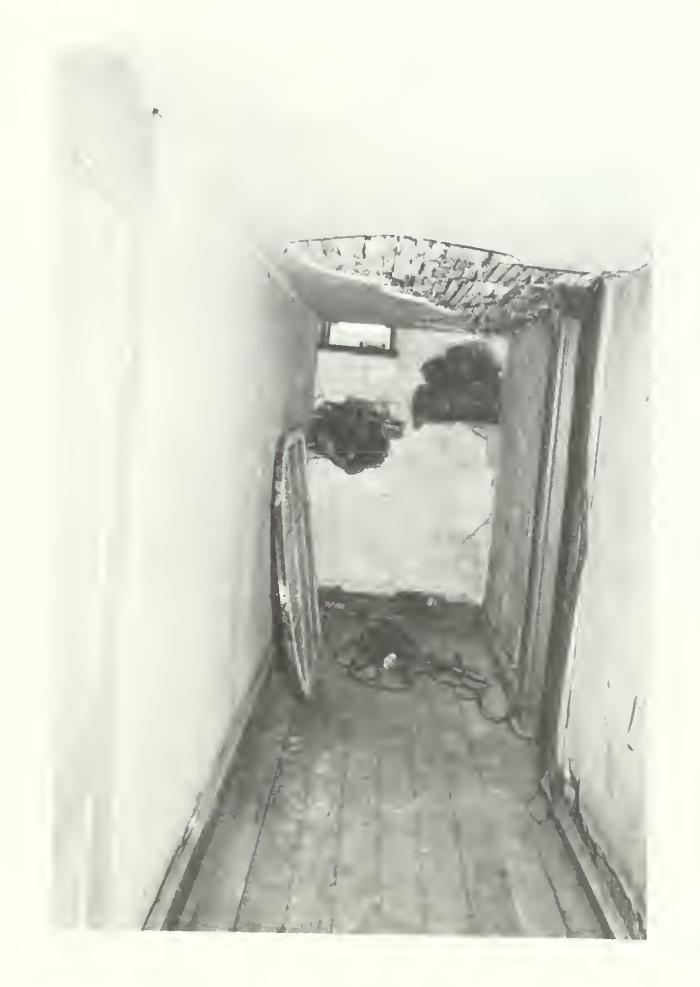
IP053, N030-10. Room 210, east and south walls, door 216, and windows 215 and 216.

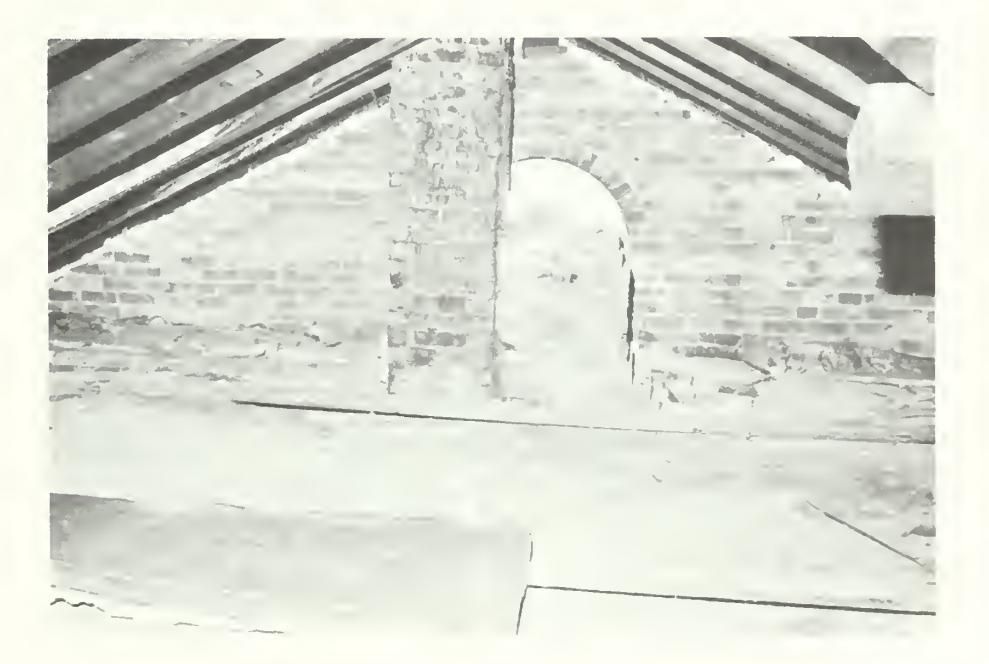
IP056, N031-24. Room 213, looking southeast, with monitor skylight framing on left, brick tower on right, and east roof truss across view.

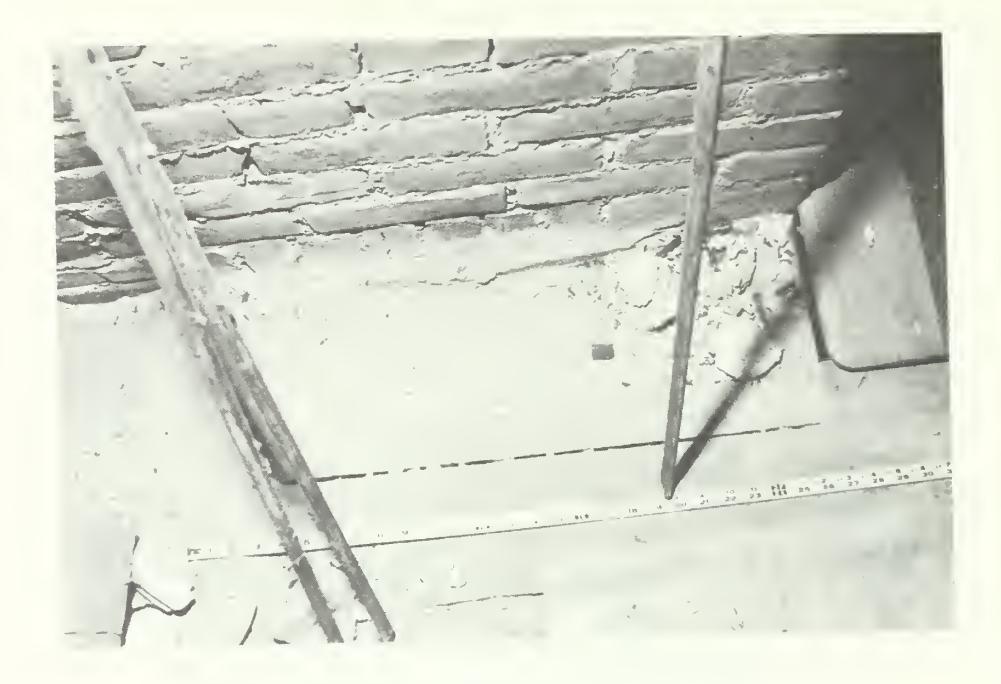
IP057, N031-26. Room 213, over room 112. Note brick chimney and window 214.

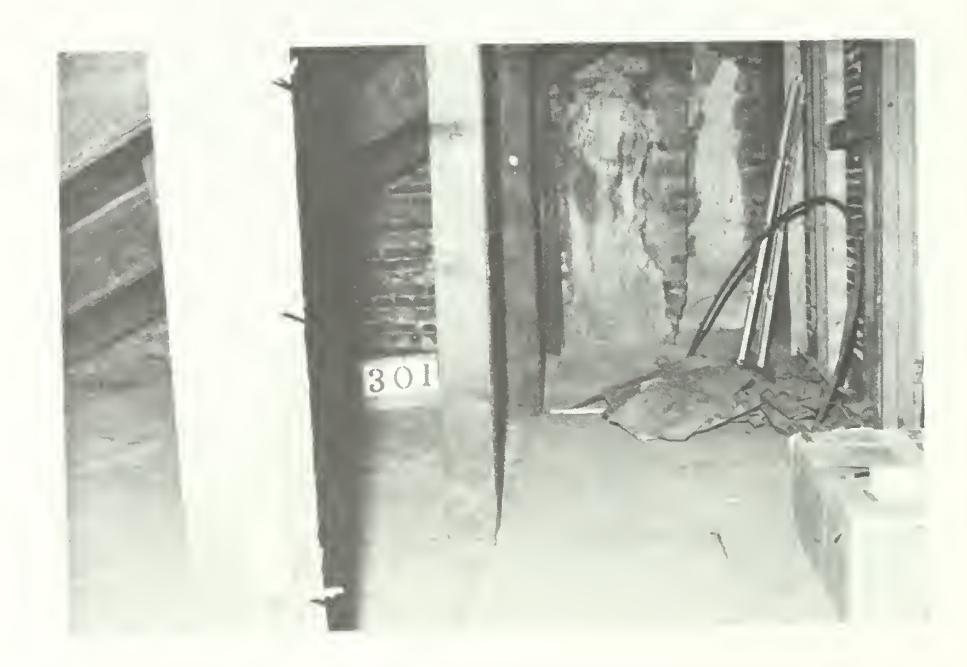
IP058, N031-27. Brownstone splashblock reused in tower masonry at floor level of room 213.

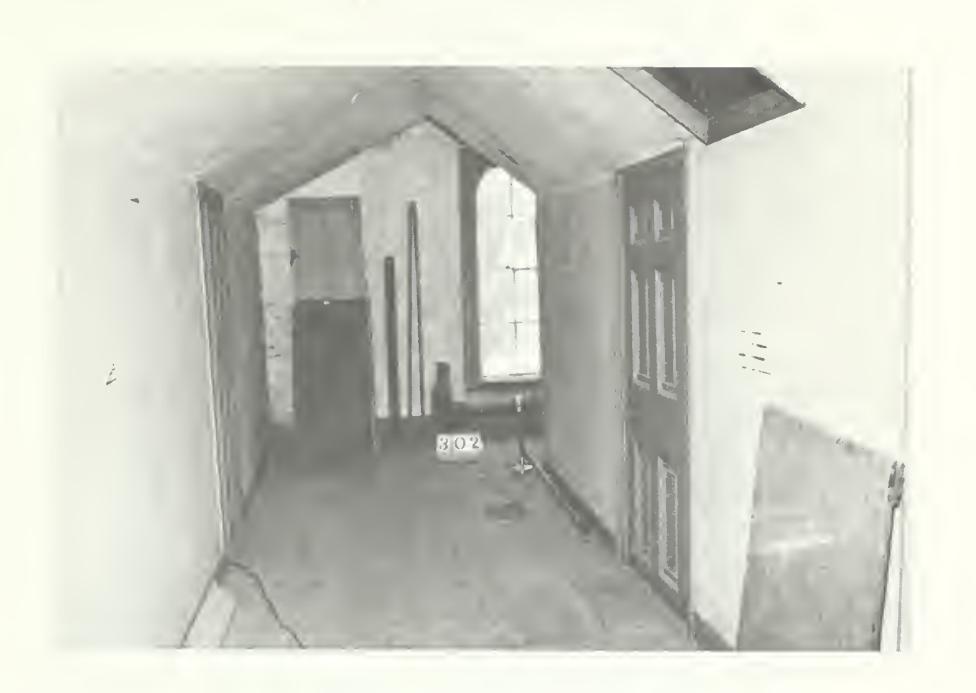
IP059, N006-32. Room 301, looking north to plastered gable end, with knee braces to the left. Note T-head wrought nails in nearest knee brace.

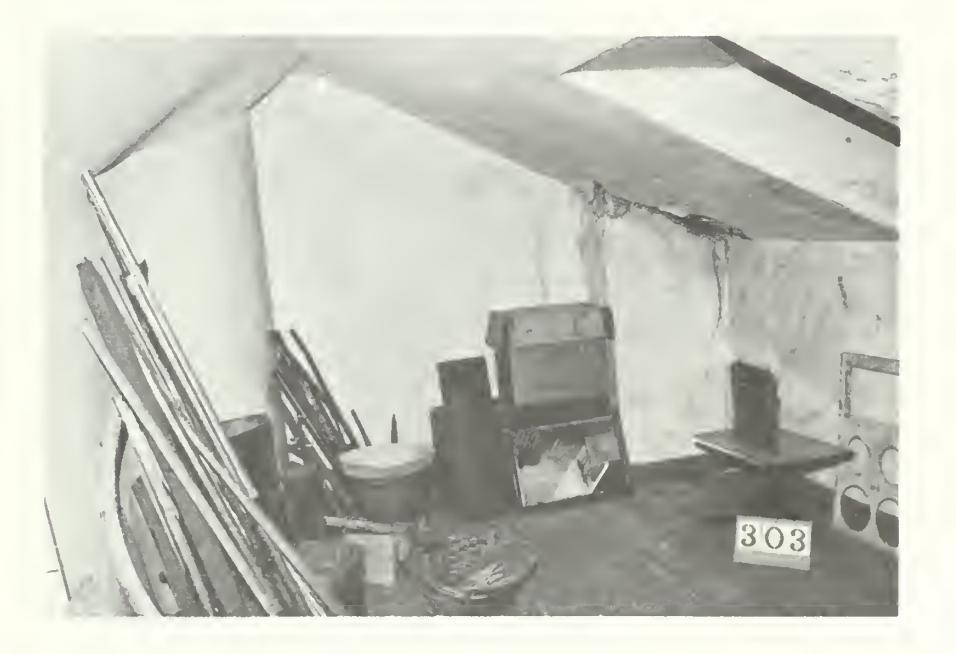
IP060, N008-08. Room 302, looking north past door 305 on the right and 306 on the left to window 305. The faint outline of the former stair opening can be seen near door 305. Note also the floor register and the hatch opening to the ridge space.

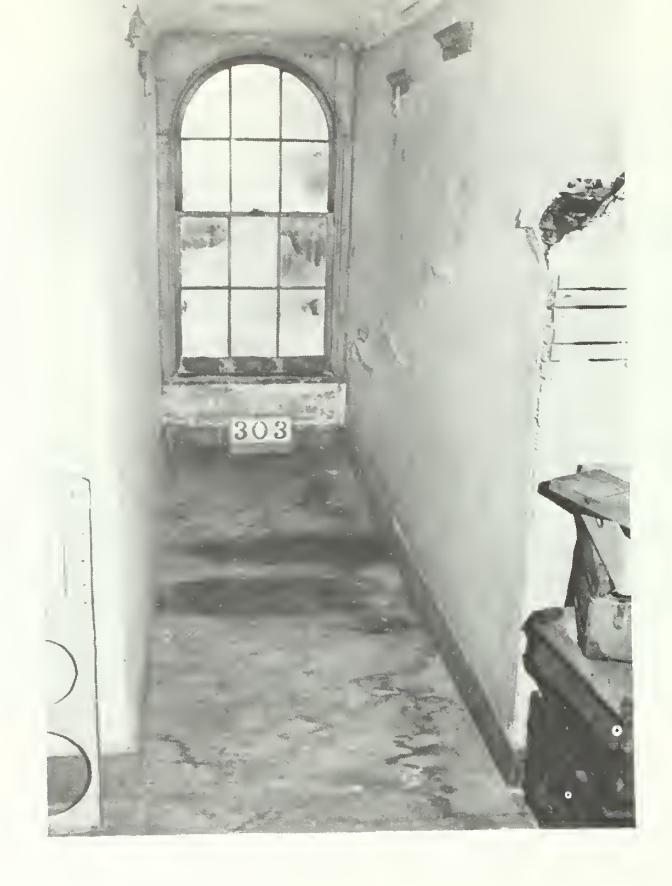
IP061, N008-11. Room 303, looking north. Curve at left was made to provide light from window 305 to room 302. Faint outline of former window 304 can be seen on north wall.

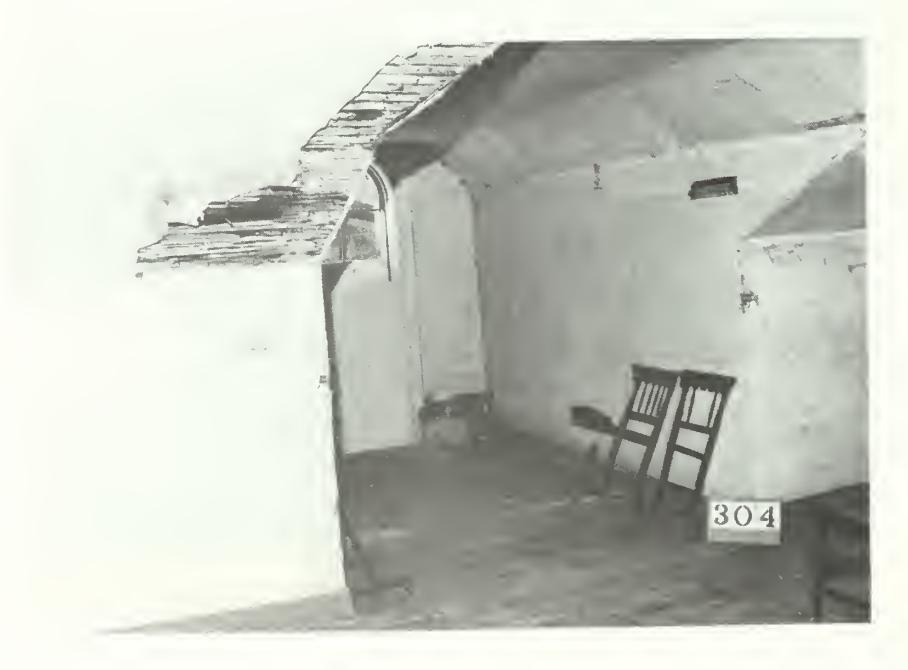
IP062, N008-15. Room 303 eastward dormer extension and window 303.

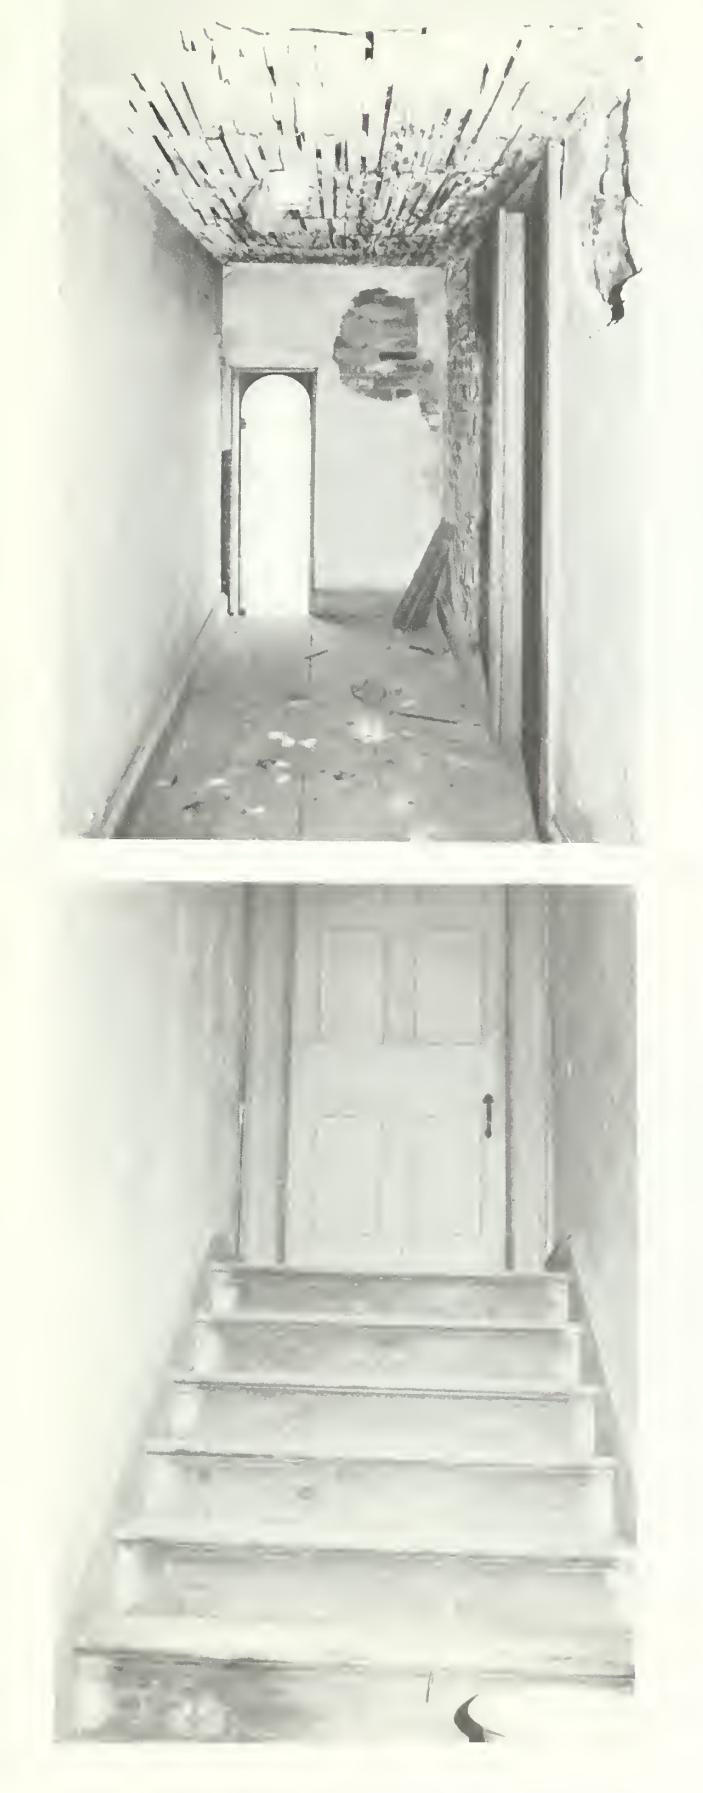
IP063, N008-17. Room 304, looking east into gable extension and window 302.

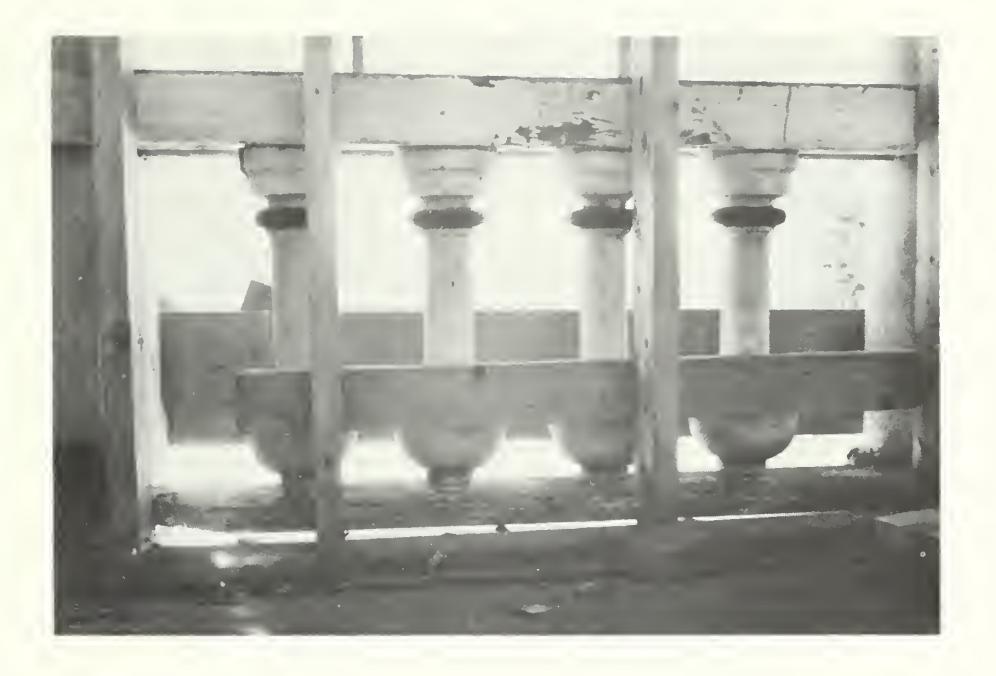
IP007, N032-02. Belvedere (room 501), deck.

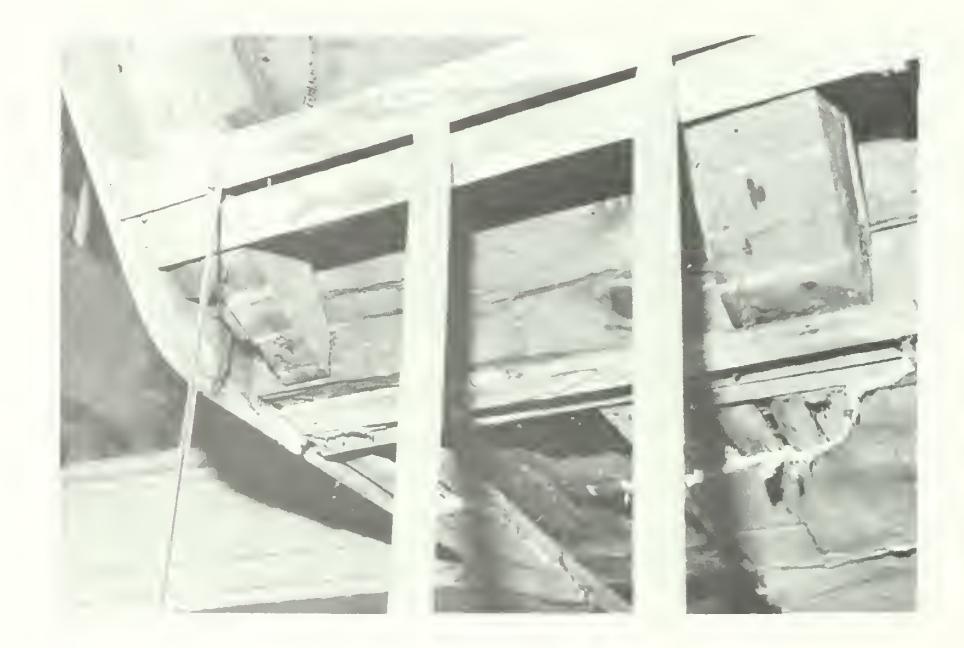
IP074, N041-05. Tower stair construction at a landing, looking up and slightly south. Note that joist running across photograph is continuous between two brick walls of tower. Stub joist to support stair stringer is vertical member mortised through main joist and pulled tight by wedge.

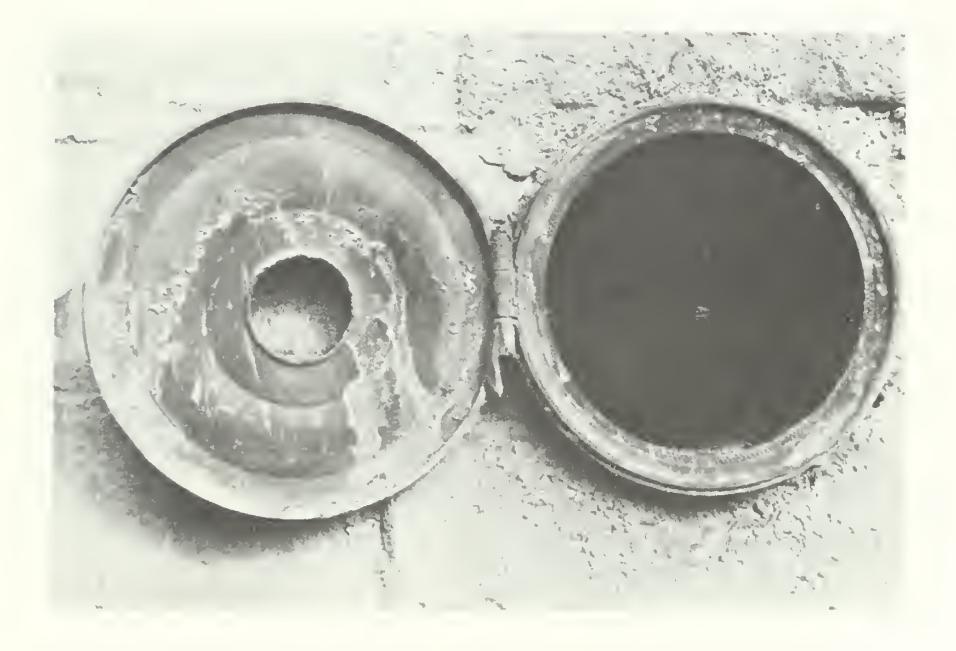
IP076, N015-16. Exterior cover for fresh-air intake duct.

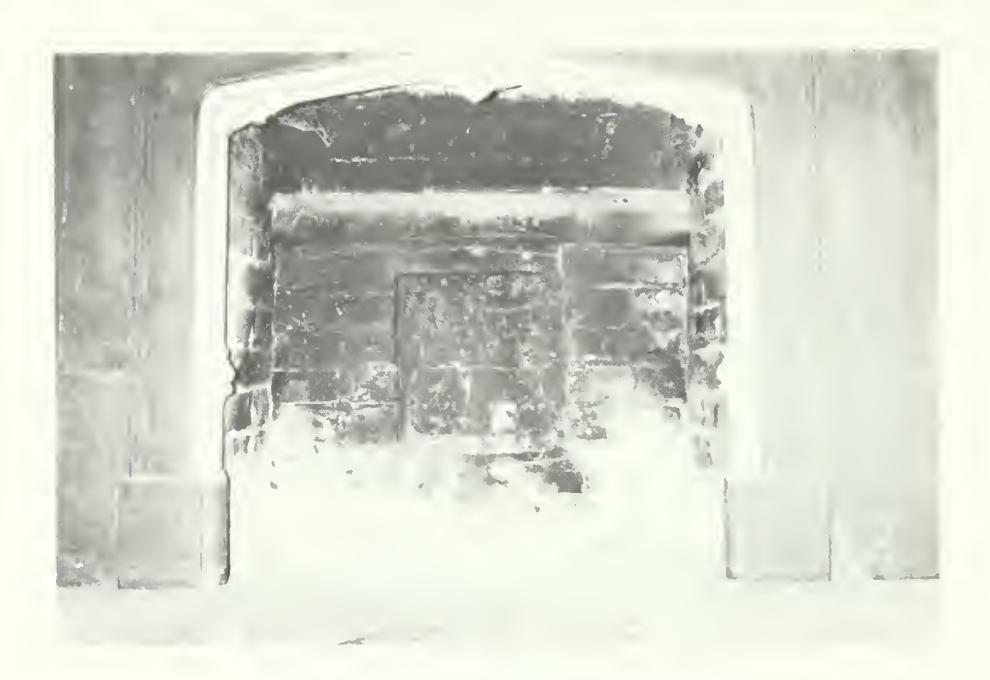
IP077, N015-17. Exterior cover in open position.

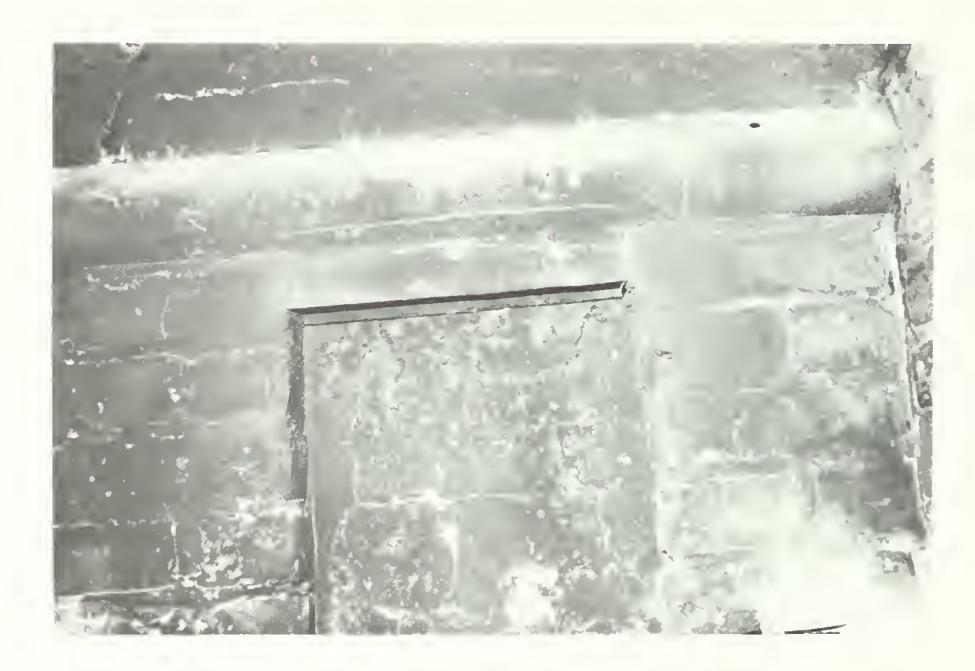
IP078, N023-19. Fireplace, room 109, with part of fresh-air heating apparatus in place.

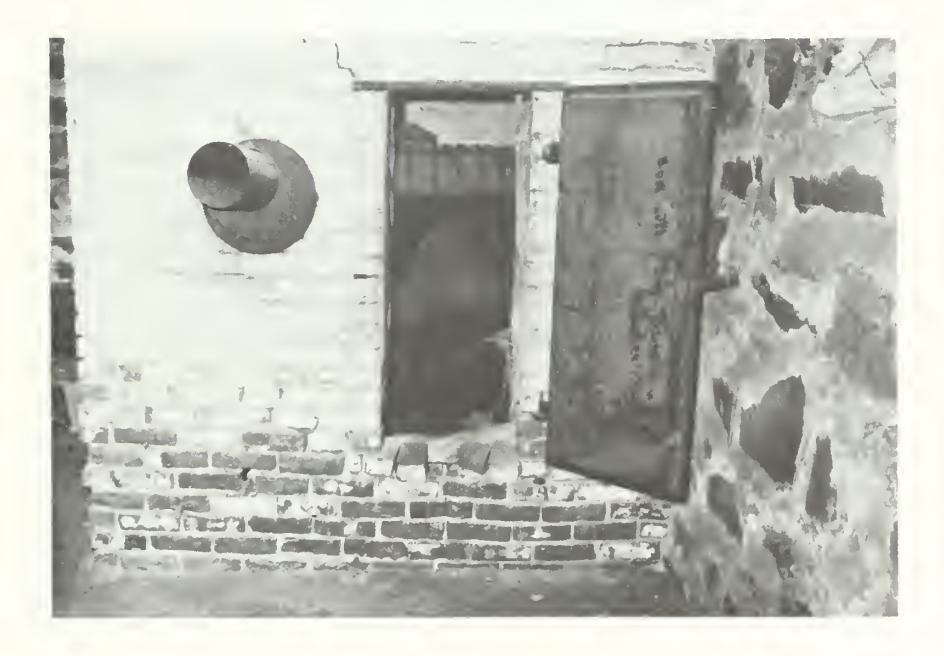
IP080, N018-06. East wall of furnace enclosure.

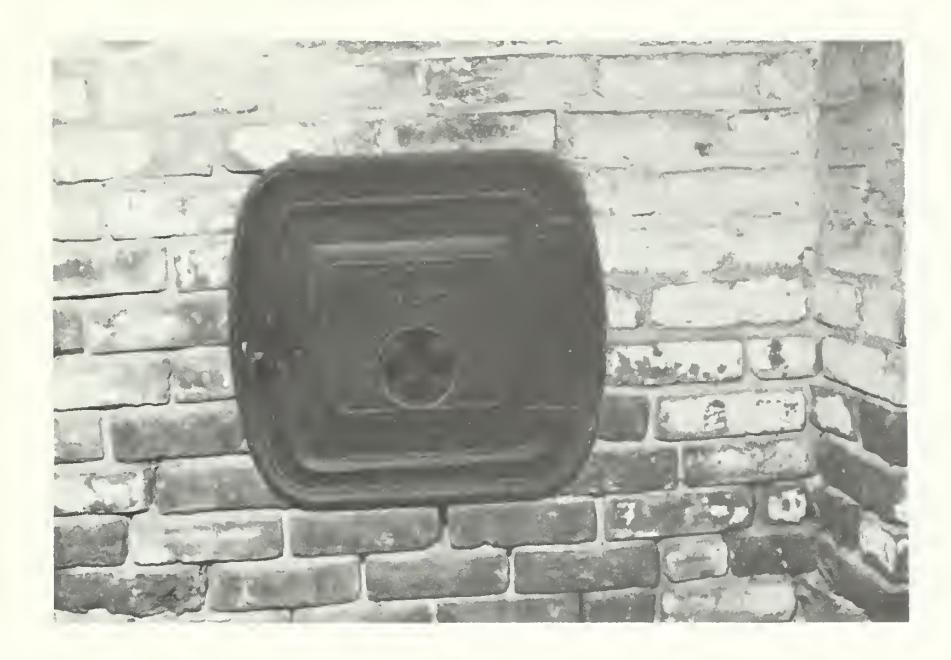
IP082, N010-07. Boynton's patent cast-iron furnace.

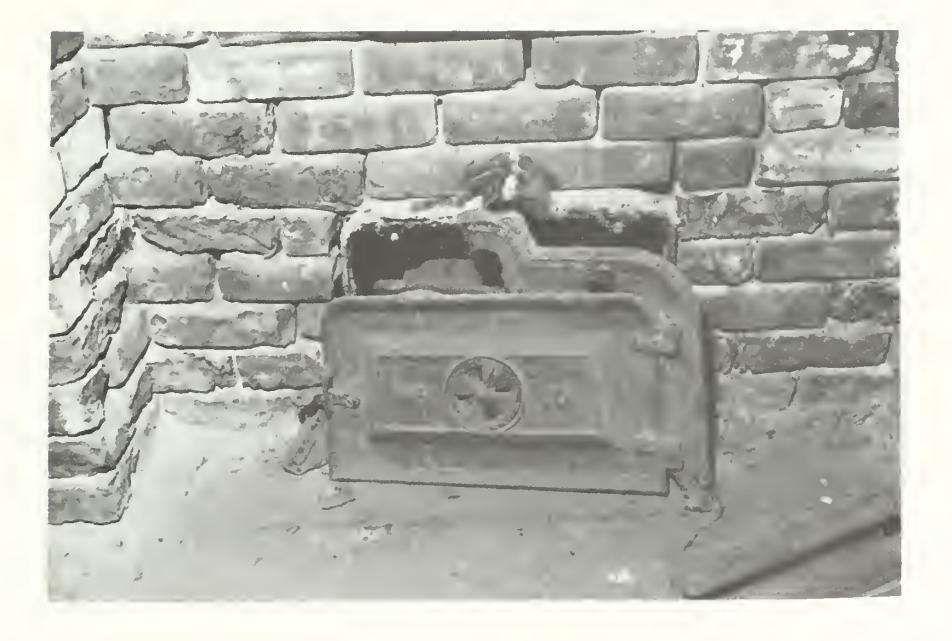
IP083, N010-04. Cast-iron fuel door with patent data.

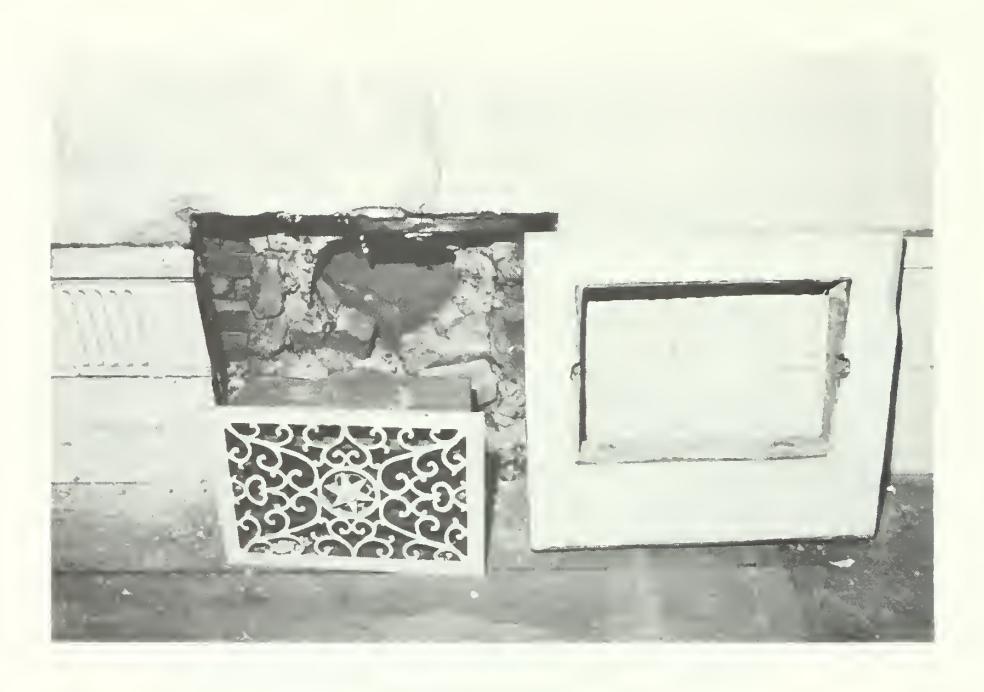
IP084, N010-10. Cast-iron ash cleanout door.

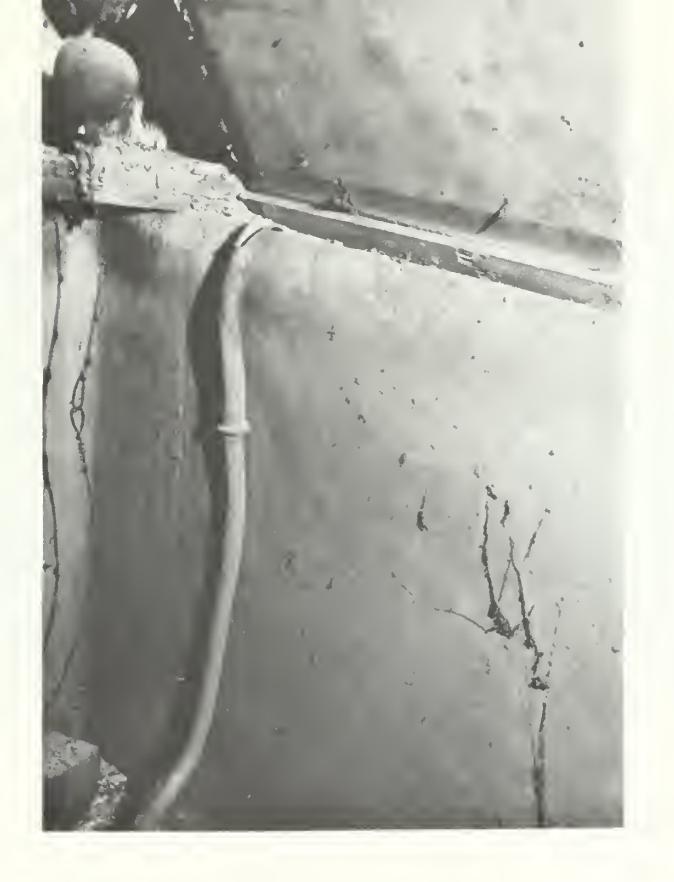
IP095, N018-18. Water tank, room 115, stopper lever and vacuum breaker pipe.

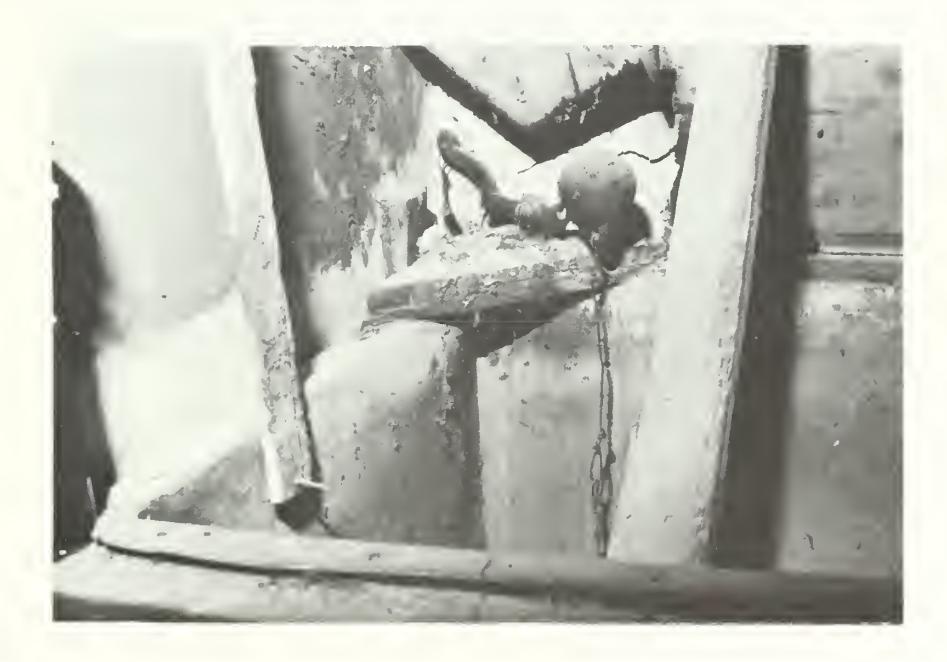
IP096, N018-16. Water tank, room 115, stopper lever.

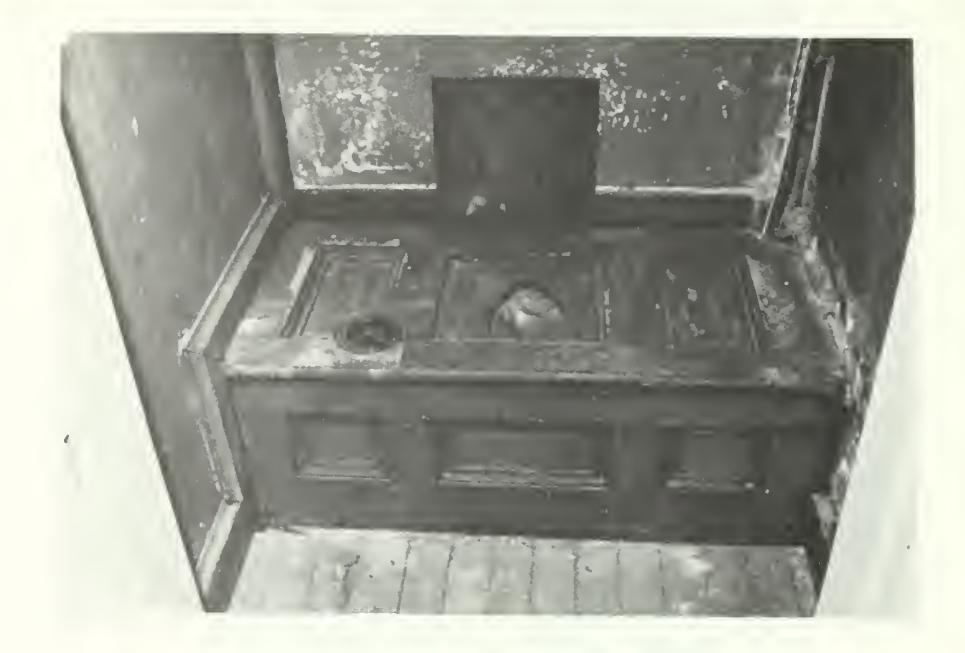
IP097, N018-20. Room 115 water closet and enclosure.

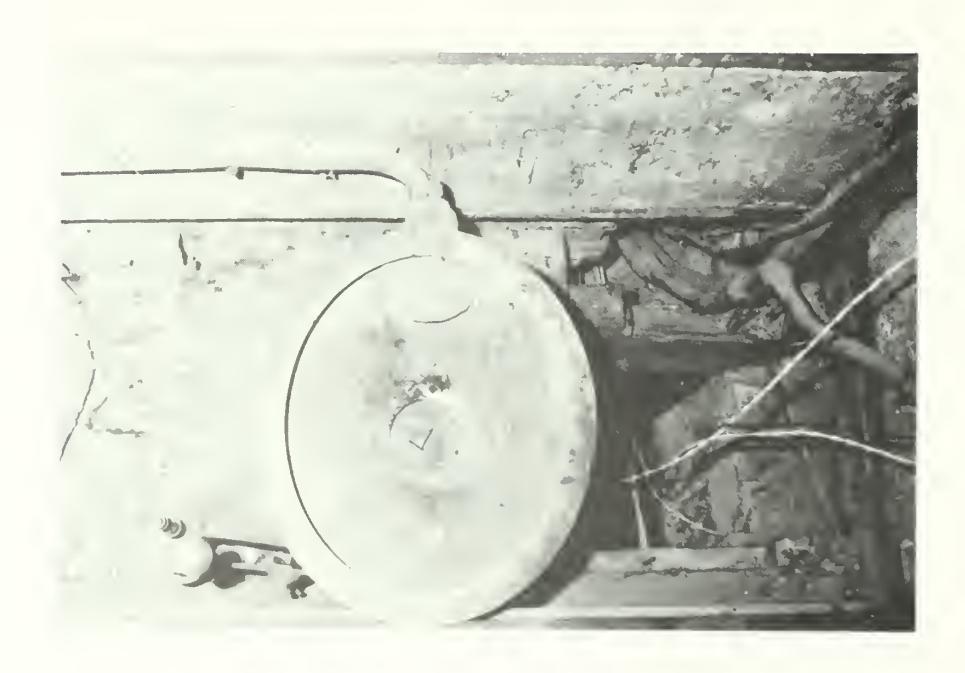
IP098, N036-03. Water closet with top removed.

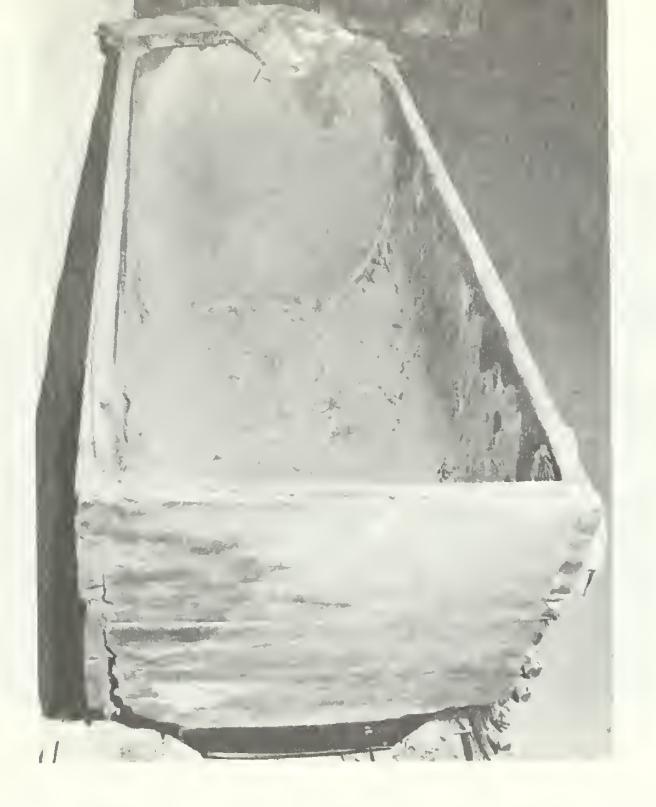
IP099, N007-26. Historic bathtub and case. Note dovetailed joints.

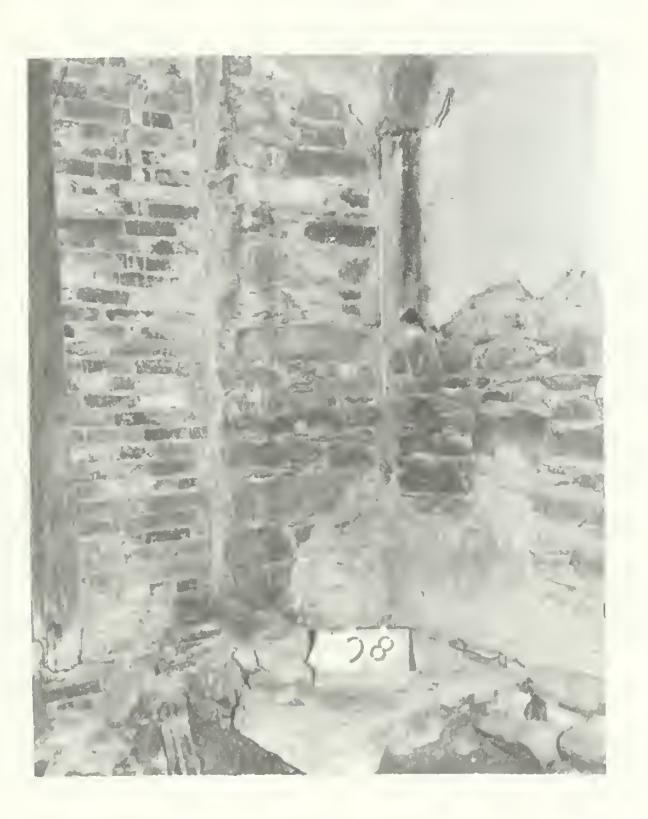
IP100, N009-18. Room 009, brick platform at southeast corner and stovepipe hole above.

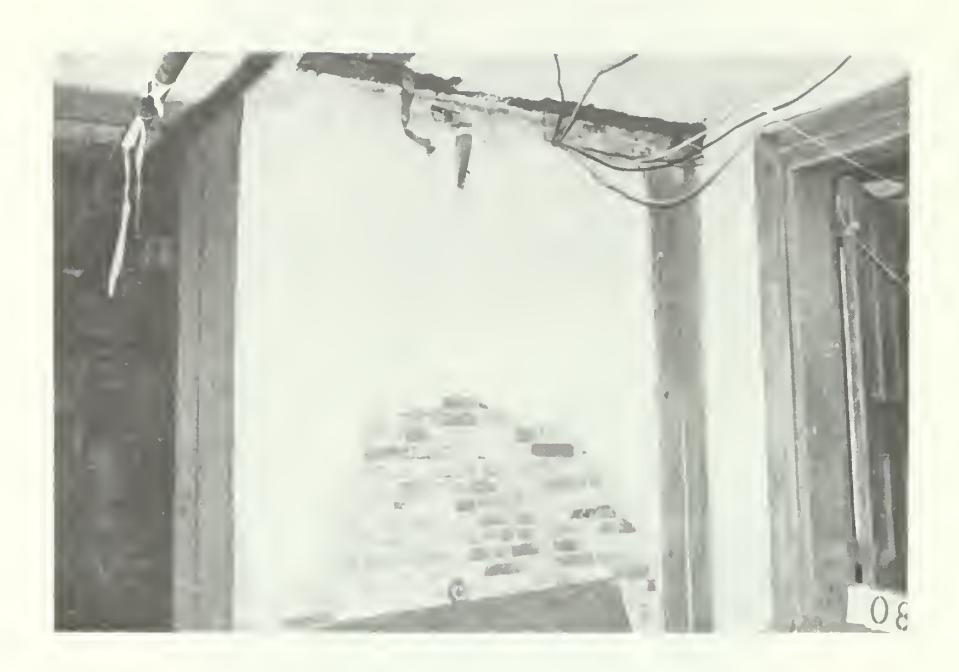
IP101, N009-20. Room 009, northeast corner. Note remains of wooden pipe chase.

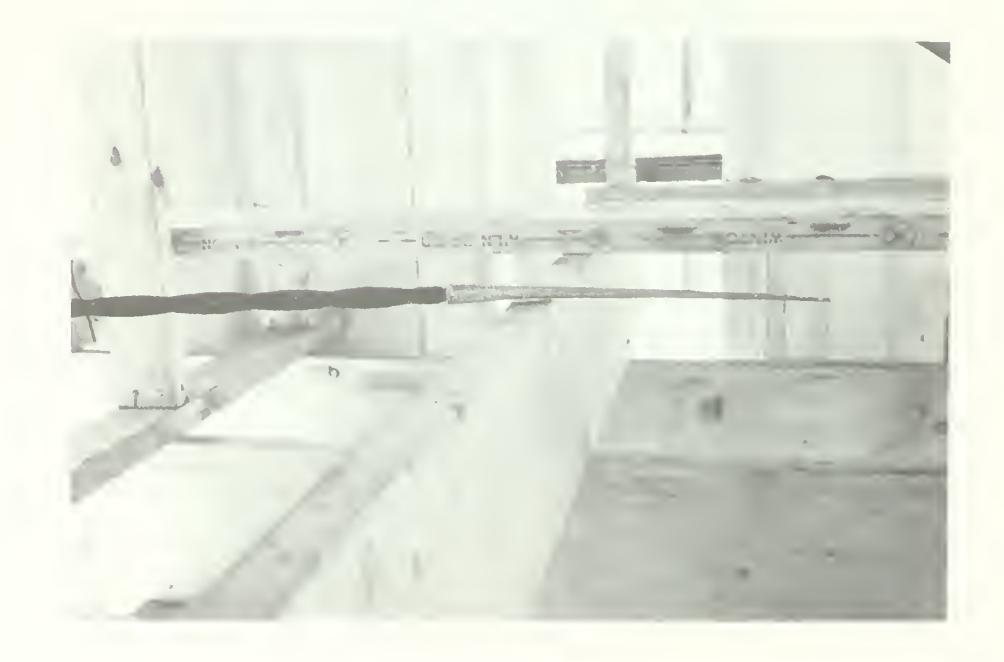
IP102, N031-36. Copper point attached to spiral fluted iron lightning rod.

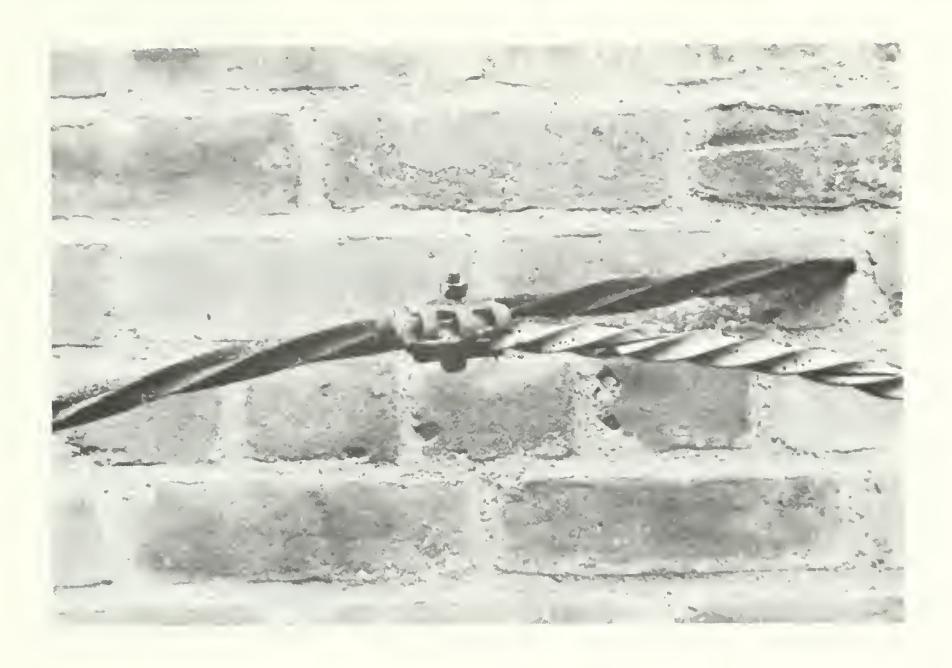
IP103, N050-12. Detail of iron lightning rod.

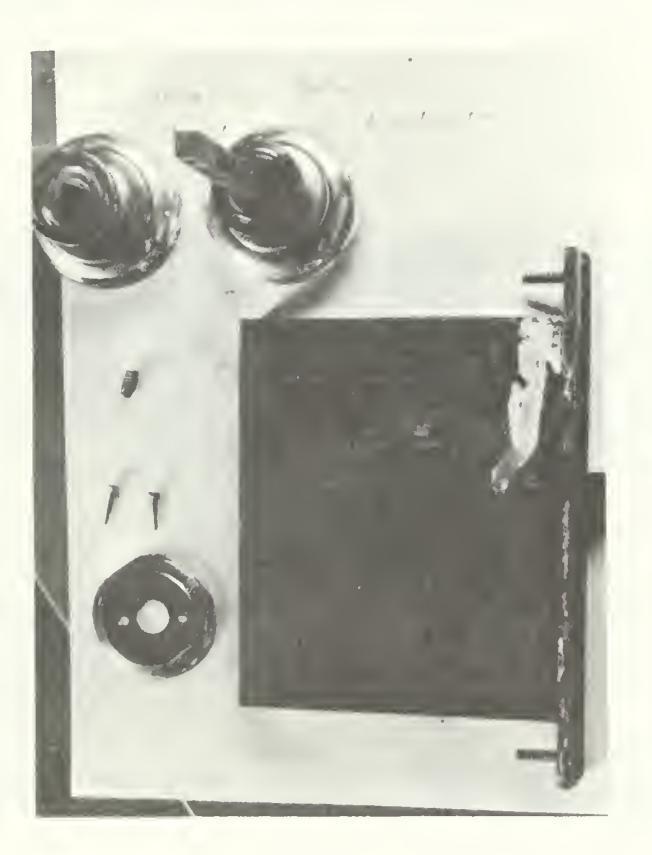
IP124, N016-18. Lock 133.

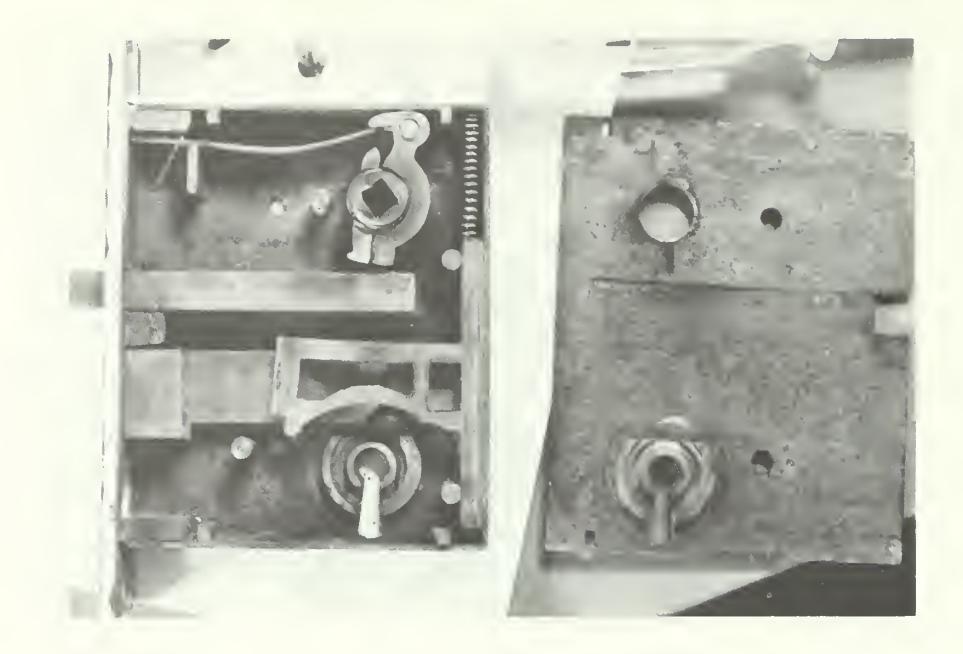
IP125, N016-21. Lock 133, with cover removed.
