historic structure report architectural data section volume 2: appendixes

#### HISTORIC STRUCTURE REPORT

#### LINDENWALD

## MARTIN VAN BUREN NATIONAL HISTORIC SITE

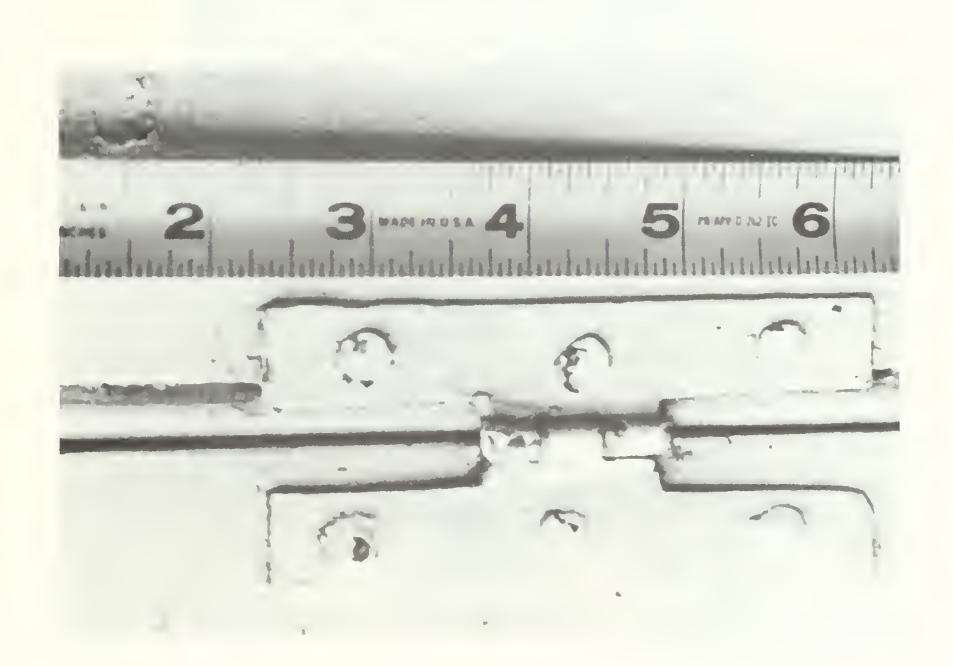
IP128, N036-36. Wrought-iron H hinge for ca. 1797 interior shutters.

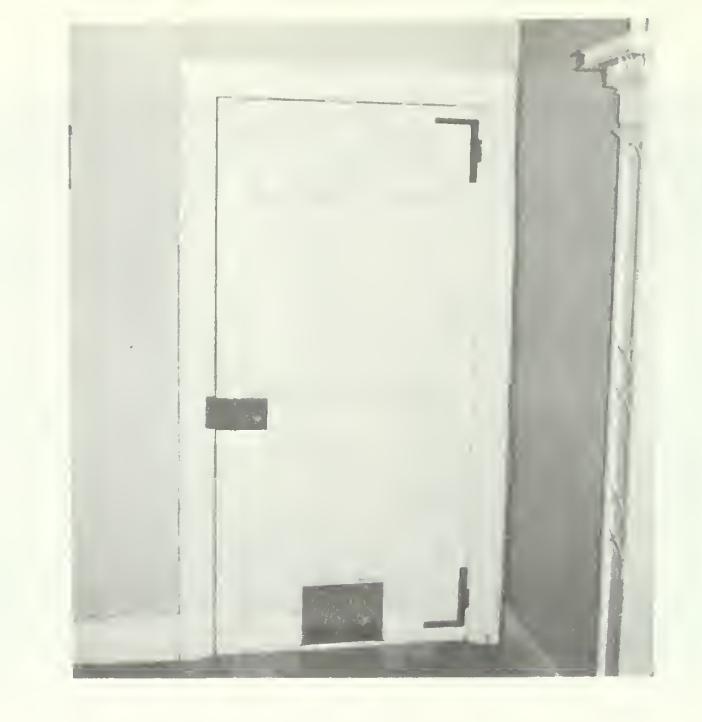
IP129, N030-06. Door 210, typical mounting of HL hinges on ca. 1797 door.

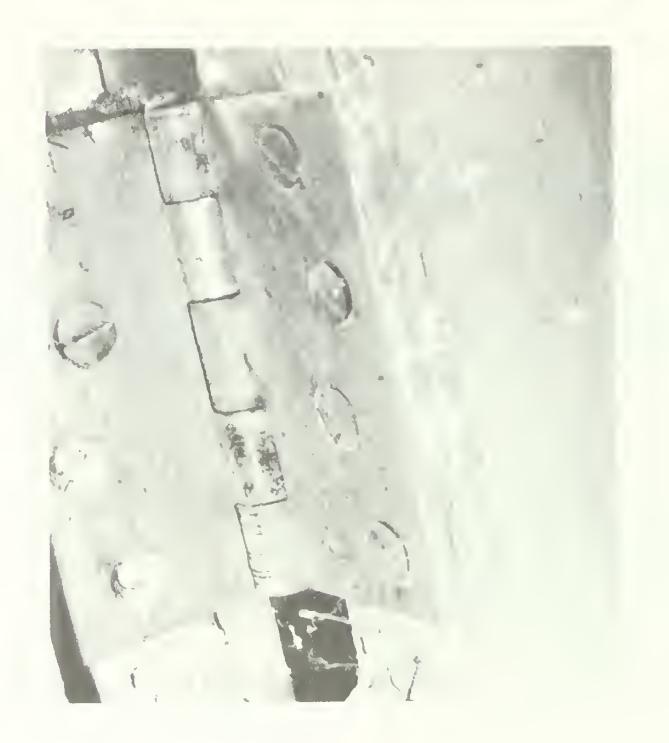
IP130, N037-28. 4" by 4" five-knuckle, eight-hole cast-iron butt hinge.

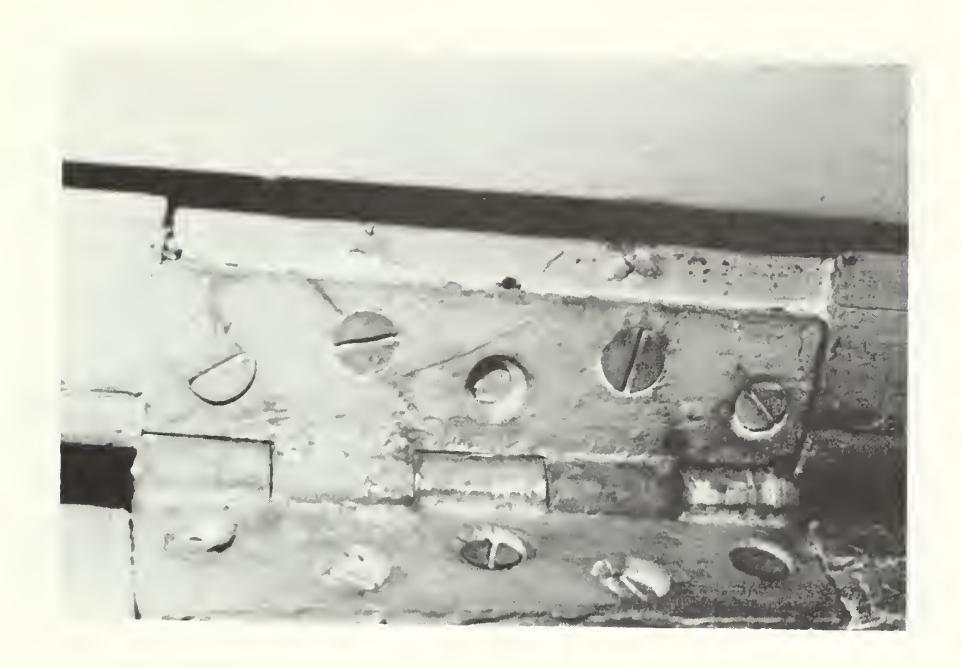
IP131, N037-27. 5" by 3" five-knuckle, ten-hole cast-iron butt hinge.

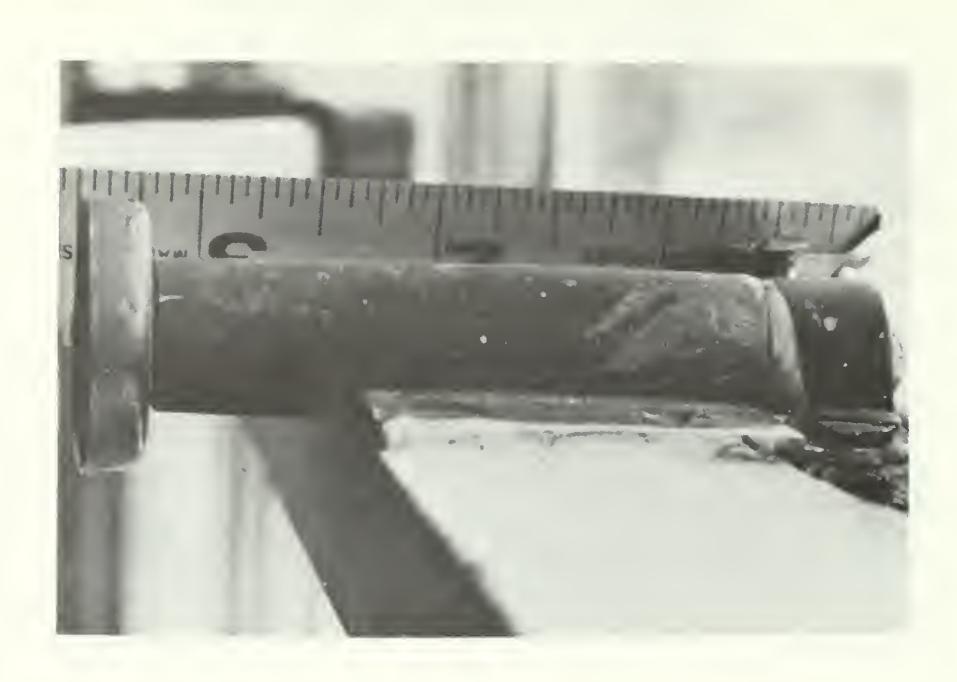
IP133, N036-40. Ca. 1840 sash lock.

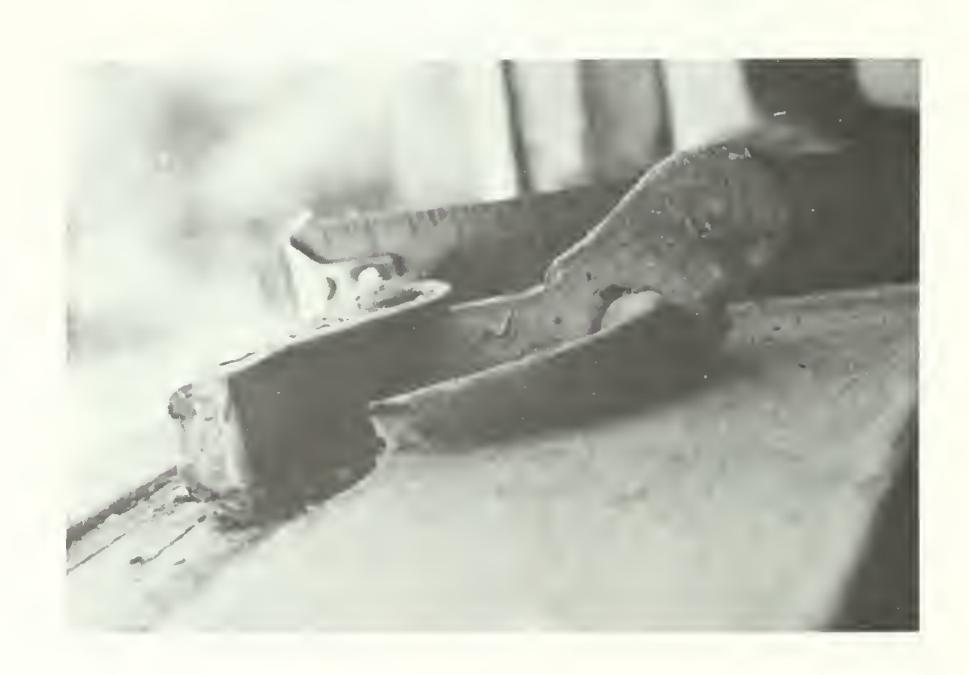
IP134, N036-27. Ca. 1850 sash lock.

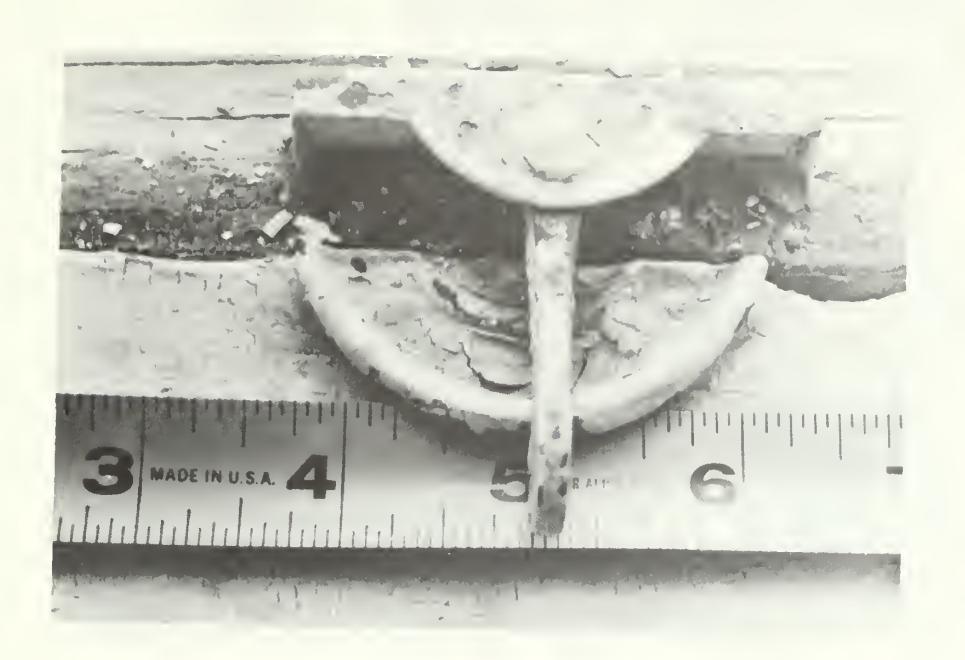
IP135, N036-26. Ca. 1850 sash lock.

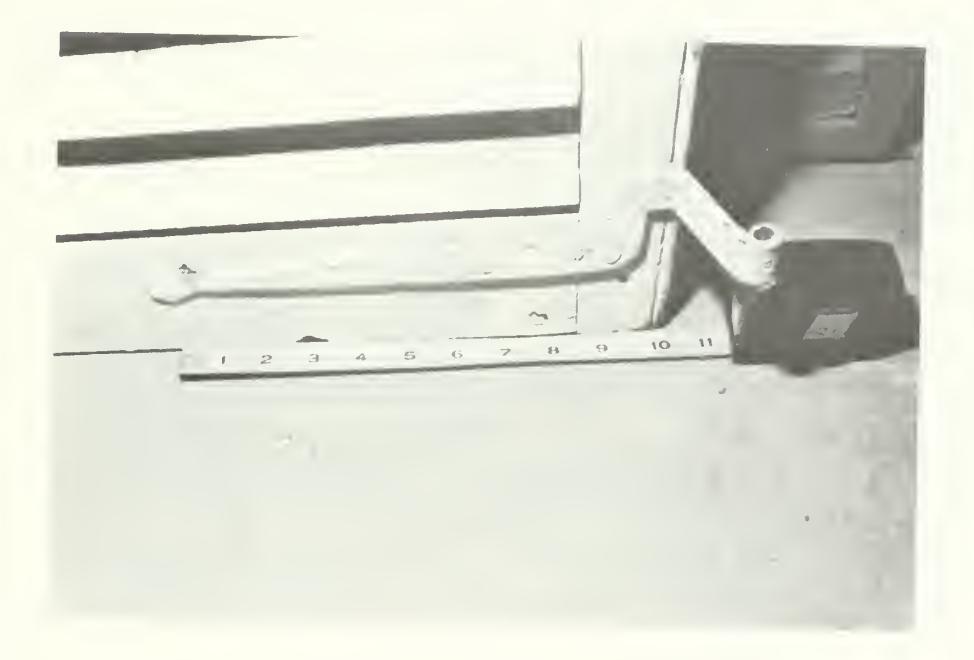
IP136, N033-16. Wrought-iron hinge for exterior shutter blind.

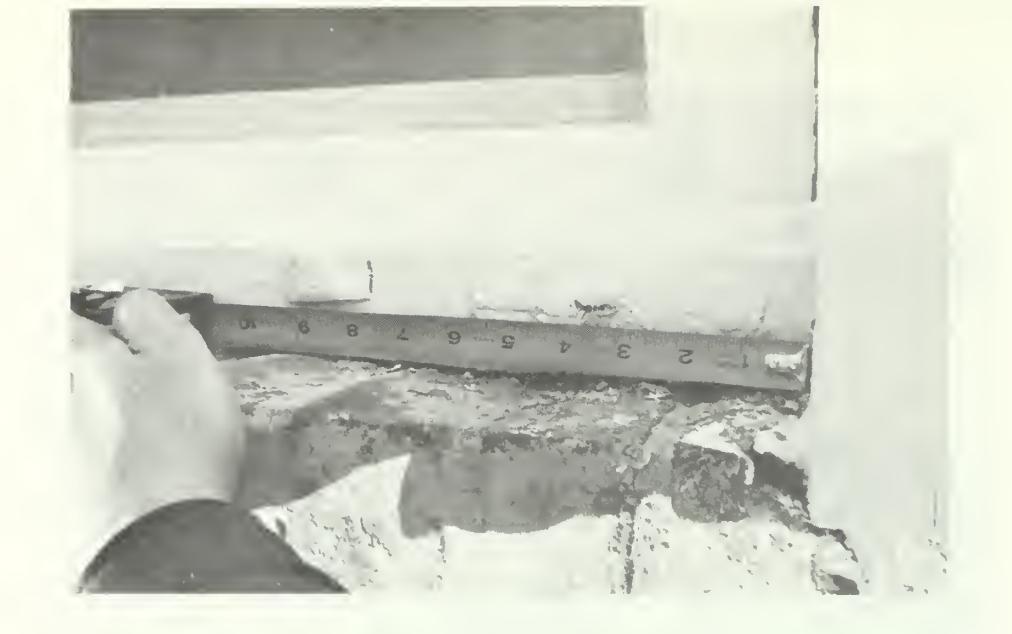
IP137, N034-04. Wrought-iron pintle for exterior shutter blinds.

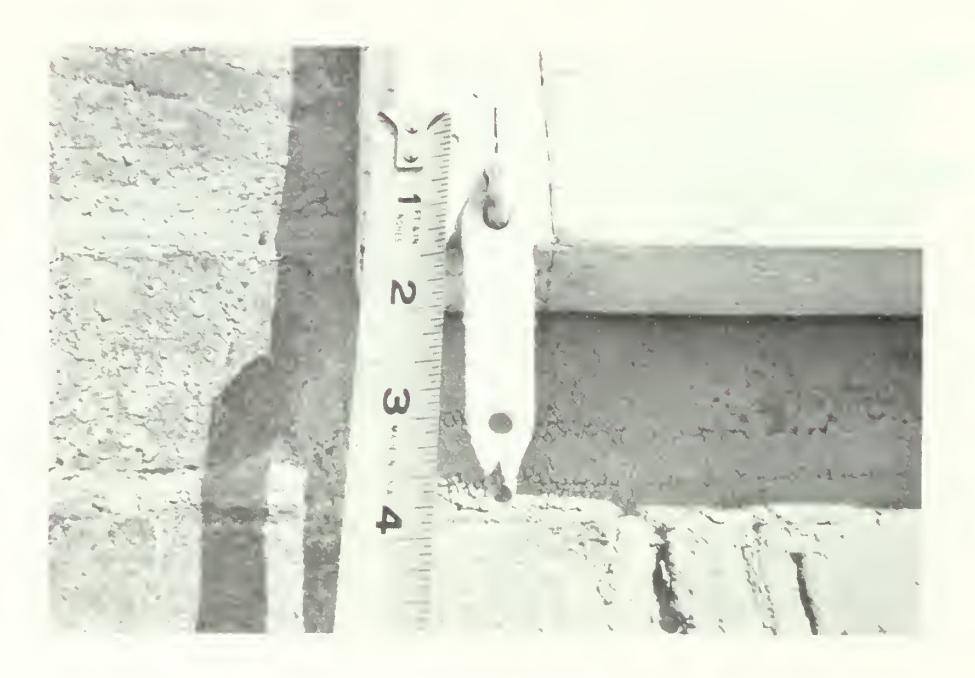
IP138, N033-17. Fastener for exterior shutter blinds.

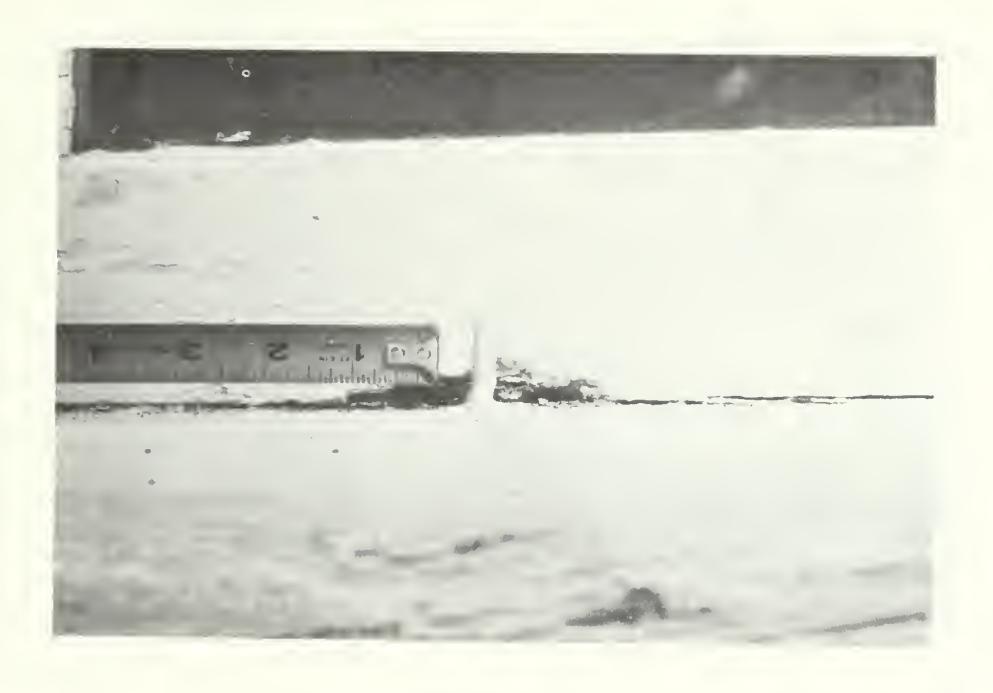
IP139, N033-19. Post for above fastener.

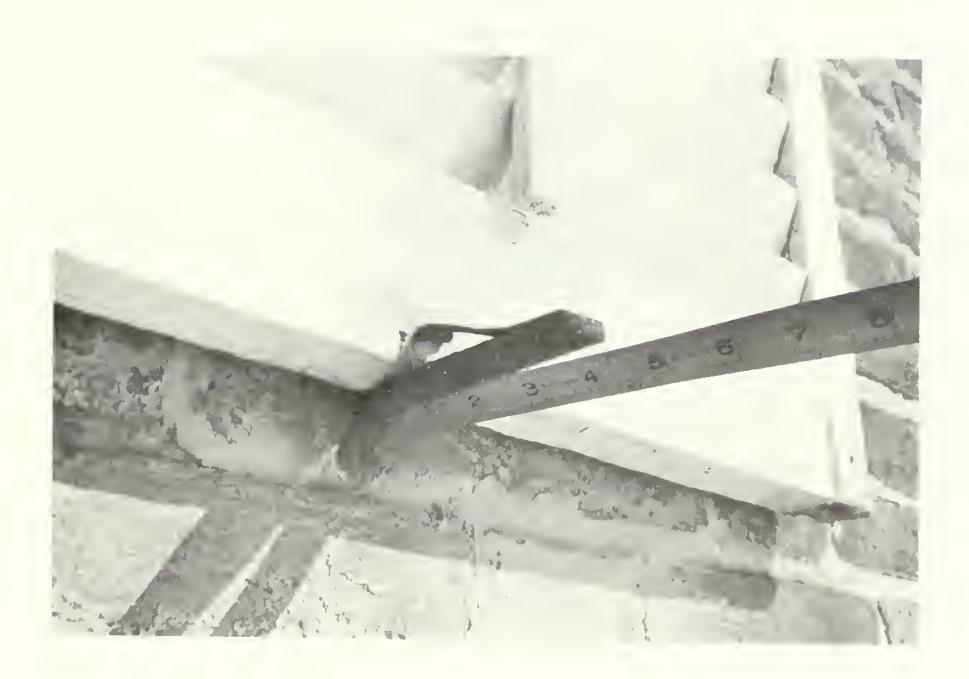
IP140, N033-18. Spring-type shutter holdback.

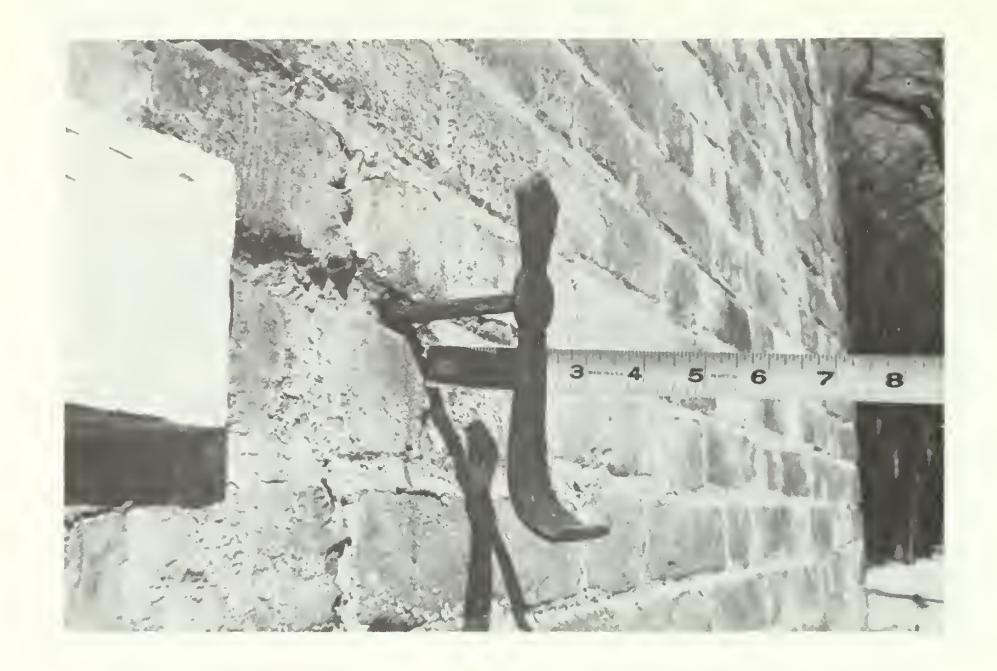
(P14), N034-03. Propeller-type shutter holdback.

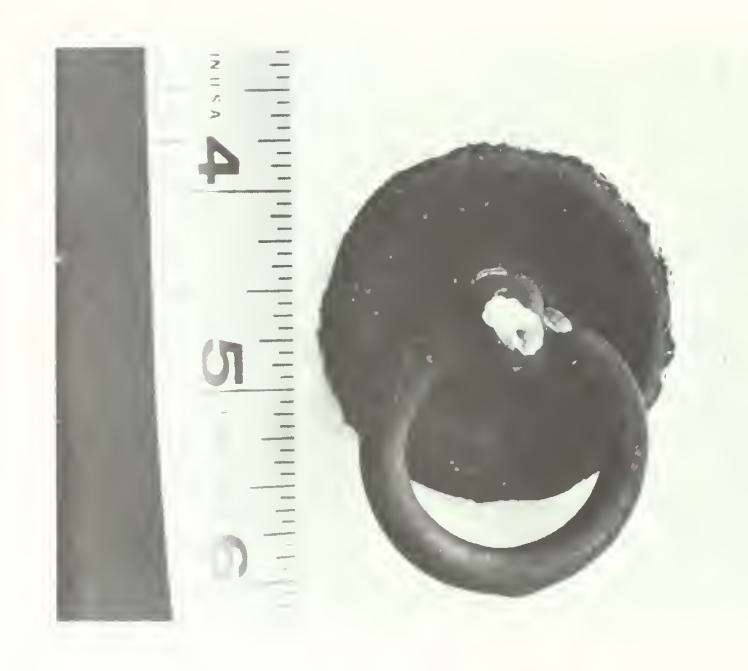
IP142, N036-31. Ring pull for ca. 1797 interior shutters.

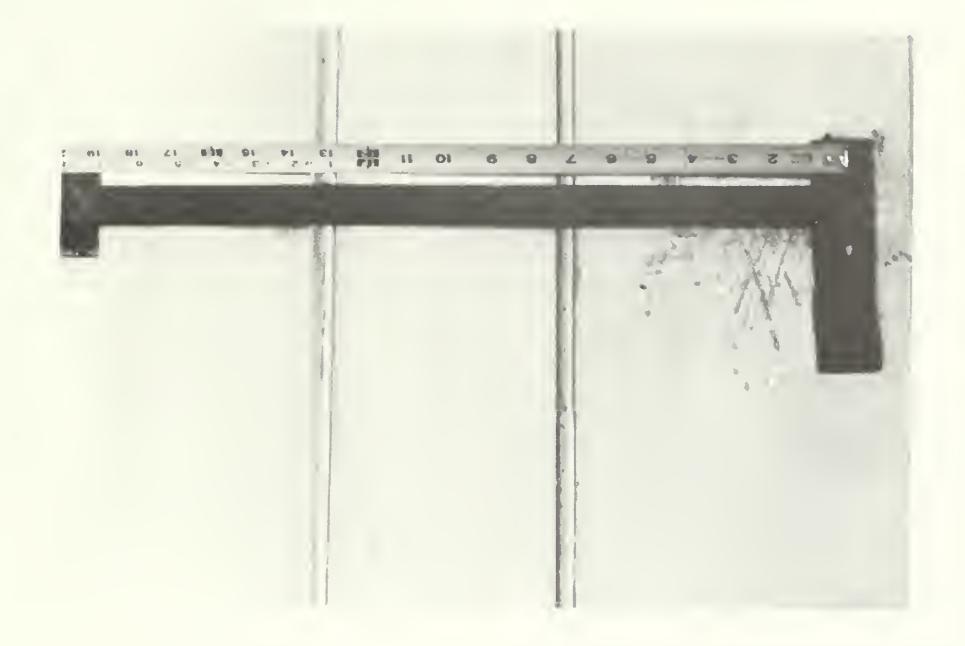
IP143, N036-34. Bar hardware for ca. 1797 interior shutters.

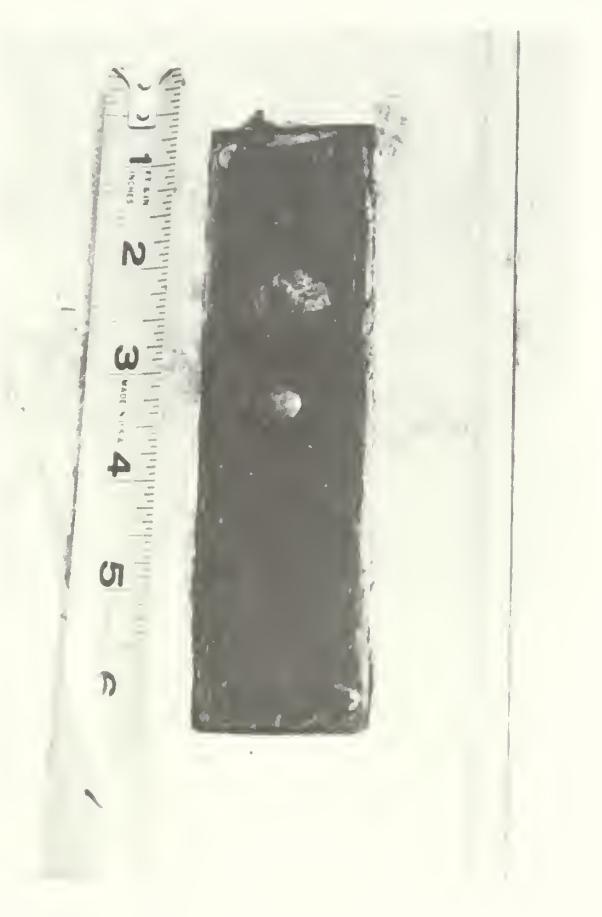
IP144 N036-32. Detail of catch for shutter bar.

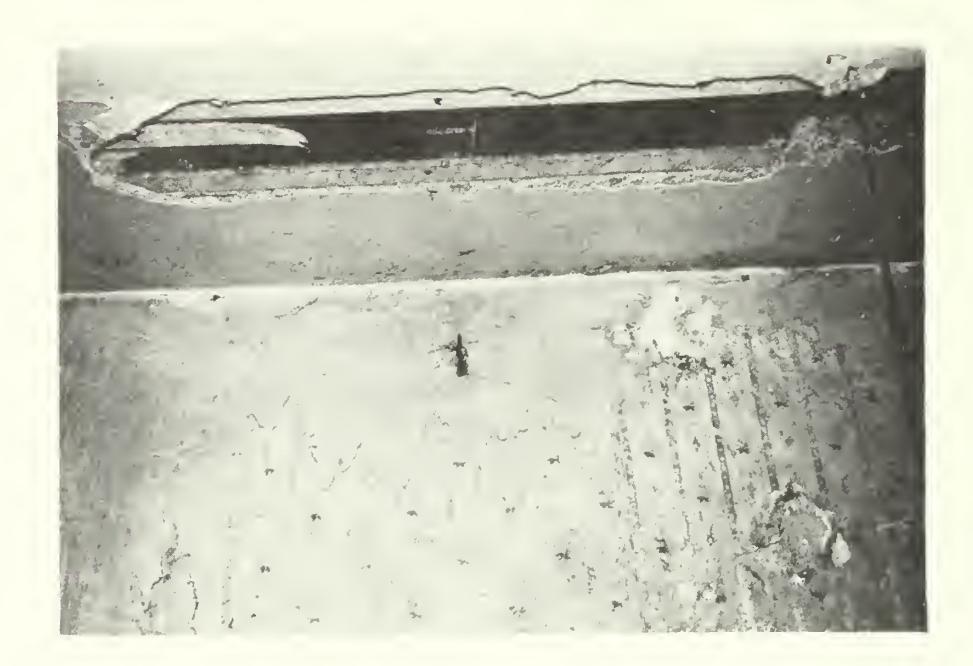
Sample No: MAVA 01 WP001 Location: Room 005 (west wall) Substrate: Plaster

Comments: This wallpaper hangs in the servants' dining room. It was the only wallpaper found in the basement. The moisture of the basement has caused the paper to deteriorate significantly so that it crumbles when an attempt is made to remove it from the walls.

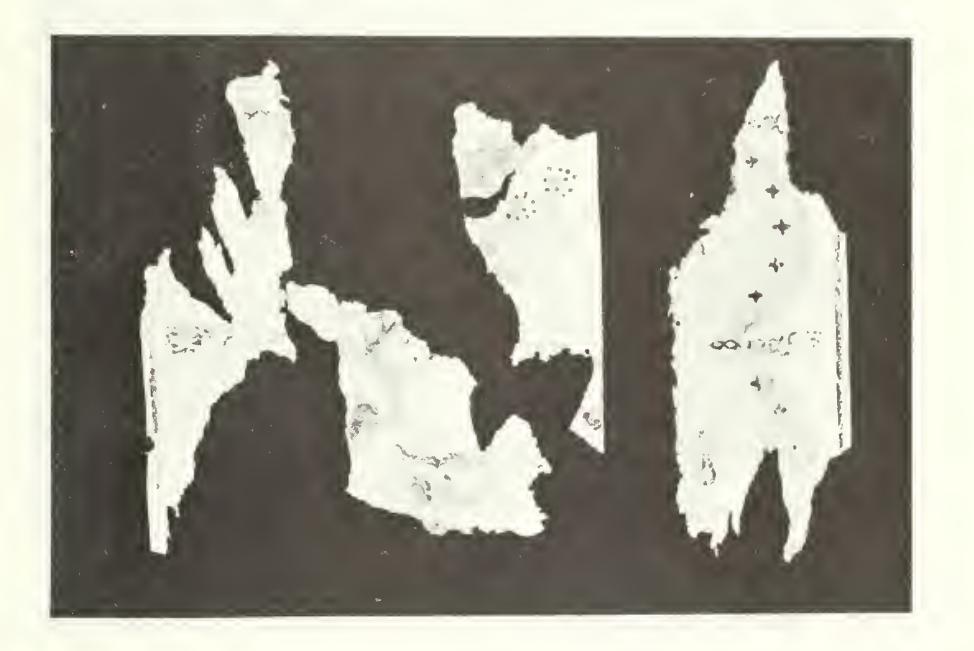
Sample No: MAVA 01 WP004 Location: Room 106 Substrate: Plaster

Comments: This paper was found on the east wall of room 106, behind the pier mirror that hung between the windows. It was covered by two later layers of wallpaper before the pier mirror was hung. The wallpaper does not extend across the chair rail area. The border ran down the sides of the windows as well as at the cornice. The paper has horizontal seams, indicating that it was handmade. A portion of this wallpaper is still on the walls and should be conserved.

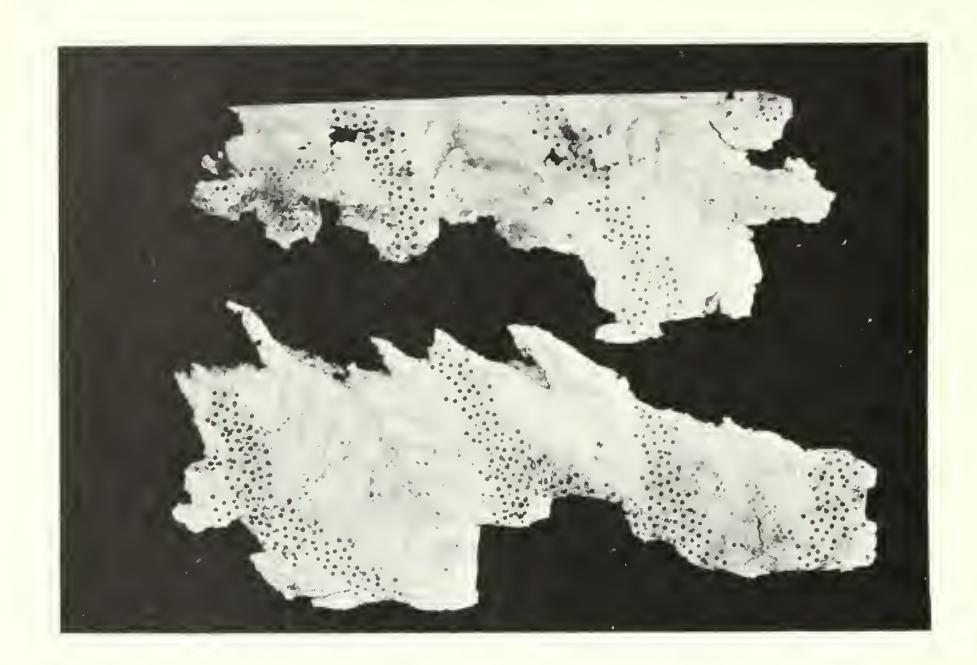
Comments: This is the second layer of wallpaper (counting up from the plaster) found under the pier mirror in room 106. It does not extend across the area from which the chair rail was removed, indicating that it predates Van Buren. Part of a strip of this wallpaper is still on the walls and should be conserved.

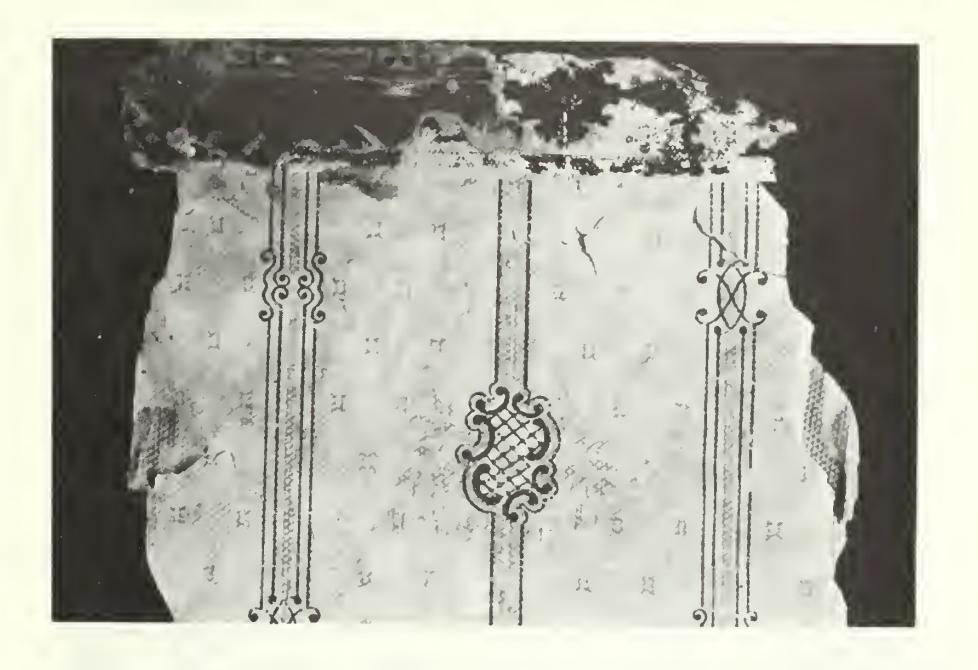
Sample No: MAVA 01 WP006 Location: Room 106 (east wall) Substrate: Plaster

Comments: This is the third layer of wallpaper (counting up from the plaster) found under the pier mirrow in room 106. It extends across the area from which the chair rail was removed. It is directly on top of the green lining paper that was placed over the chair rail area, indicating that it is very likely a Van Buren wallpaper. Nearly a full panel of this wallpaper still hangs in room 106. It should be removed from the walls and conserved. The border is the same border found on the fireboard of room 109.

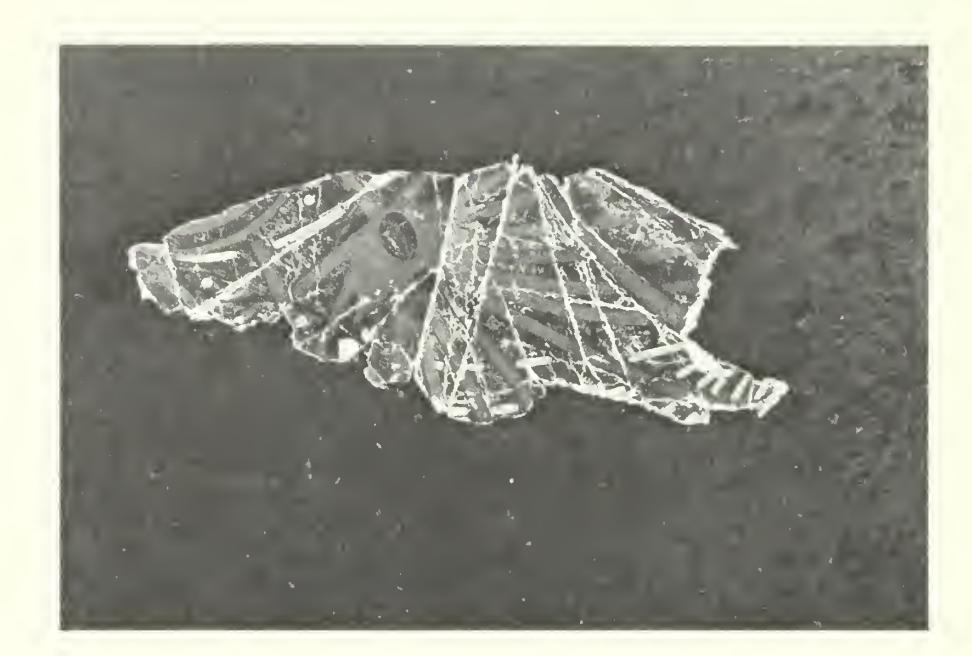
Sample No: MAVA 01 WP009 Location: Room 109 (north wall under stair platform) Substrate: Plaster

Comments: This sample was found under the stair platform of room 109. It was loose and therefore cannot be positively identified as having come from this room. The fragment is too small to be used as the basis for a reproduction wallpaper.

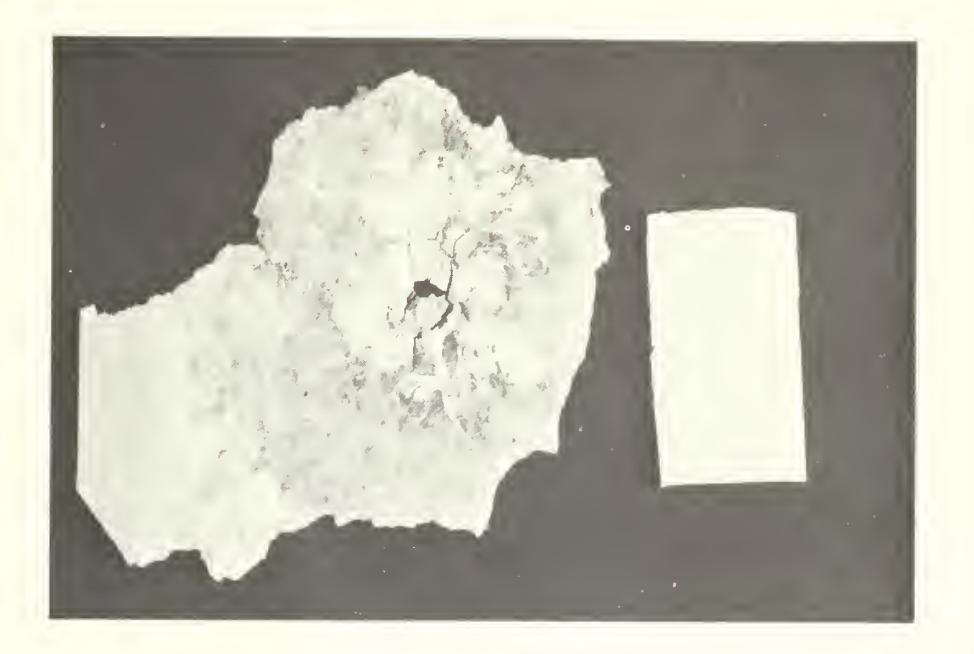
Sample No: MAVA 01 WP019 Location: Room 210 (fireboard) Substrate: Canvas

Physical Characteristics	Wallpaper	Border
Pattern and Date:	Floral, ca. 1840	Geometric
Sample Size:	Full firescreen	2-3/4" wide × 4"
Principal Colors:	Green and white on white ground	Green and black on white ground
Paper Type:	Rag	Rag
Paint Type:	Distemper	Varnish and sheared rag
Method of Paper Manufacture:	Machine	Machine
	Maerinie	
Paper Texture:	Smooth	Smooth
Printing Technique:	Block	Flock

Comments: It has been assumed that the wallpaper found on the fireboard in this room was also used on the walls, as was the case in room 201.

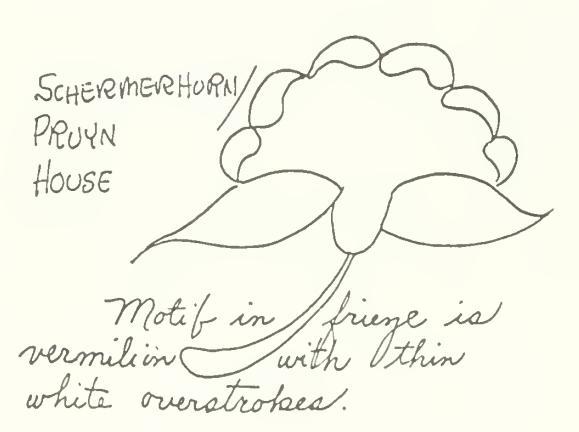
SCHEMERHORN/PRUYN HOUSE, Kinderhook, is now owned by Roderick Blackburn. A remnant of plaster from an early chimney breast which shows painting has been preserved. The background paint is brown, the shade used in the Van Alen house. The portion which has been saved is a frieze largely made up of brush-stroke motifs in the same colors as those at MVBHS with the additional use of light brown. A flower somewhat like the shell-like flower in Design A, MVBHS, is a part of a central motif. A brush-stroke border is the same as the one which is a part of Design F, MVBHS. The house was probably built in the mid-1700's.

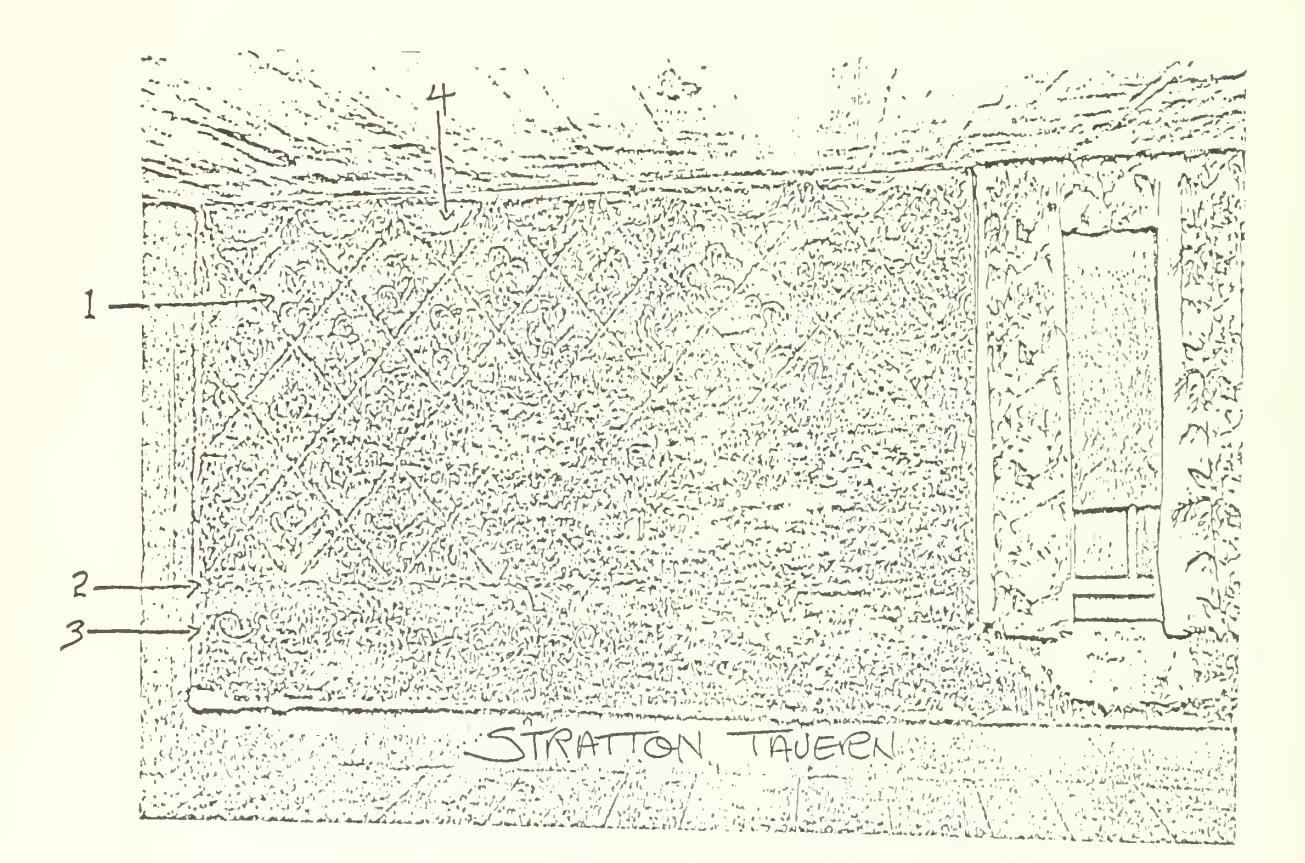
STRATTON TAVERN, Northfield, Massachusetts. (Present owner is Old Sturbridge Village, Inc. The building eventually will be moved.) An upper chamber here has a well-preserved wall with brush-stroke motifs within diamonds like the (2) Van Wormer house; brush-stroke borders; a scroll design on the lower wall, (4) and a frieze with brush-stroke swags. The scroll design is like that at the Van Alstyne House. The workmanship is excellent and obviously the hand of the MVBHS painter. The tavern was built in the early 1760's.
