historic structure report PUBLIC INFORMATION
unit one buildings DEPOS. SYSTEM
volume 2
part two

ELLIS ISLAND
STATUE OF LIBERTY

**HISTORIC STRUCTURES REPORT
UNIT ONE BUILDINGS**

**Beyer Blinder Belle/
Anderson Notter Finegold**

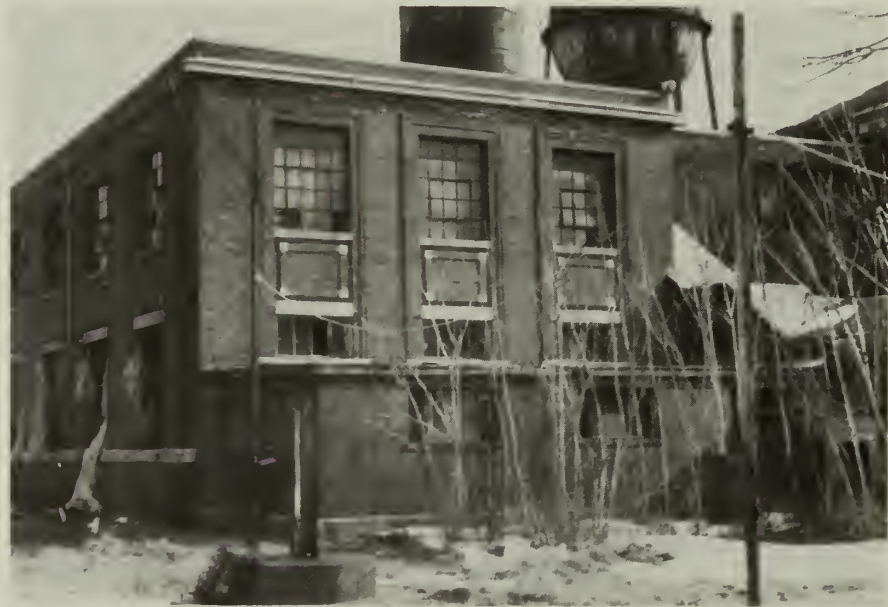
2. south elevation, one-story oven room, view northeast.

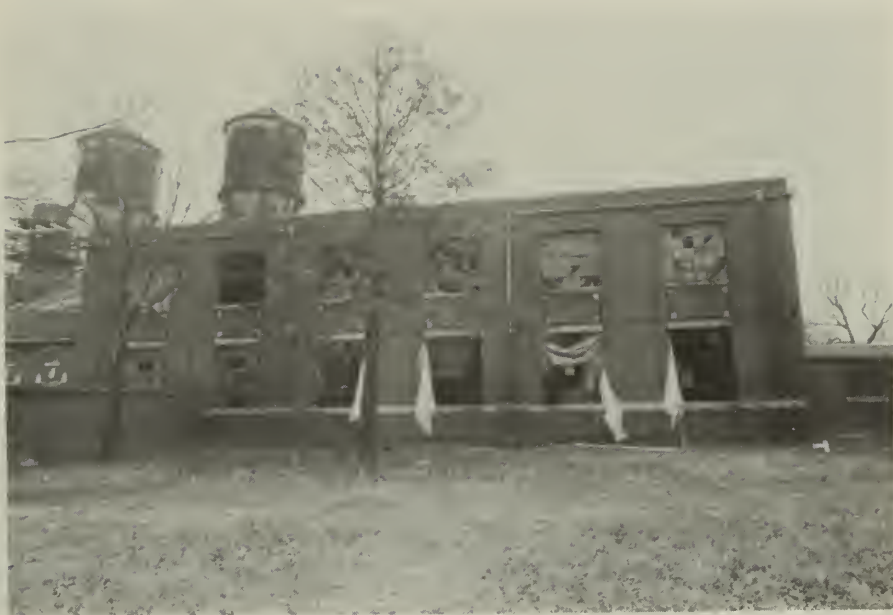
3. West elevation, view east.

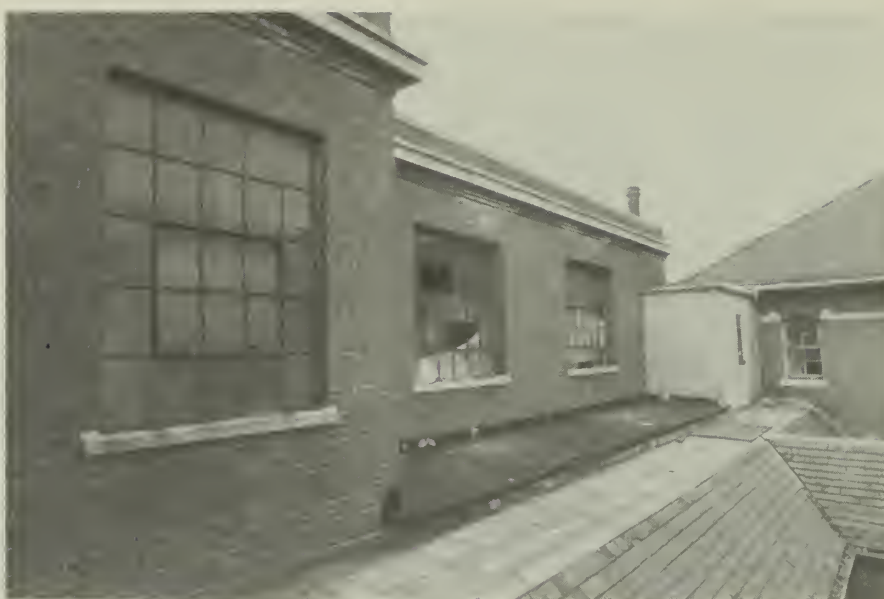
Some efflorescence is present, notably at the corbel table on the south elevation and under the cornice on the east elevation (photo 5). Biological staining is located at the base on the west and north elevations.

5. East elevation, view northwest.

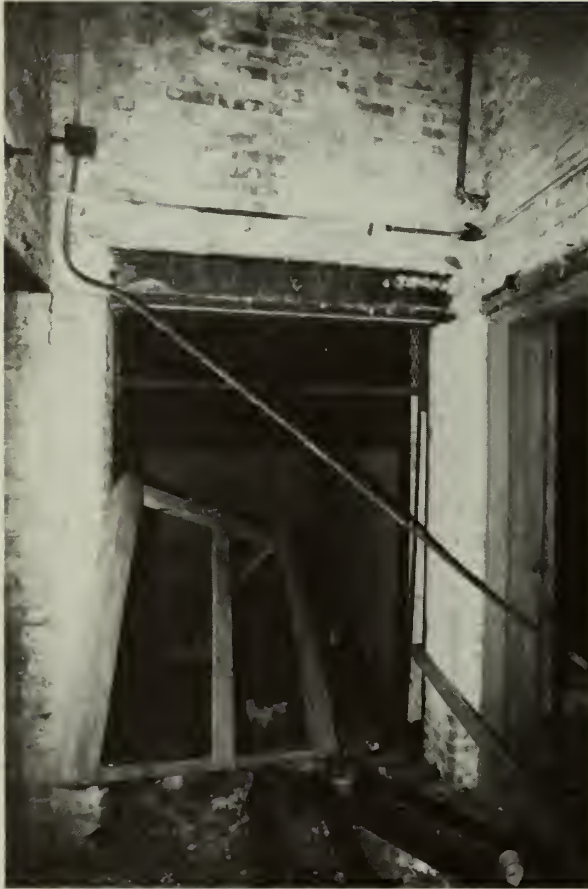
The suspension ropes for the elevator have been disconnected and the car and counterweight are resting at the bottom of the hoistway. However, the hoistway doors have not been permanently barricaded or sealed in the closed position on the hoistway side as required by the present elevator code. All machine room equipment, including the hoisting machine and control panels, is badly corroded. The cab floor is covered with debris and the interior is badly deteriorated. All hoistway equipment, such as guide rails, sheaves and overhead sheave beams are rusted. The elevator is in such an advanced state of deterioration that it is not reusable.

6. Elevator car at first floor hoistway entrance.

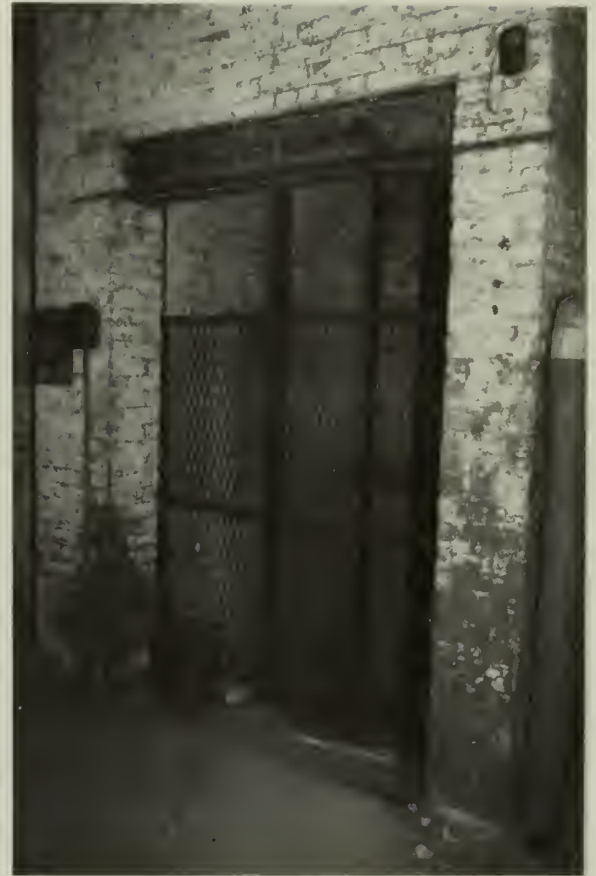
7. Elevator entrance at second floor.

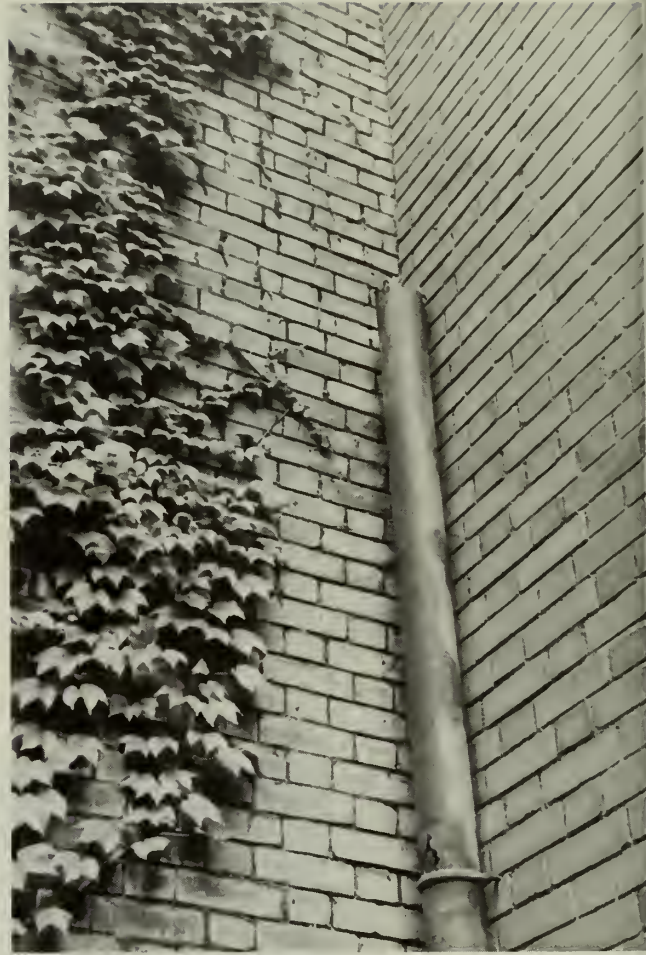
6. Biological staining, north elevation at juncture with corridor 2.

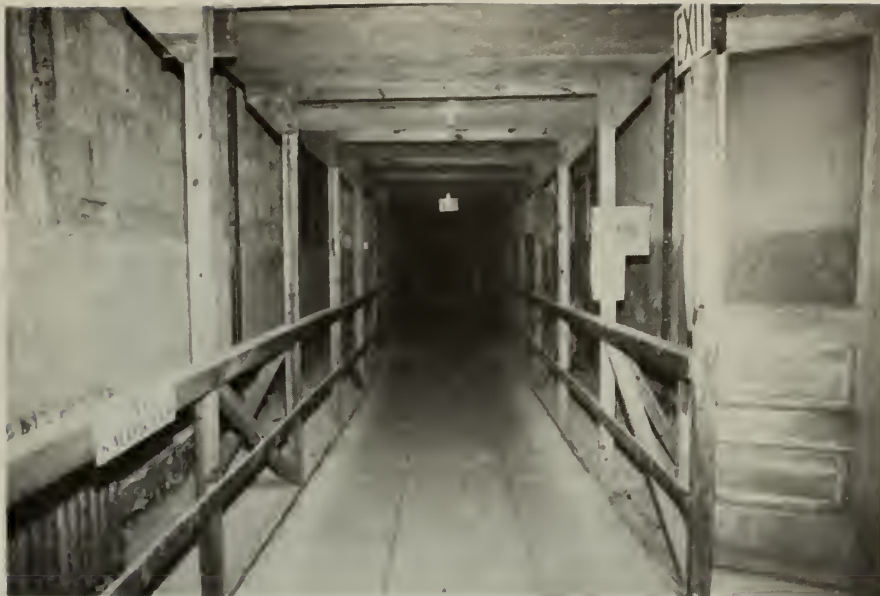
7. First floor of C-1 looking east to main building-
temporary wood railings and overhead protection.

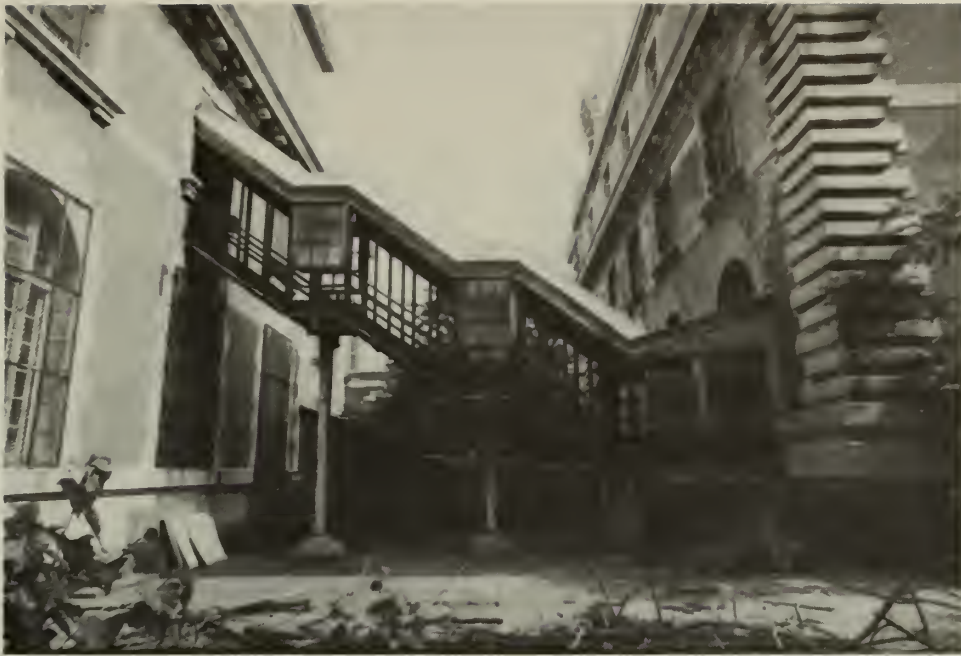
1. View looking east toward covered stairway (C-3).
Main building is at right and baggage and
dormitory building is at left.

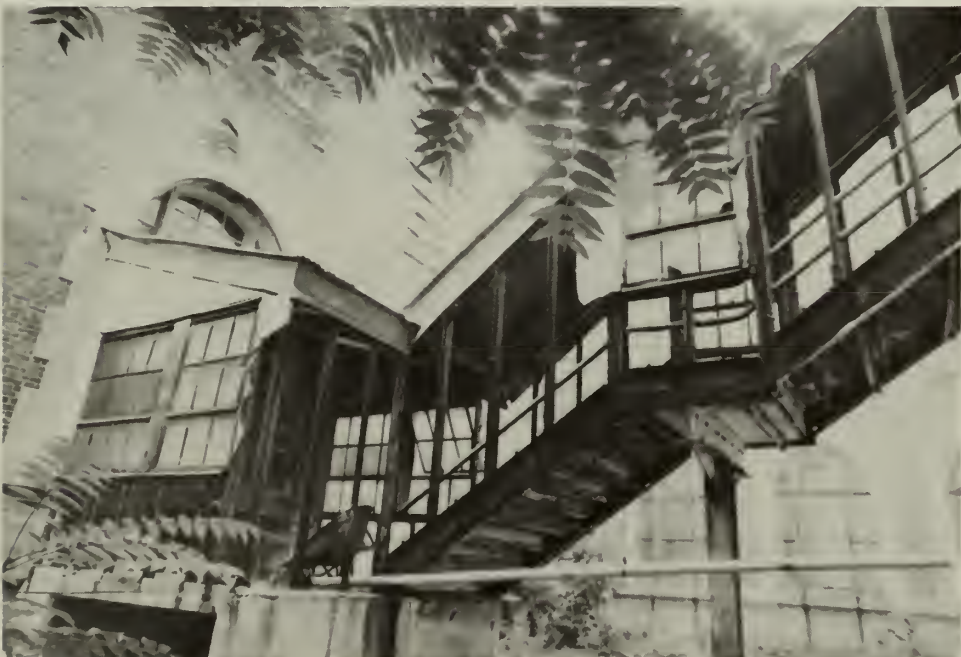
2. View of stair looking west toward platform from first
floor of main buildng. No side sheathing remains.

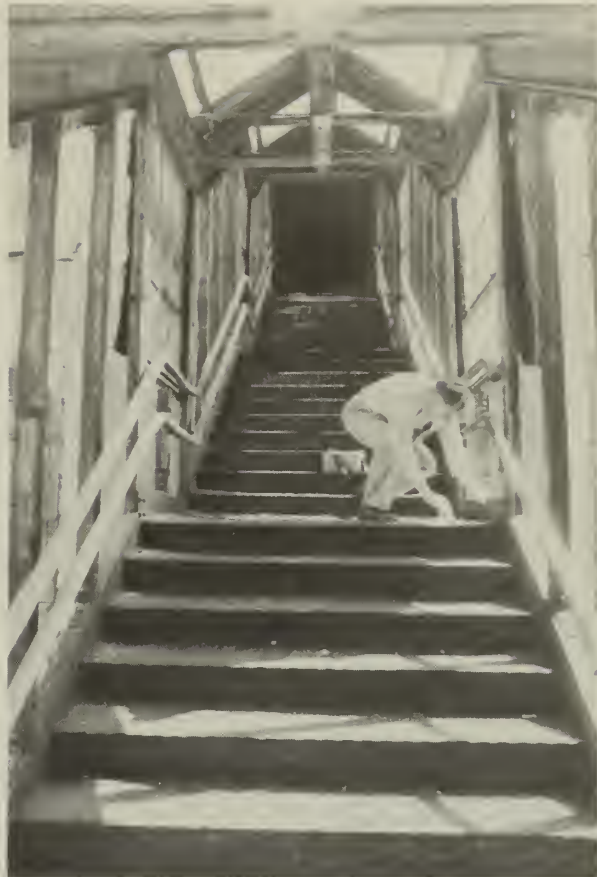
4. View north to baggage and dormitory building vestibule.

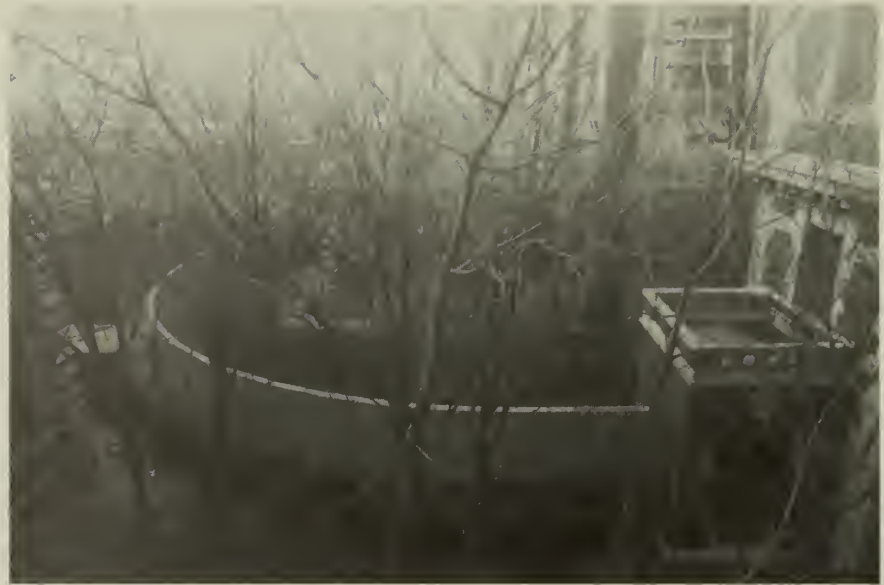
1. C-4- looking west from third floor of C-2.

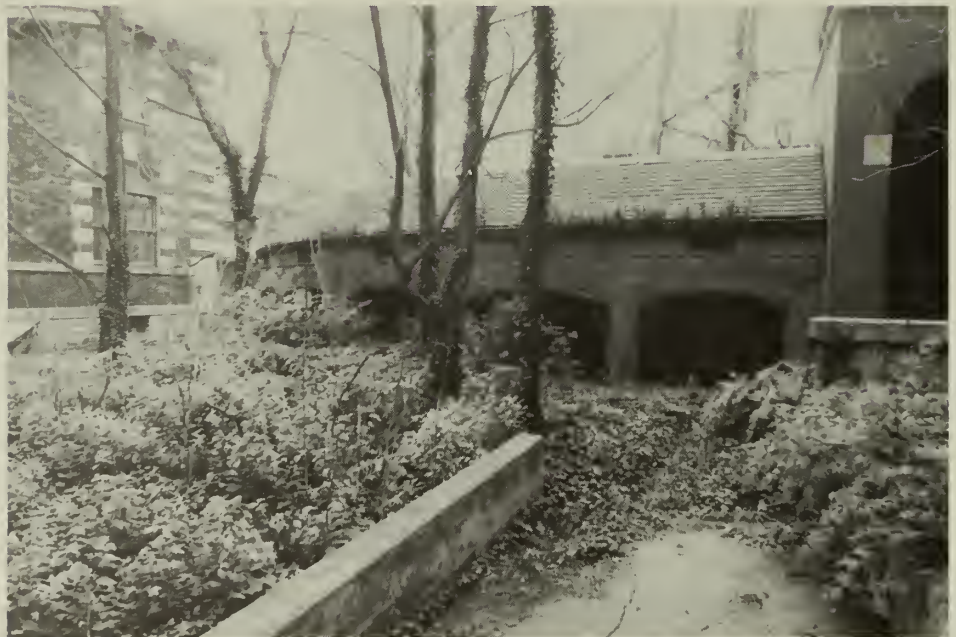
2. East wall of C-4.

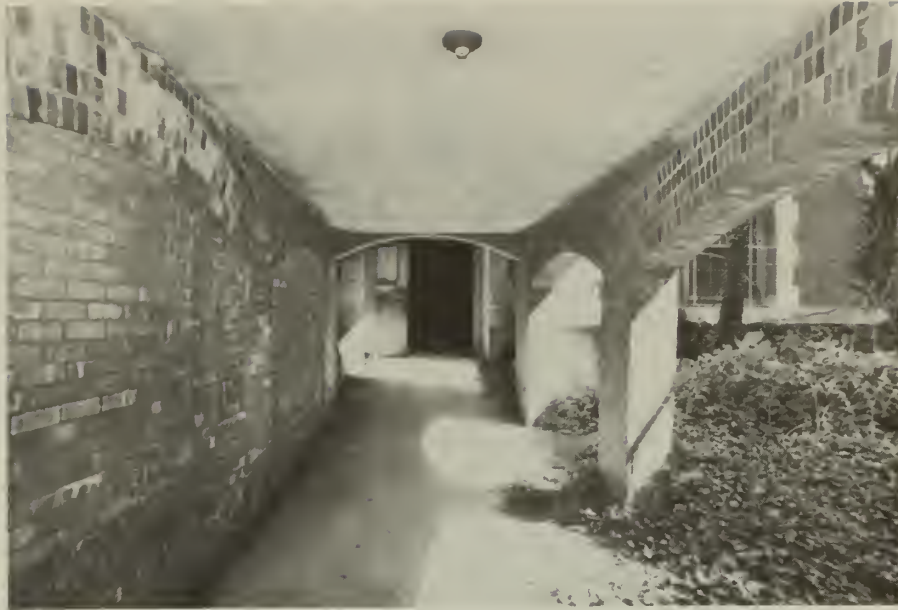
3. C-4- view north into entry to baggage and dormitory building.

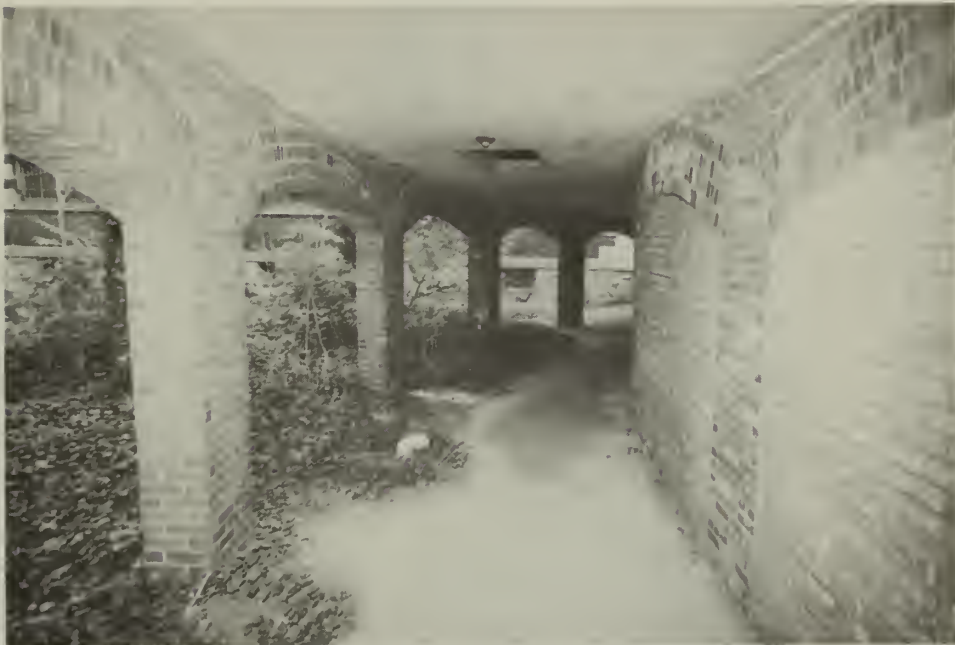
4. C-4- view south from baggage and dormitory building entry.

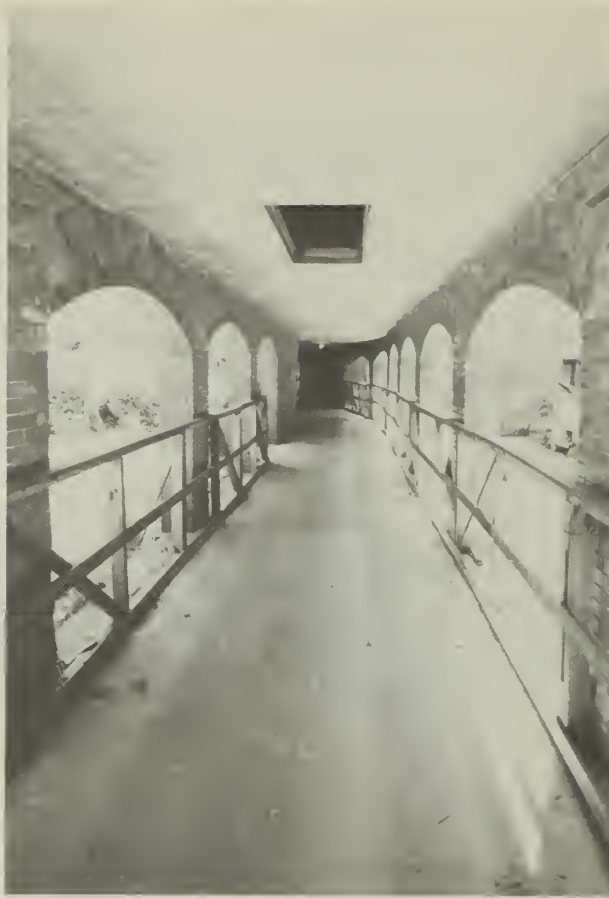
5. C-4- view east toward curving portion.

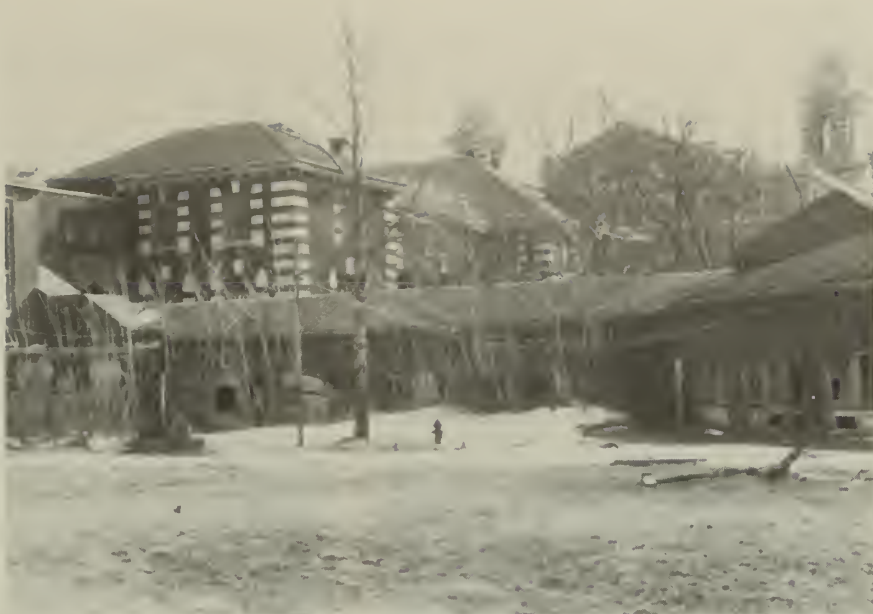
7. North section of west elevation, view east.

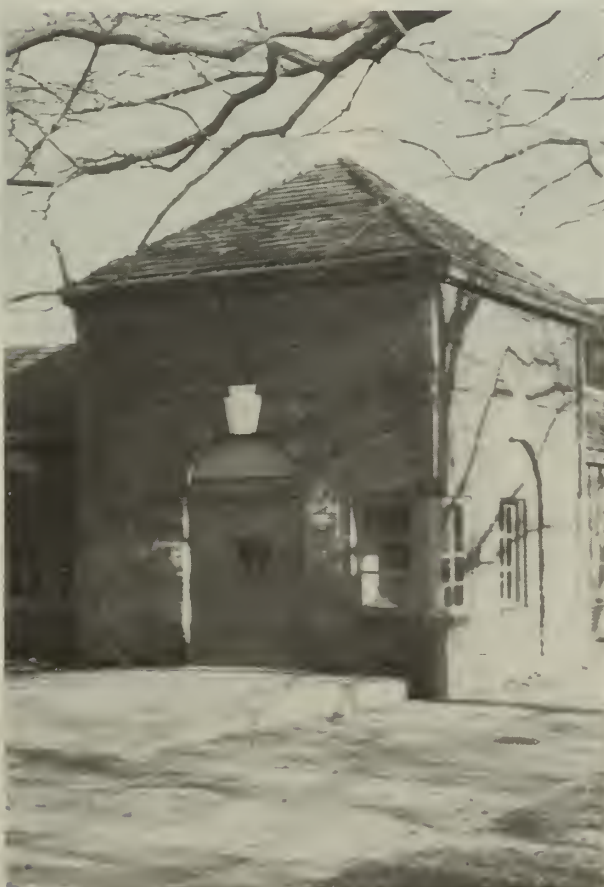
8. Northeast pavilion, view north.

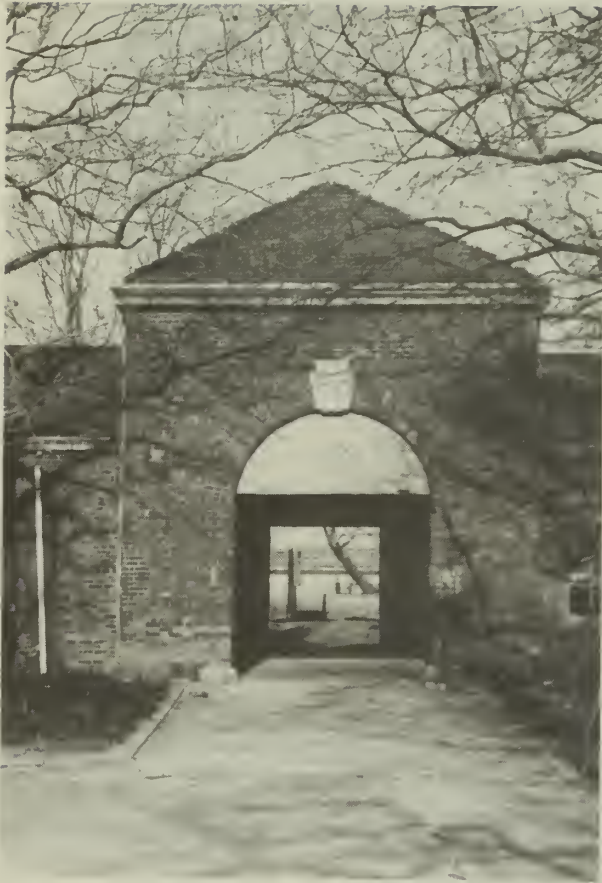
9. Southwest pavilion, view west.

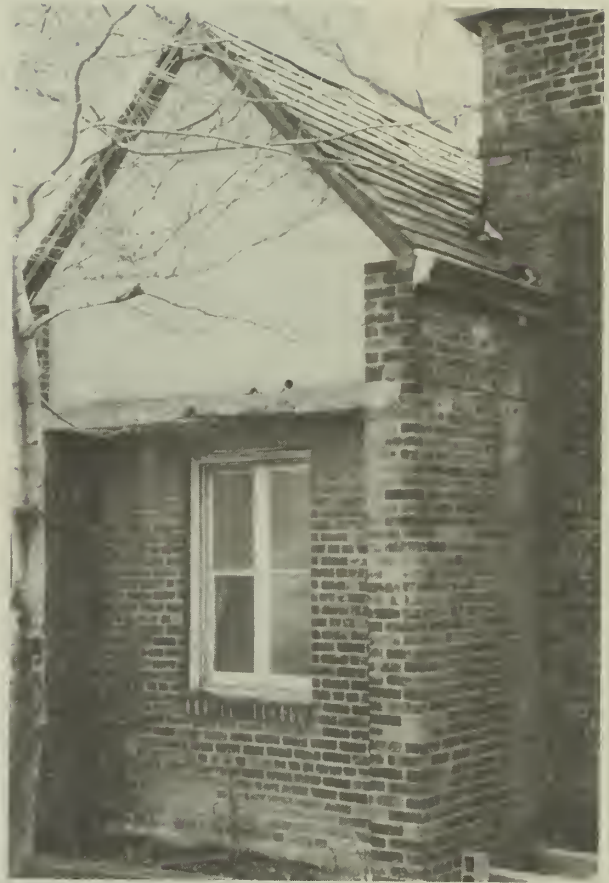
10. Gabled projection north of pavilion, west elevation., view northeast.

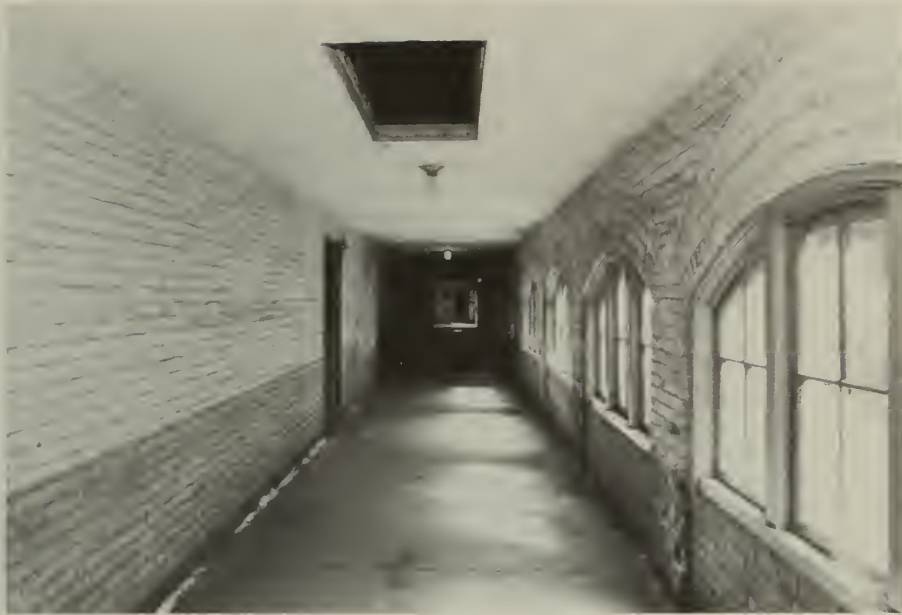
19. C-5- east side of corridor looking north to power-house.

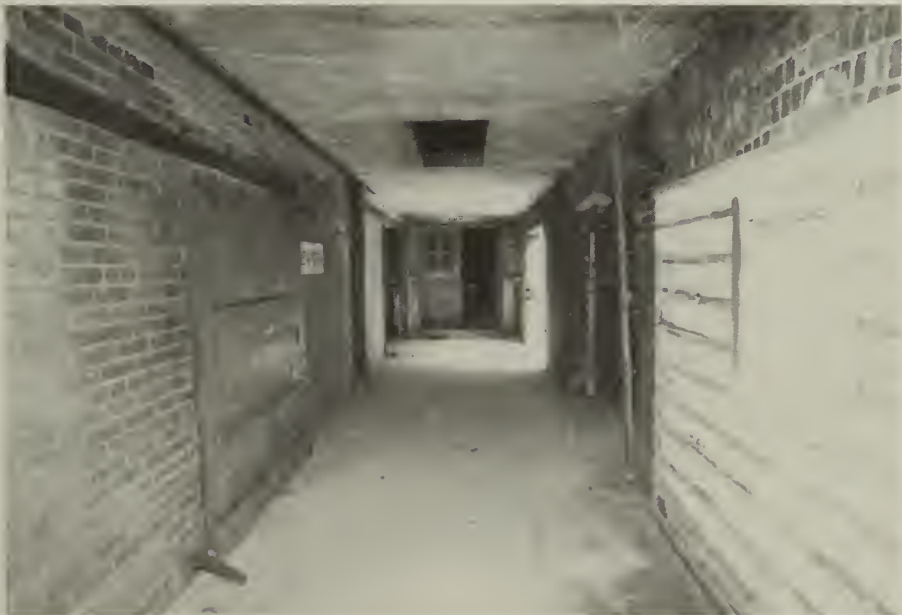
20.C-5- northern section looking toward entry to power-house. Bakery and carpentry at left. Entrance arch to C-4 at right.

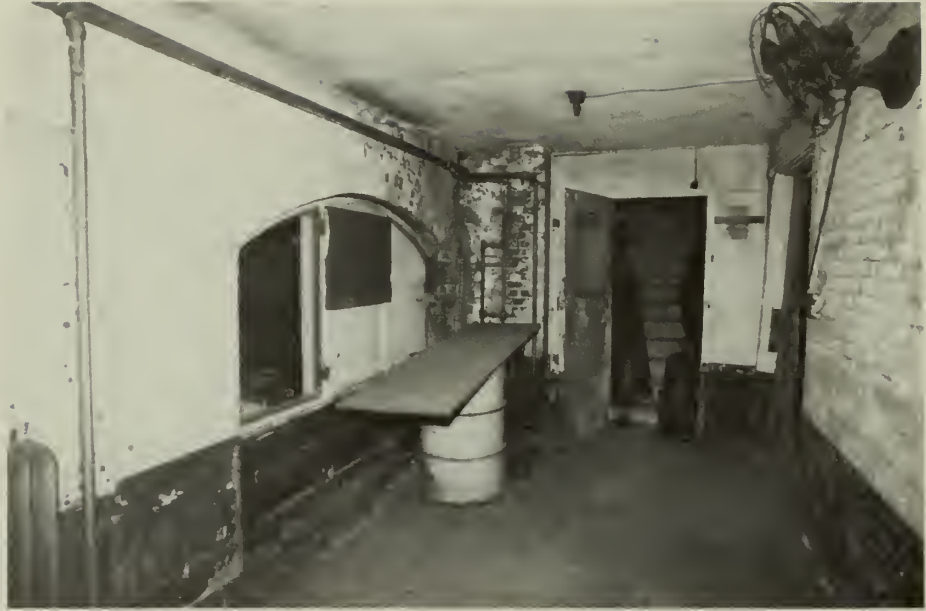
21. Western half of C-5, room 107, looking north to stairway entrance.

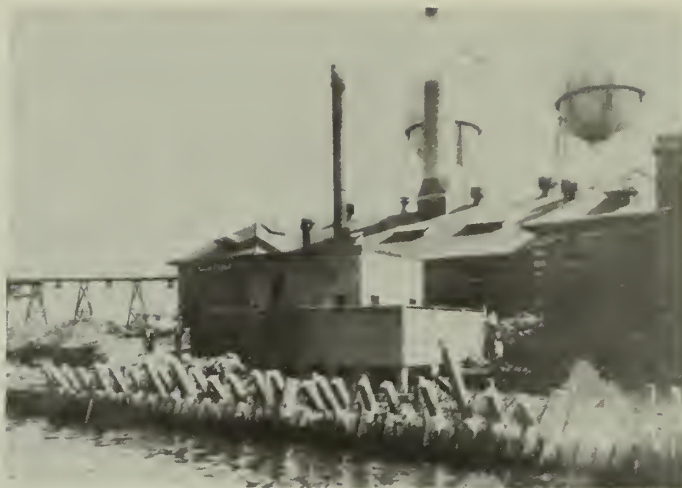
1. South and west facades of incinerator with enclosure wall, during construction of new seawall, September 1934. National Archives, Audiovisual Archives Division, Still Picture Branch.

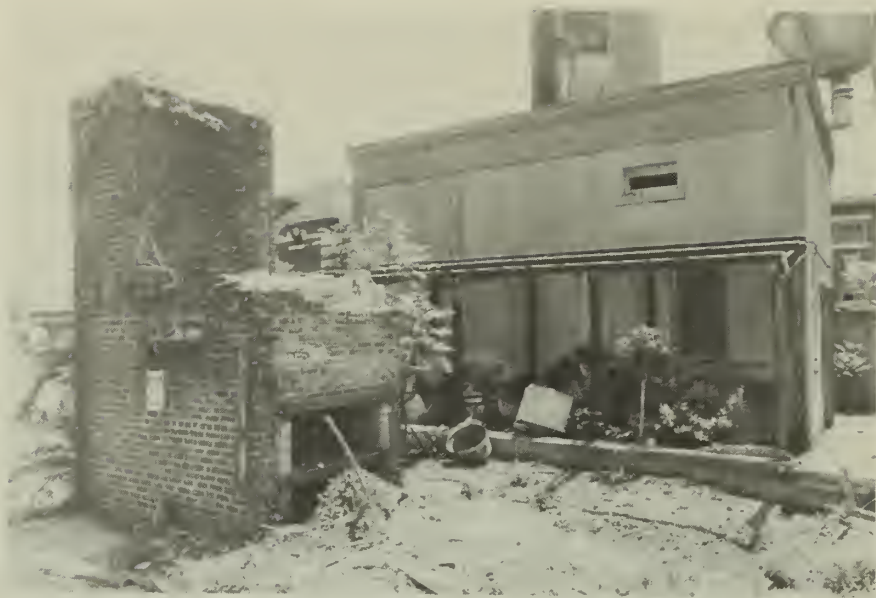
5. West elevation, furnace, view east.

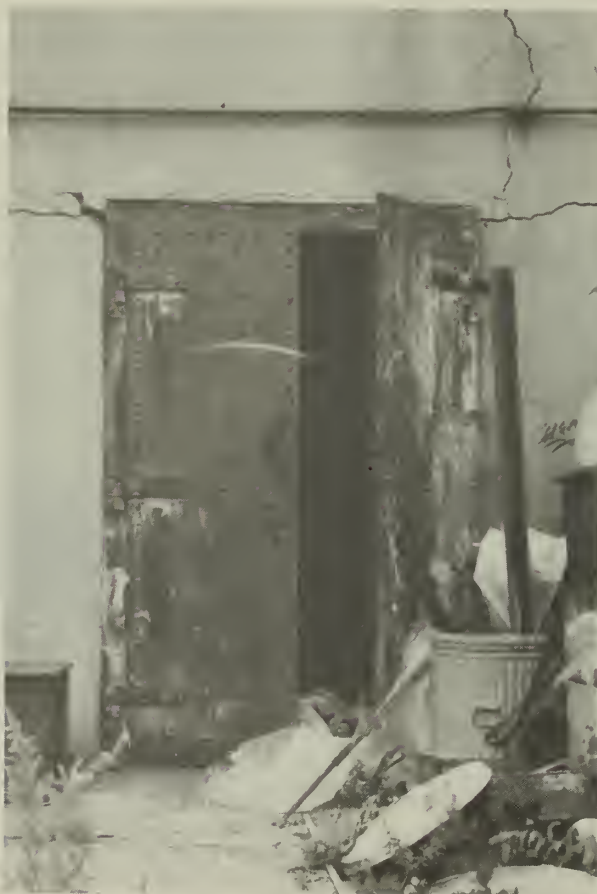
6. Entrance, south elevation, view north.

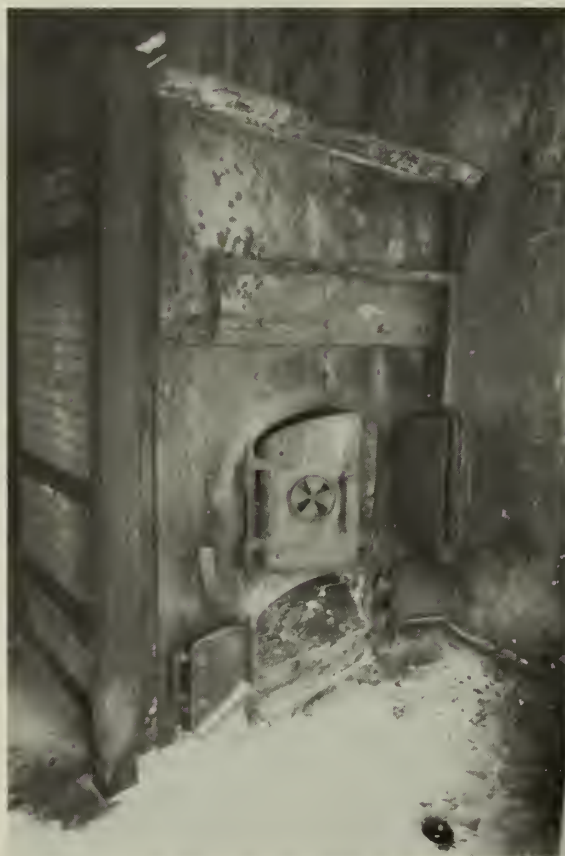
10. Front of eastern incinerator.

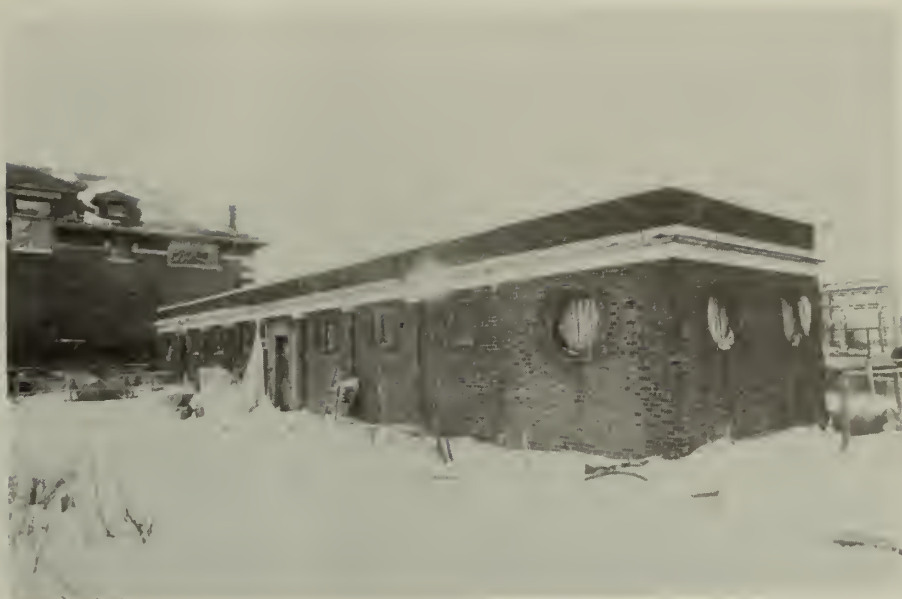
2. East and north elevations, view southwest.

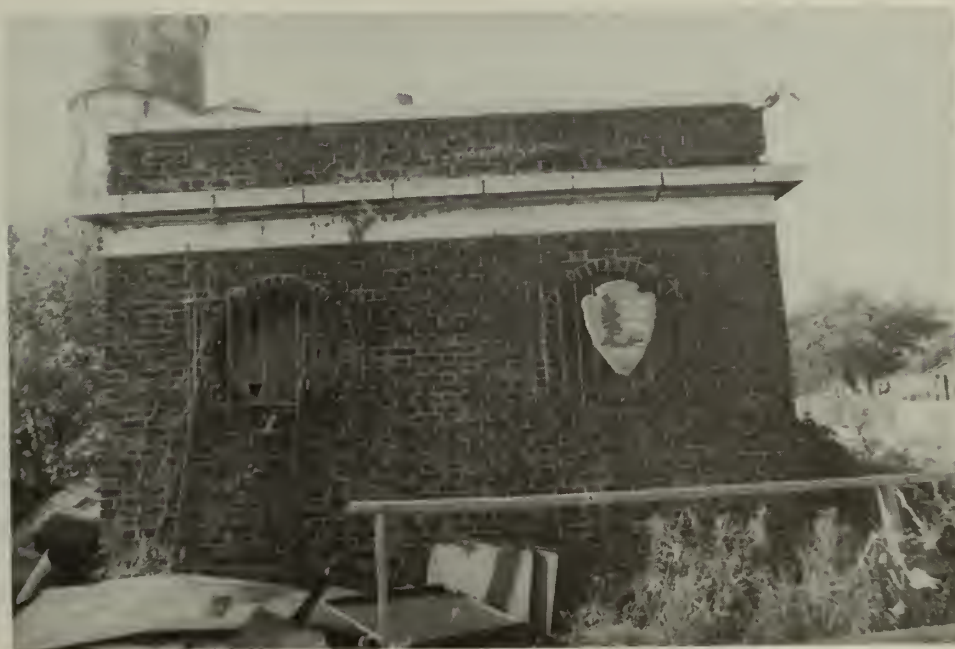
3. North elevation, view south.

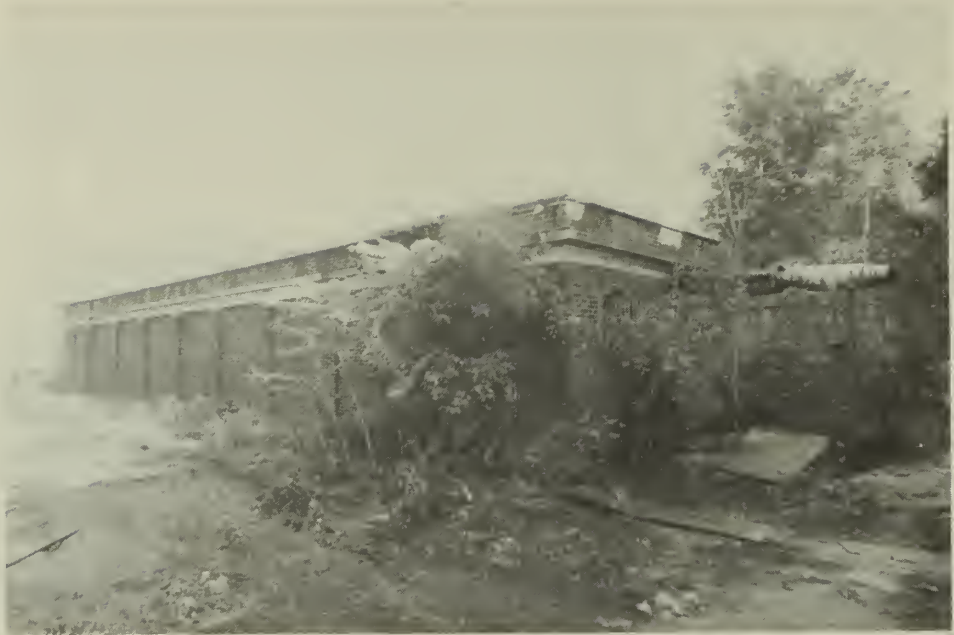
4. West elevation, view northeast.

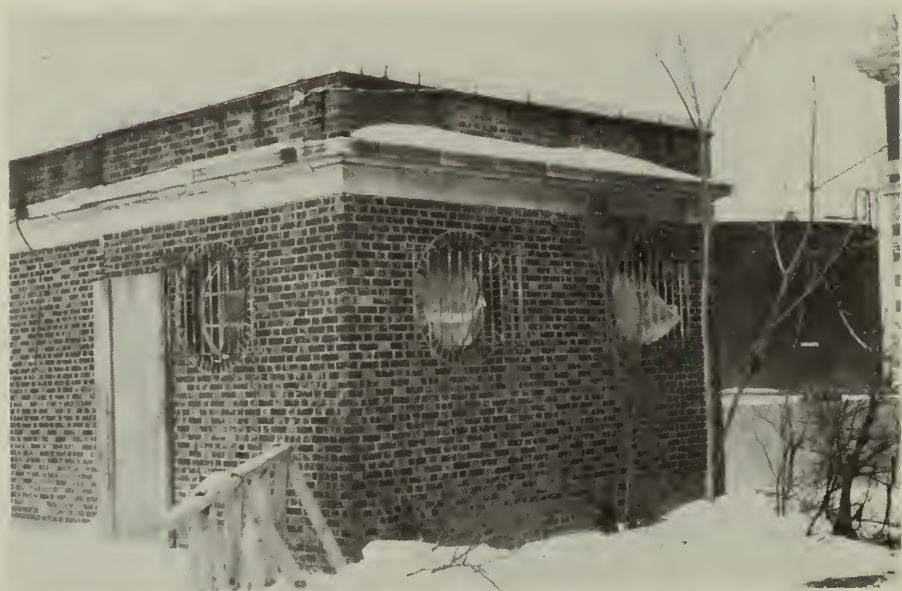
5. South elevation, view northeast.

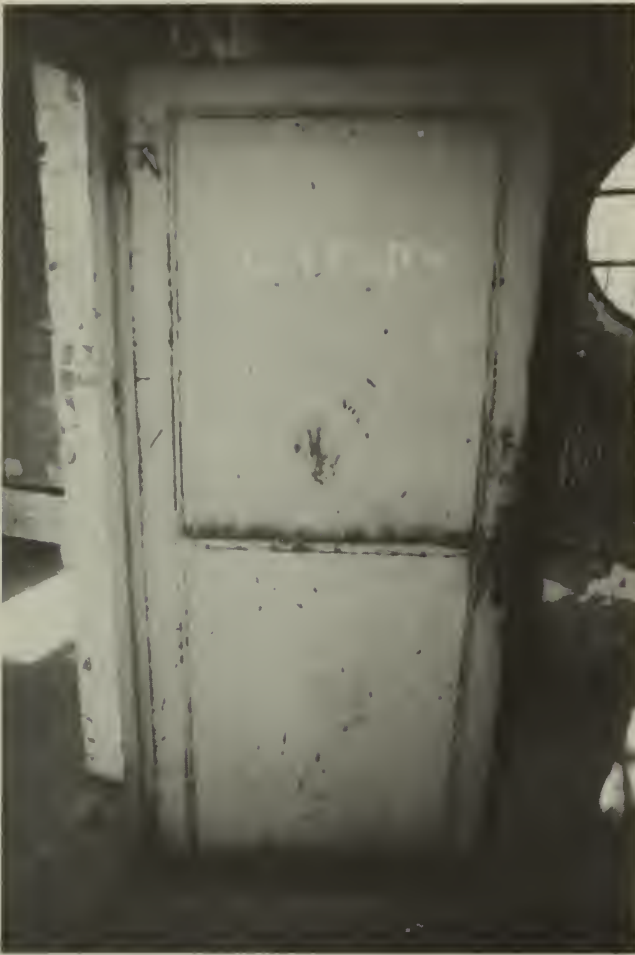
10. Galvanized metal door to room 103, solitary confinement. ¹⁹⁰

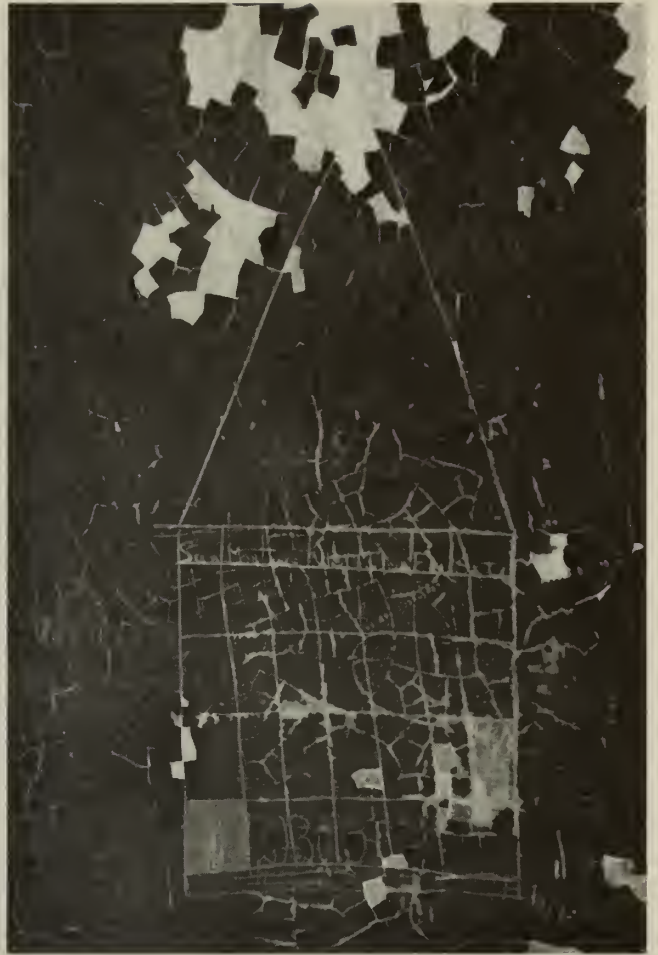
11. Room 103- calendar scratched in south wall. ¹⁹¹

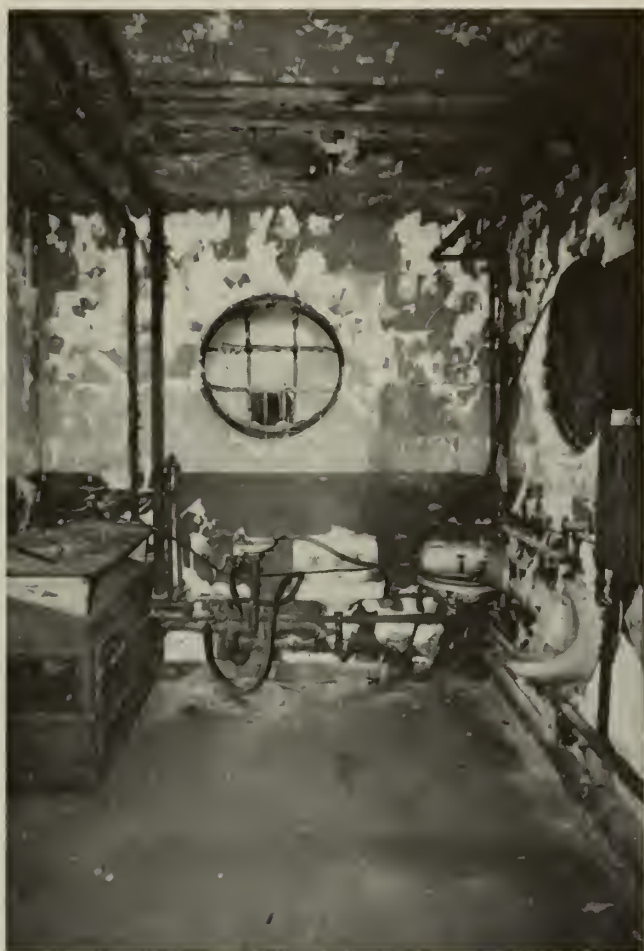
Water for the shelter is provided by an underground water main from the powerhouse that rises up in the toilet room at the south wall of the building. All water supply piping needs replacement. Two sinks, a drinking fountain, a urinal, two toilets, and enclosed aluminum shower units are intact fixtures from the 1940's (photos 13-14).

13. Room 103-view east, two wall-mounted sinks, one wall-mounted urinal, c. 1940's.

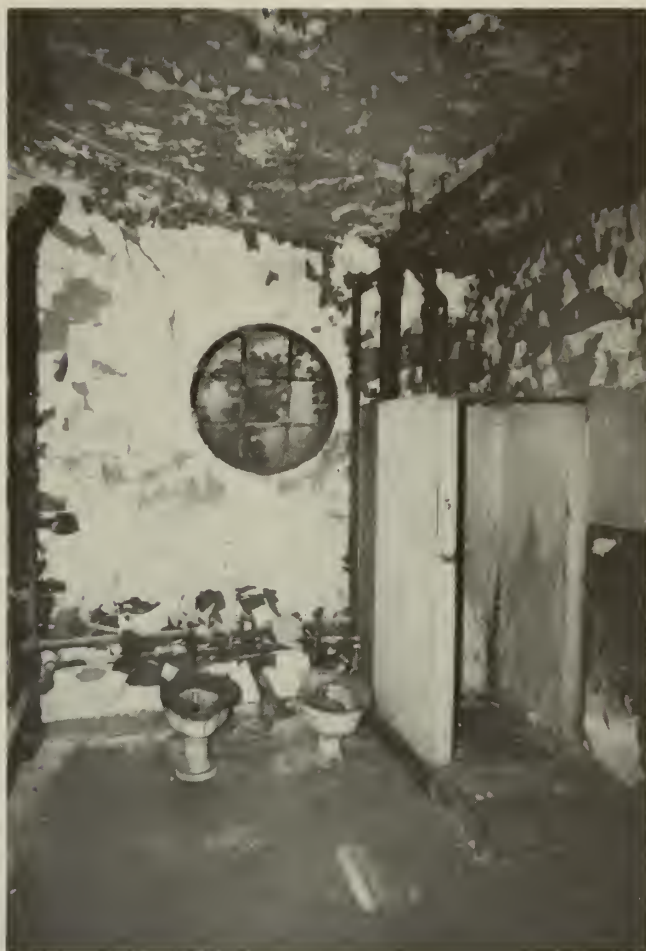
14. Room 103- view west, two toilets, one enclosed aluminum shower, c. 1940's.

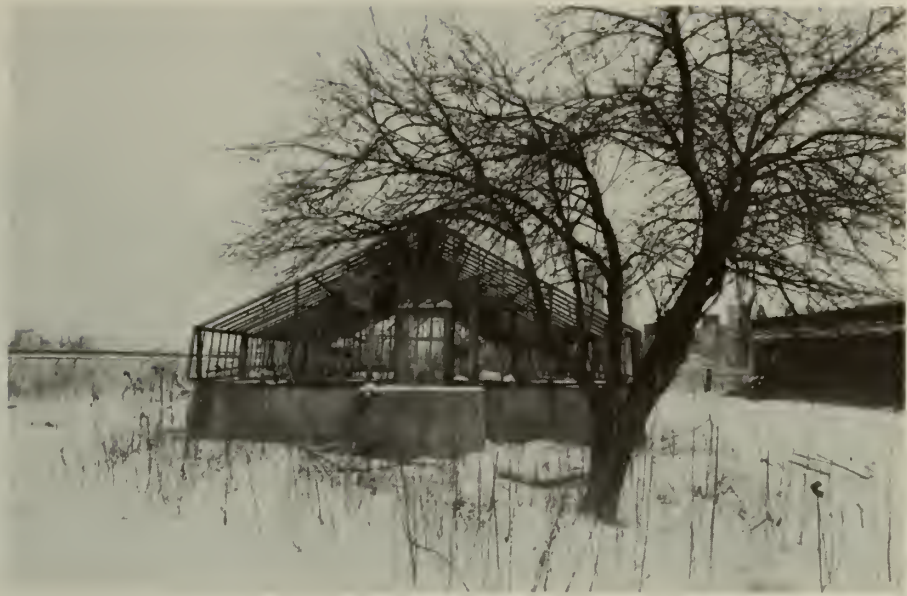
6. South elevation, view north.

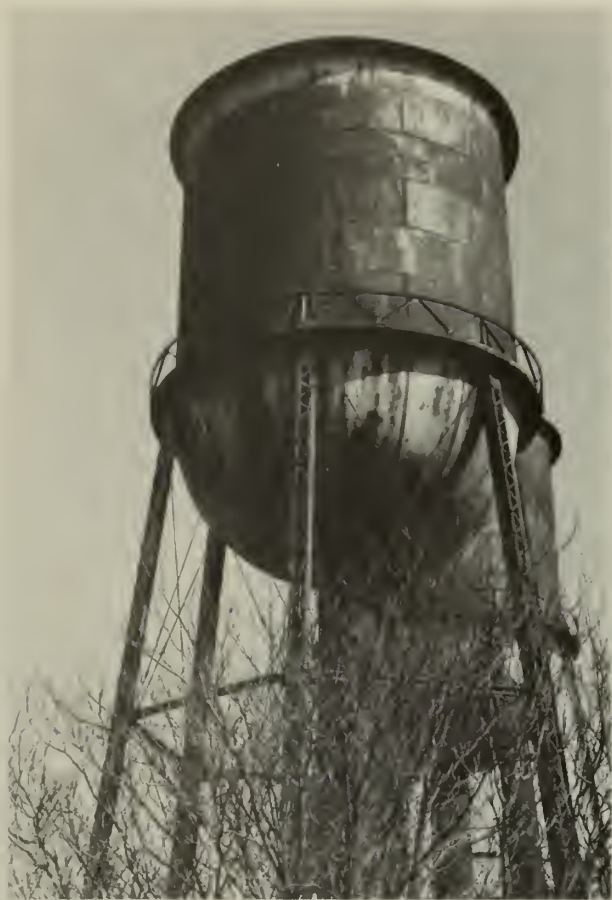
The tanks have no apparent leaks though some slight pitting does occur on the bottom of the north tank. Very little paint remains on the bottom and none is left on the remainder of the shell and the roof (photos 5-7). All six rings of the riveted shells are rusty and pitting occurs around the column connections to the shell. The metal of the bottom of the south tank is in good condition. The outside shell ladder is sound but the roof ladder of the north tank is not. On the interior of the tanks, large pits may be seen in the shell plates and the bottom is badly pitted. No paint remains on the inside. No inside ladders exist and ladder clips are badly bent.

5. South tower.

The tower supports, the risers, and the tanks require replacement due to their deteriorated condition and loss of structural integrity. Consequently, the architectural/engineering team, in conjunction with the National Park Service, determined that the water tanks and superstructures should be promptly removed. Demolition occurred in May 1985. The water tanks and towers will be replaced with new ones that have the same volume and general appearance as the existing tanks. They will meet O.S.H.A., N.F.P.A., and American Water Works Association Standard regulations.

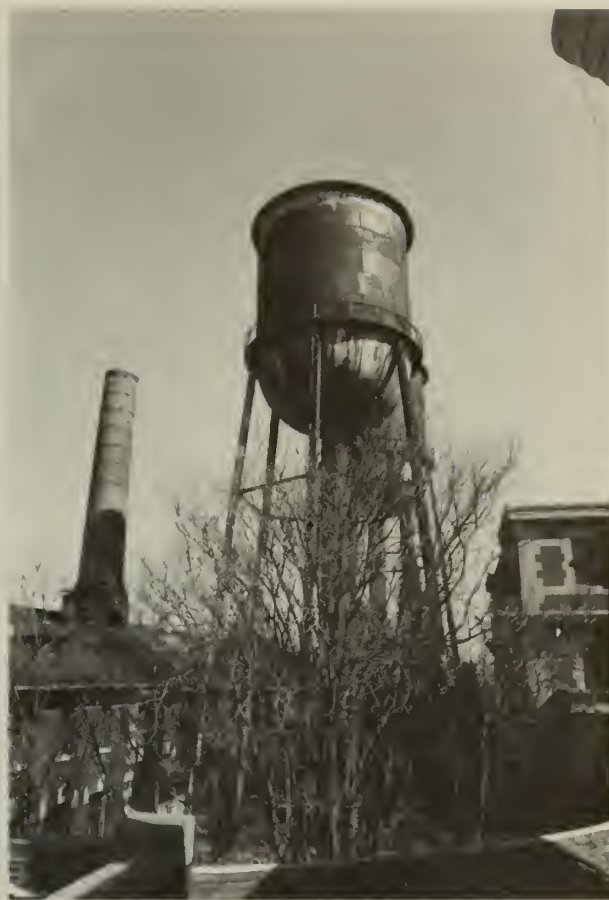
6. South tower from roof of kitchen and laundry building.

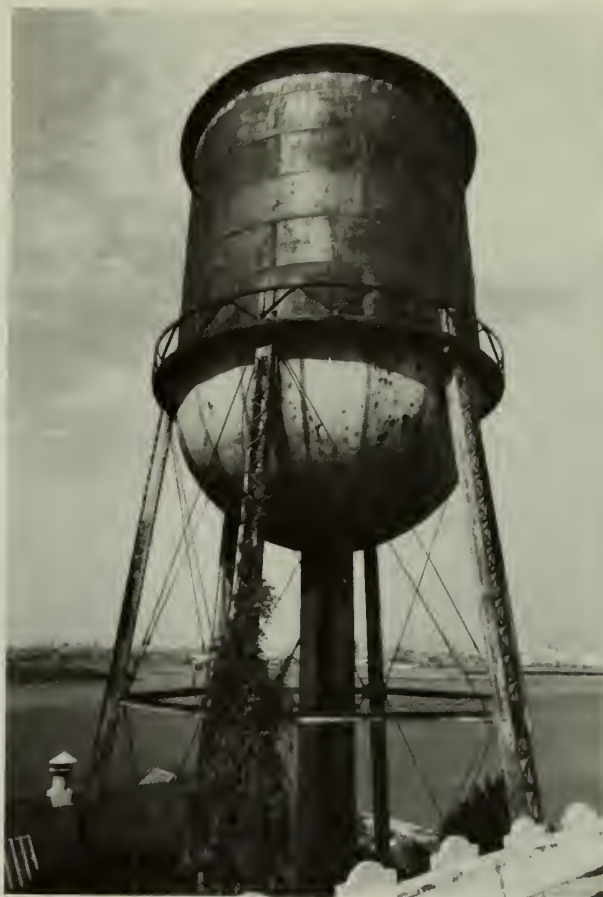
7. North tower.

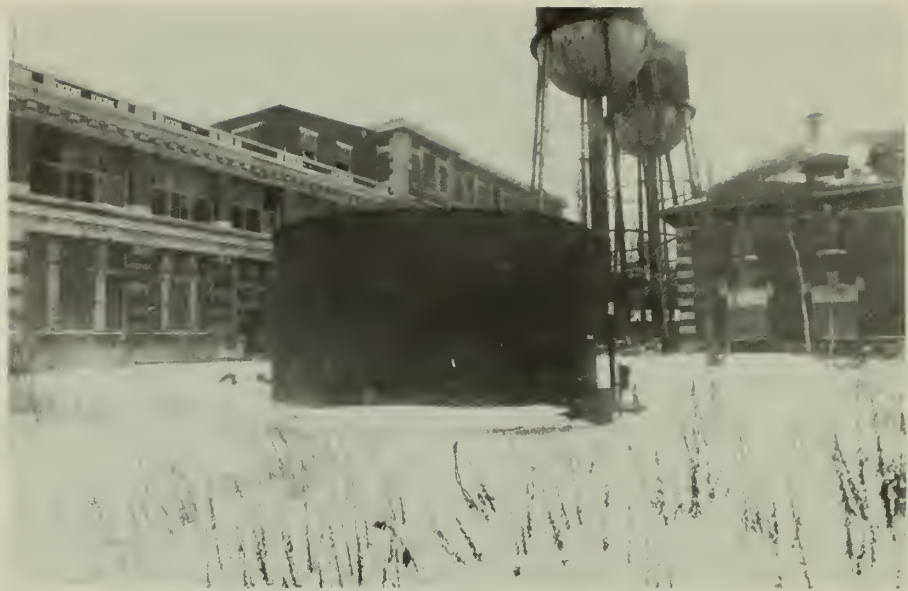
The oil tank foundation concrete is in very good condition and no settlement is apparent. The grout is good but the bottom seal is starting to deteriorate. The tank has one damp spot approximately 15 feet west of the ladder at the bottom to the foundation. Paint on the shell and roof exhibits many skipped areas. No metal pitting occurs though a slight amount of rust has built up near the ladder approximately 6" up from the foundation. The welded tank is full of fuel oil. The pipe connections are good but there is a minor leak in the pump.

1. Oil tank, view southeast.

Repair work for the tank would include cleaning and resealing the foundation, cleaning rust areas at the bottom, and repainting the entire tank. If the tank is taken out of phase, the bottom should be cleaned and vacuum boxed.
