LAWNFIELD

HISTORIC STRUCTURE REPORT JAMES A. GARFIELD NATIONAL HISTORIC SITE

Prepared by Paul Newman

DENVER SERVICE CENTER NATIONAL PARK SERVICE UNITED STATES DEPARTMENT OF THE INTERIOR DENVER, COLORADO Digitized by the Internet Archive in 2012 with funding from LYRASIS Members and Sloan Foundation

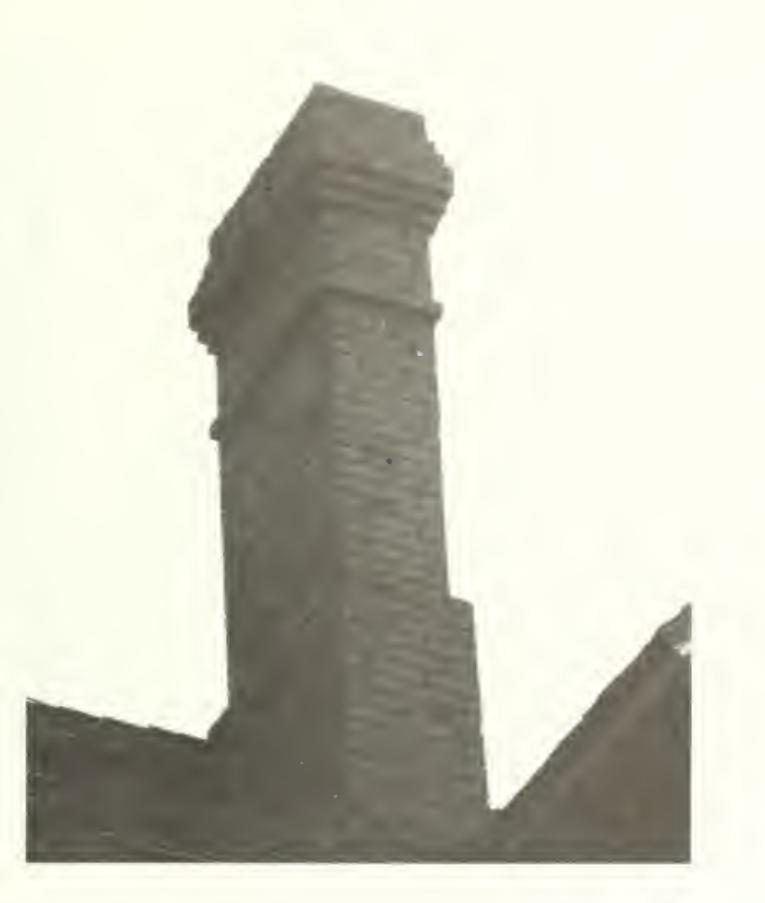
CP-9, Typical tall chimney unsupported above the roof. All chimneys need repainting.

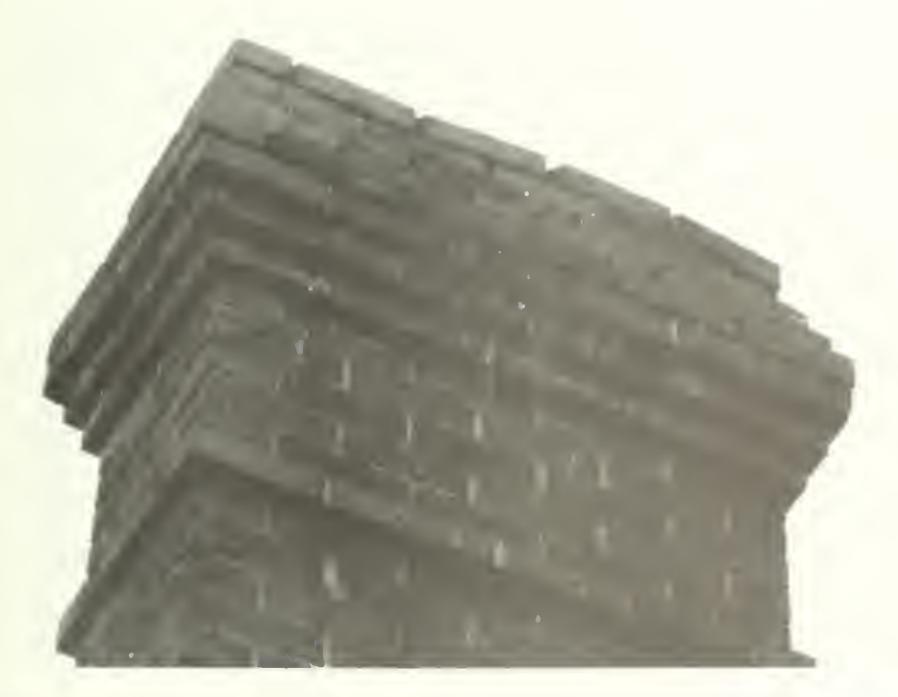
2 -10, Detail of corbeled chimney top. Severe weathering and leaching of mortar occur on of the imneys.

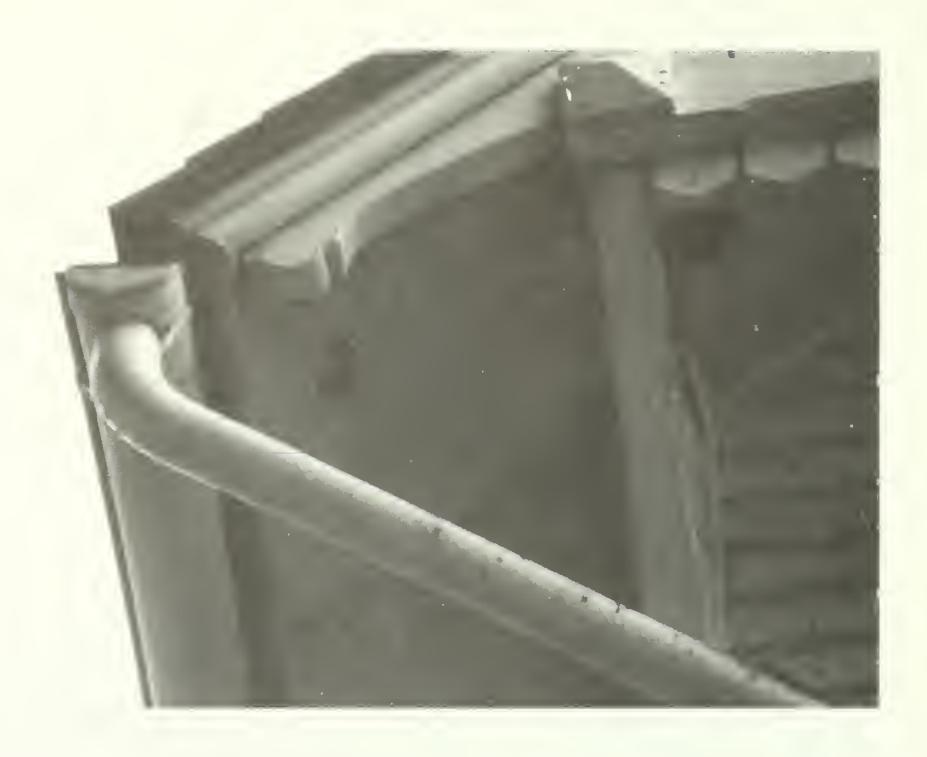
CP-15, Eave detail at the downspout. The hole through the roof sheathing at the right is from original downspout. Half-round gutter at the left has replaced the original trough gutter sys Pigeons on the bracket soil the building with waste.

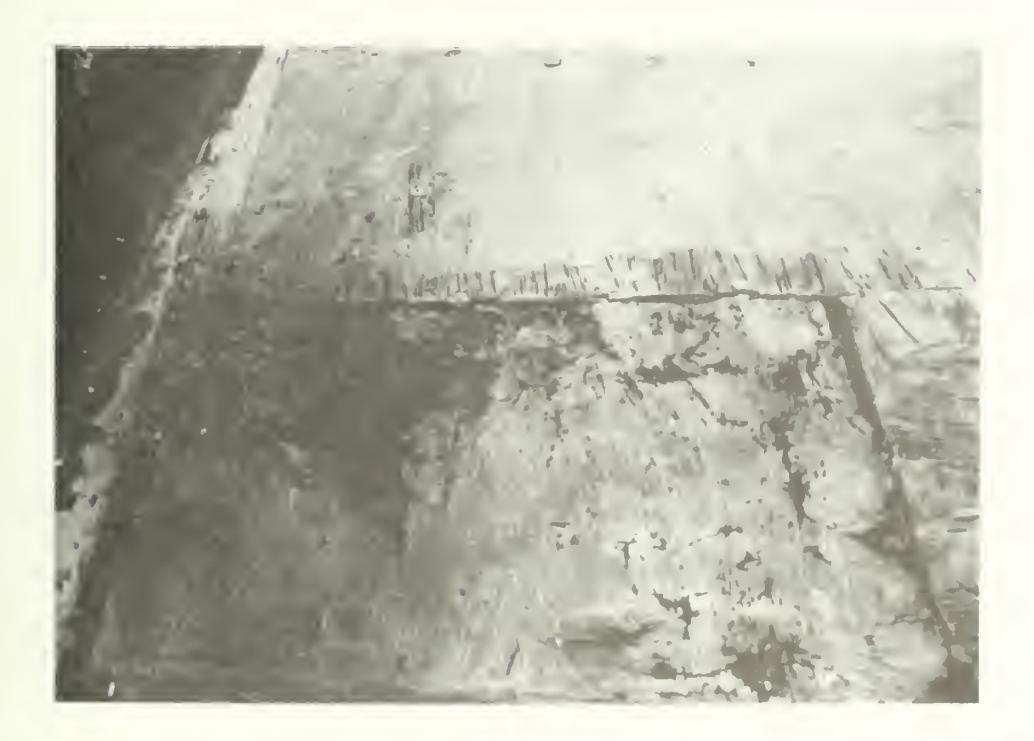
(P-18, Deteriorated roofing of the east porch.

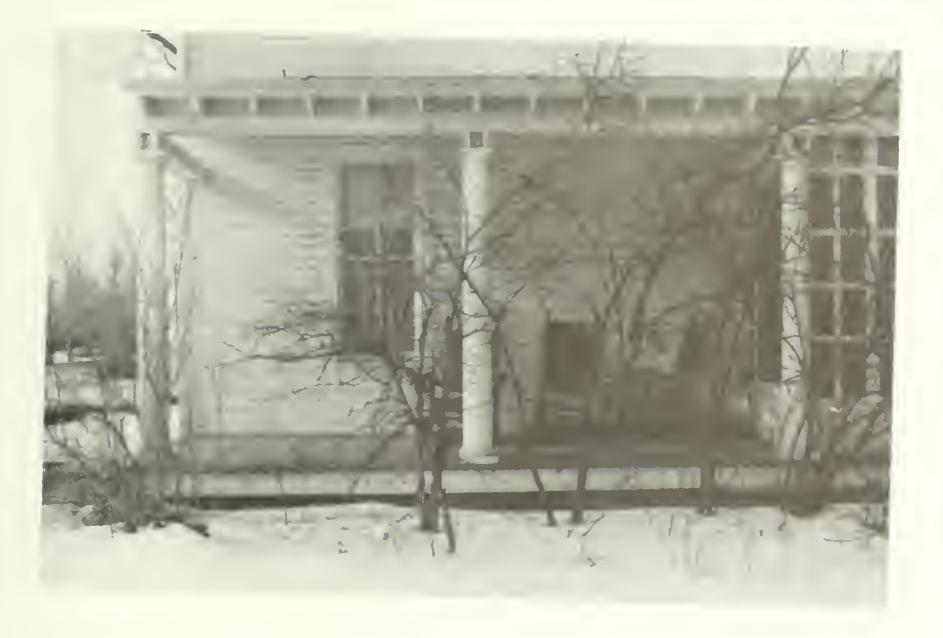
CP-25, East porch exhibits the same problems as the south porch.

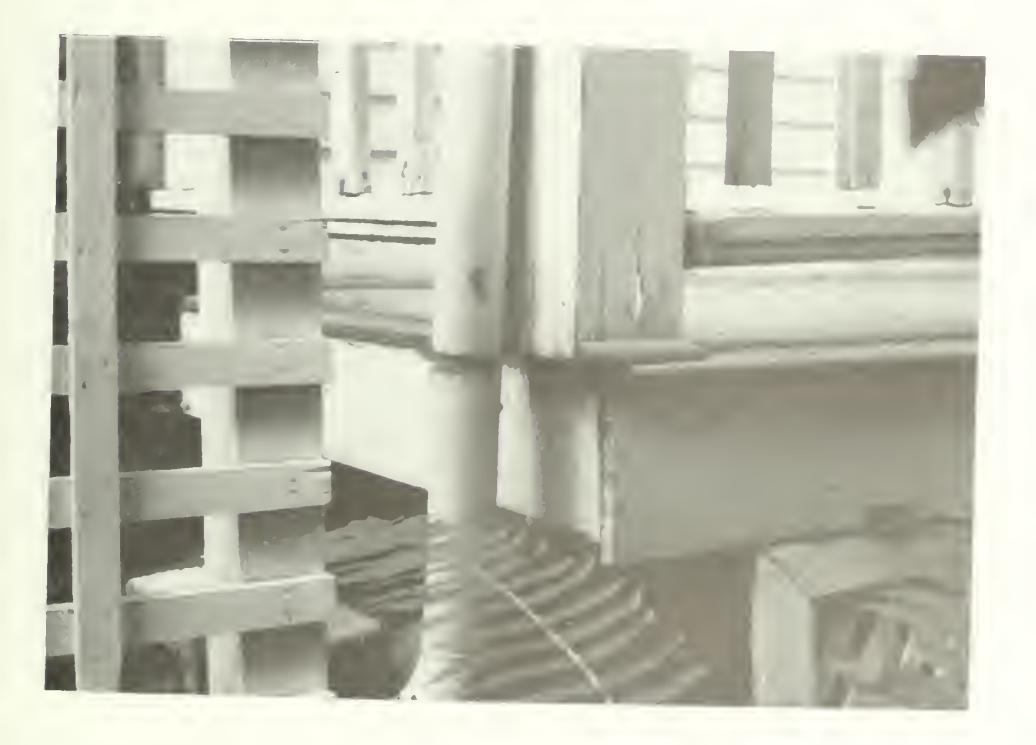
CP-30, Rotted rail, post and trim boards at the north porch.

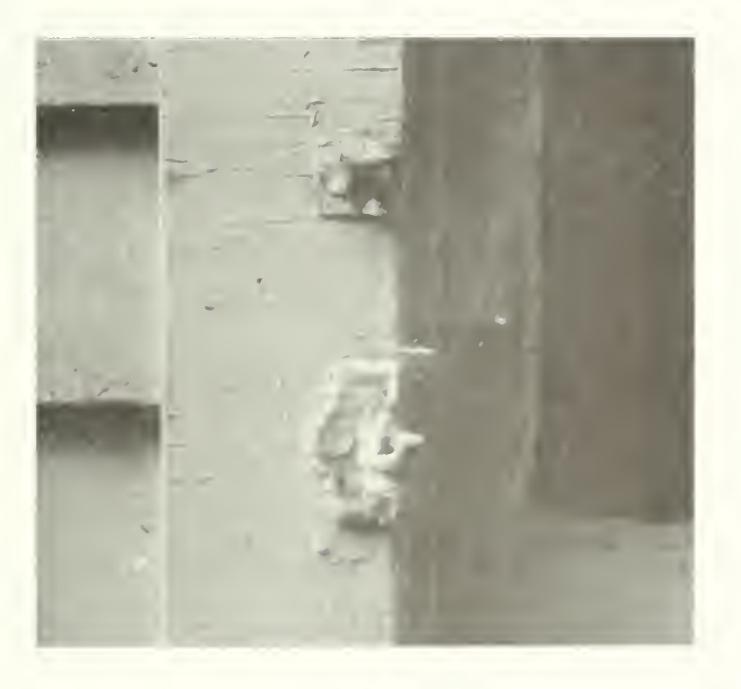
(P-46, Paint clogged surface on mounted self-locking type cast-iron shutter hinges. Several types are fund on the house. Most of the shutters are original to the 1880 period (see discussion, "Wall (penings, Shutters"). The clip above the hinge was to hold later storm windows in place.

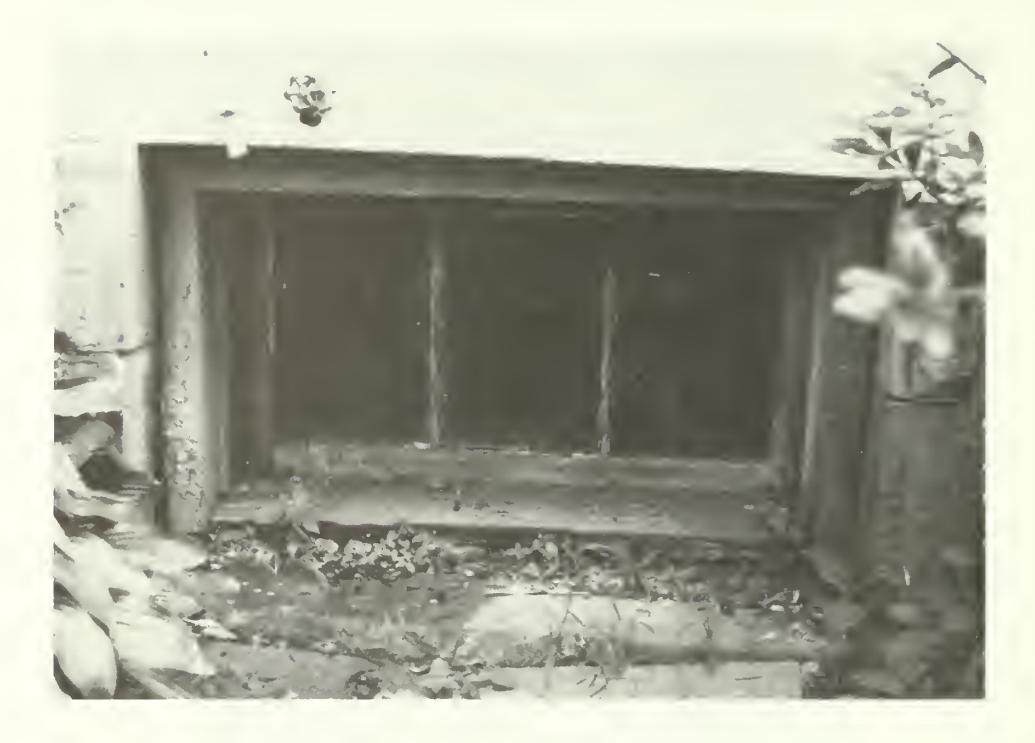
CP-47, Typical deteriorated basement window. The grade is too high and the foliage is too close the wood frames, keeping them continuously damp.

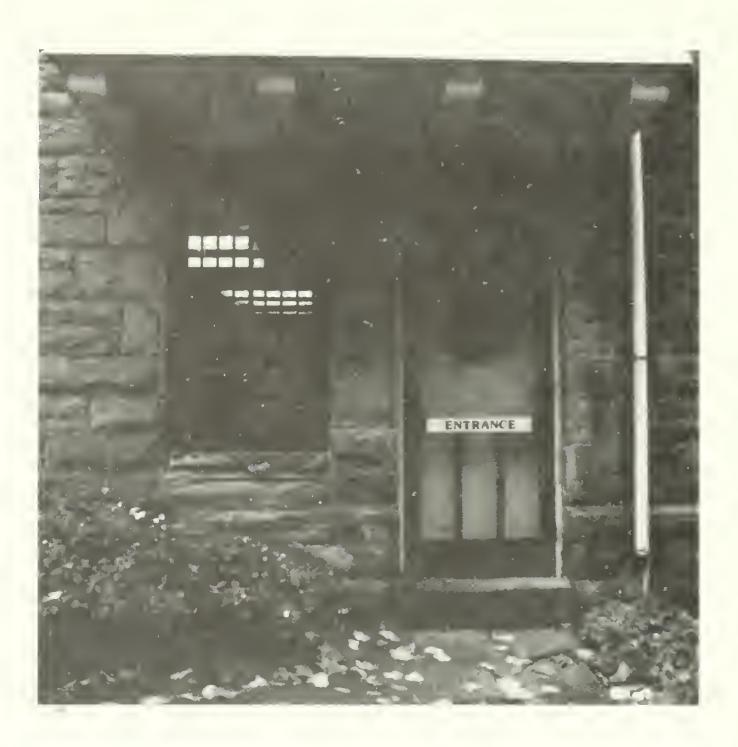
CP-55, Entrance to the gift shop and house tour. The high stoop is a barrier to wheelchairs.

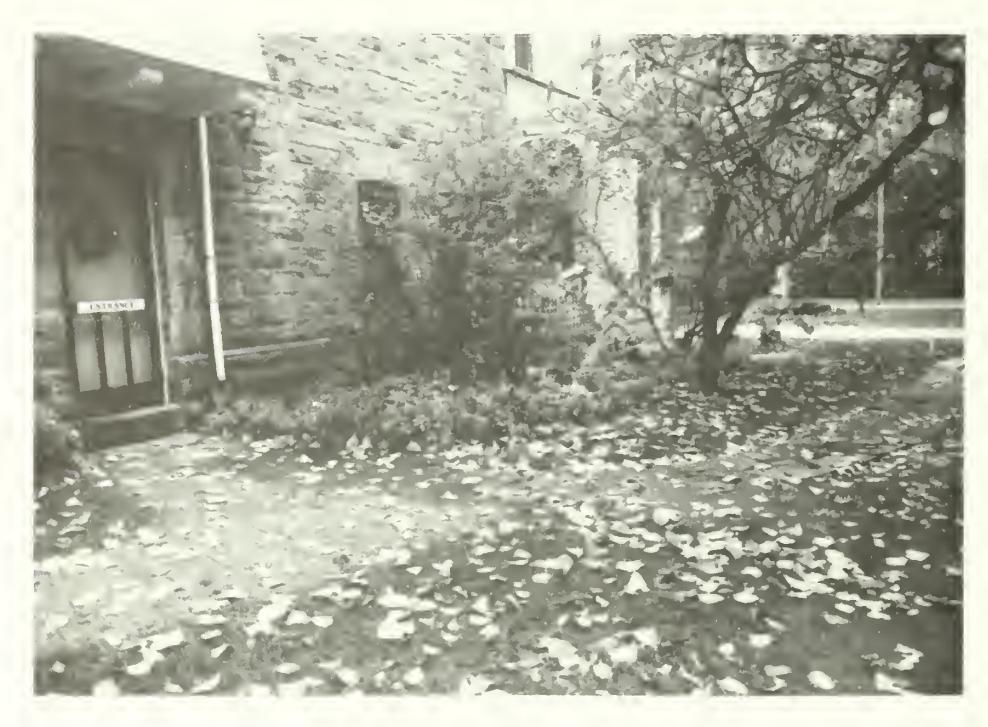
CP-56, Use of flagstone walks have historic precedent, but uneven and irregular open joints are impediment to wheelchairs.

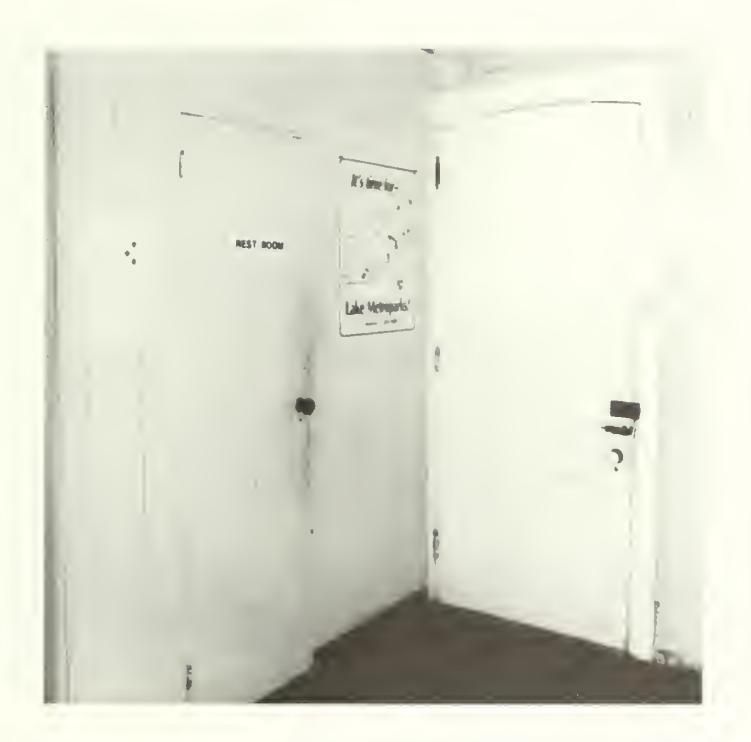
CP-57, Entrance to the rest room is too narrow for handicapped accessibility.

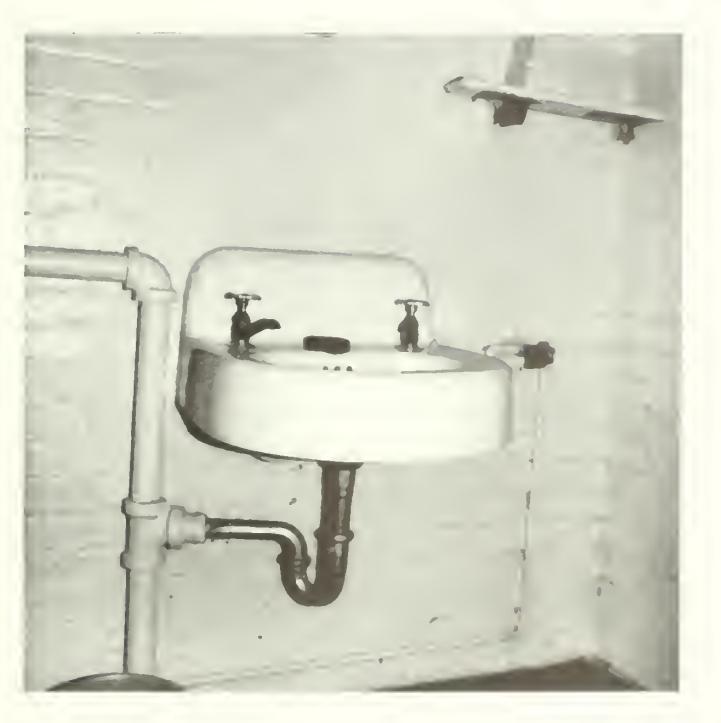
(P-58, Rest room itself is minimally accessible. The installation of grab bars will be required at the t ilet.

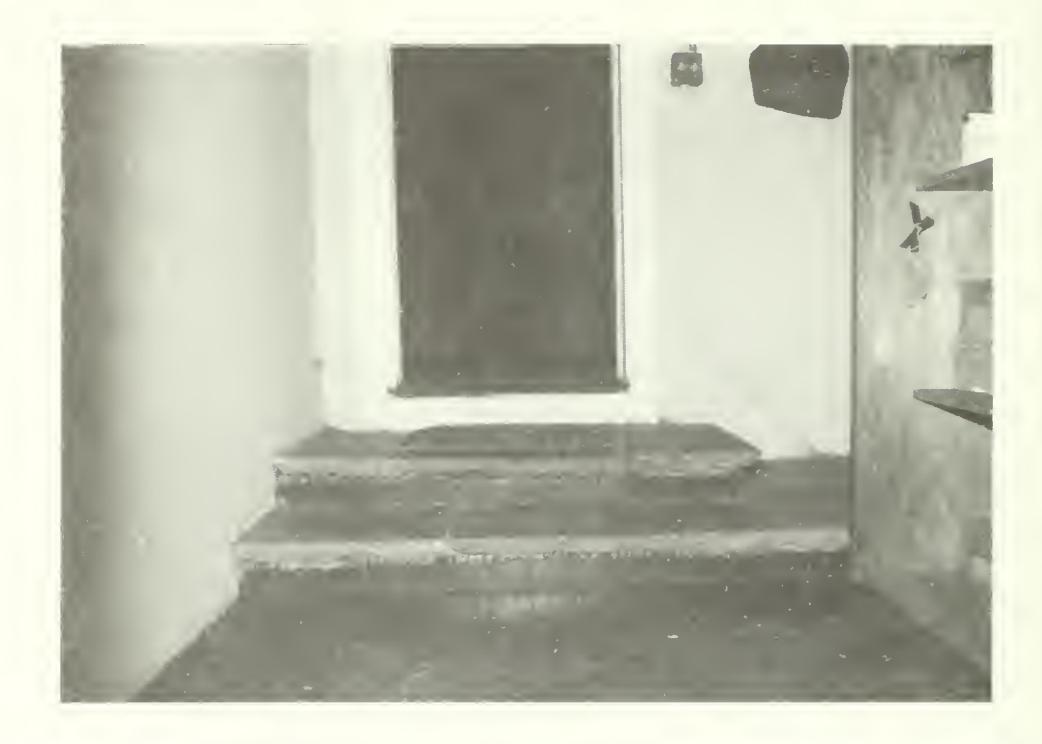
CP-59, A three-riser stair from the gift shop to the first-floor of the house is a barrier for wheelch bound visitors.

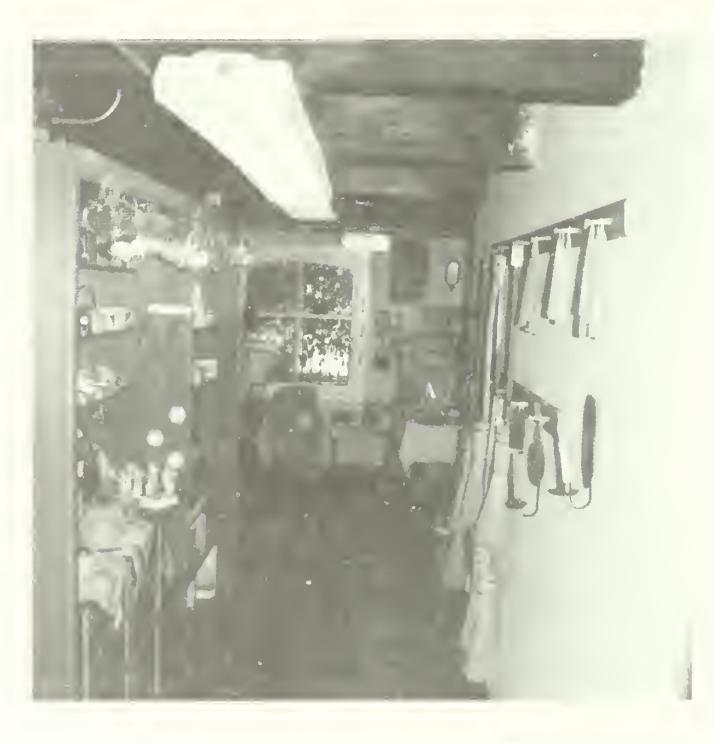
CP-60, Solution to the stair is a ramp to the hallway to meet accessibility standards.

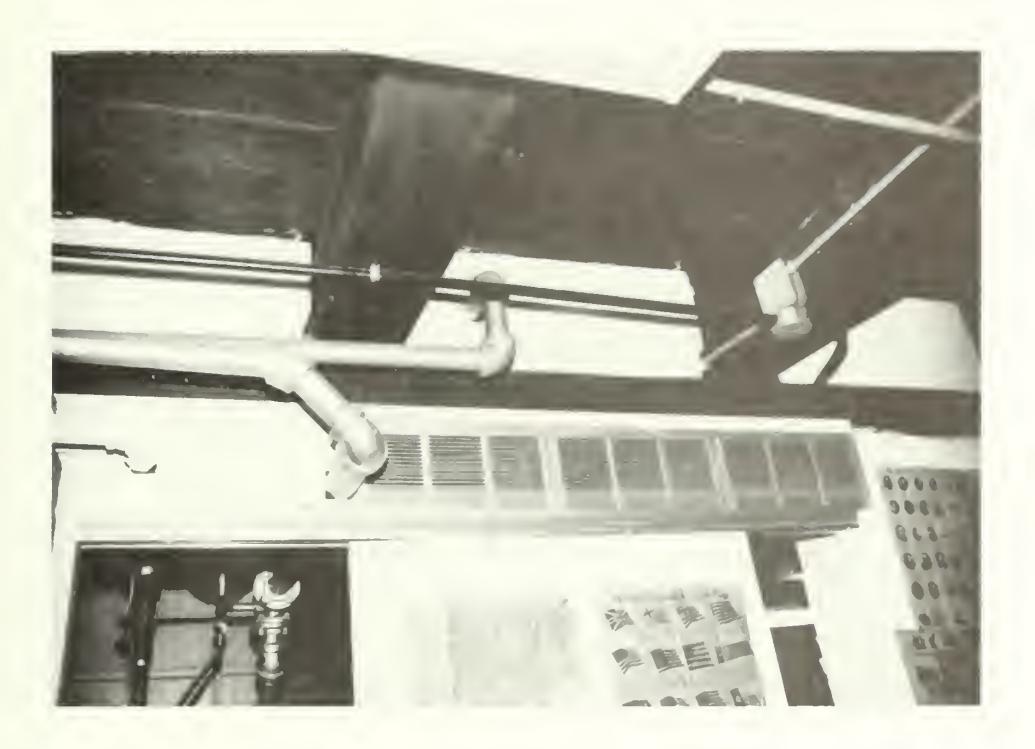
CP-61, Steam boiler is not separated by a fire-rated enclosure..

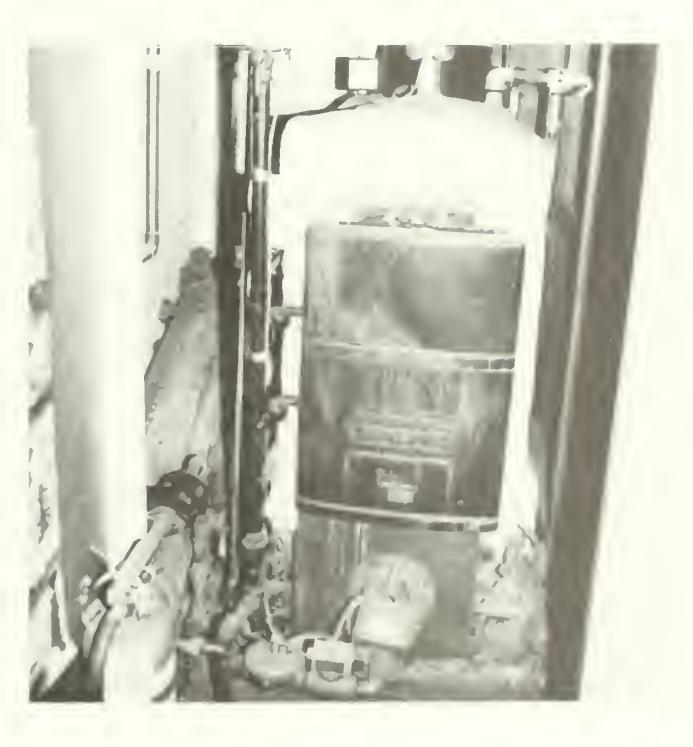
(P-62, Steam boiler has friable asbestos insulation which needs to be removed.

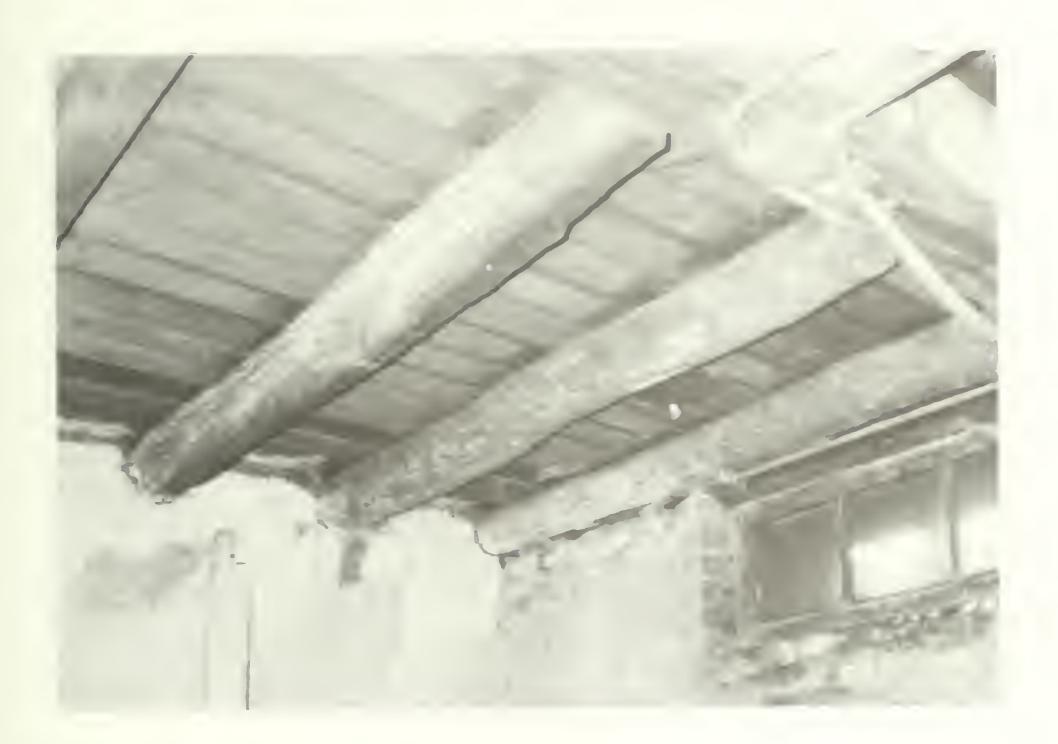
SP-1, Southeast foundation corner, room 103.

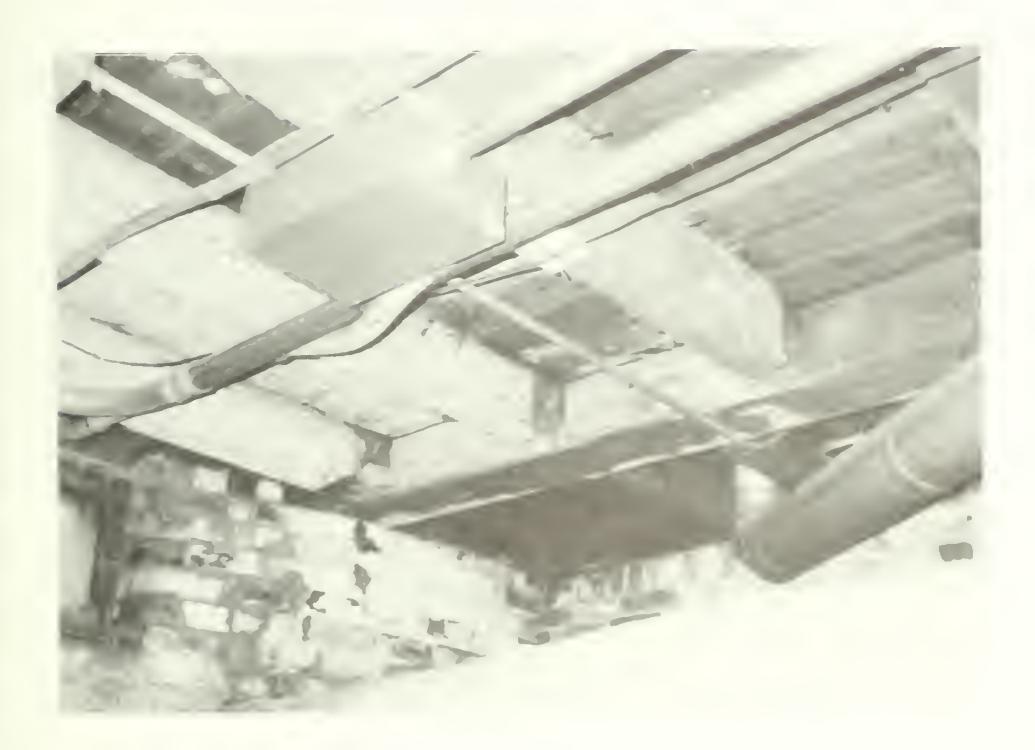
SP-2, Northeast foundation corner, room 103.

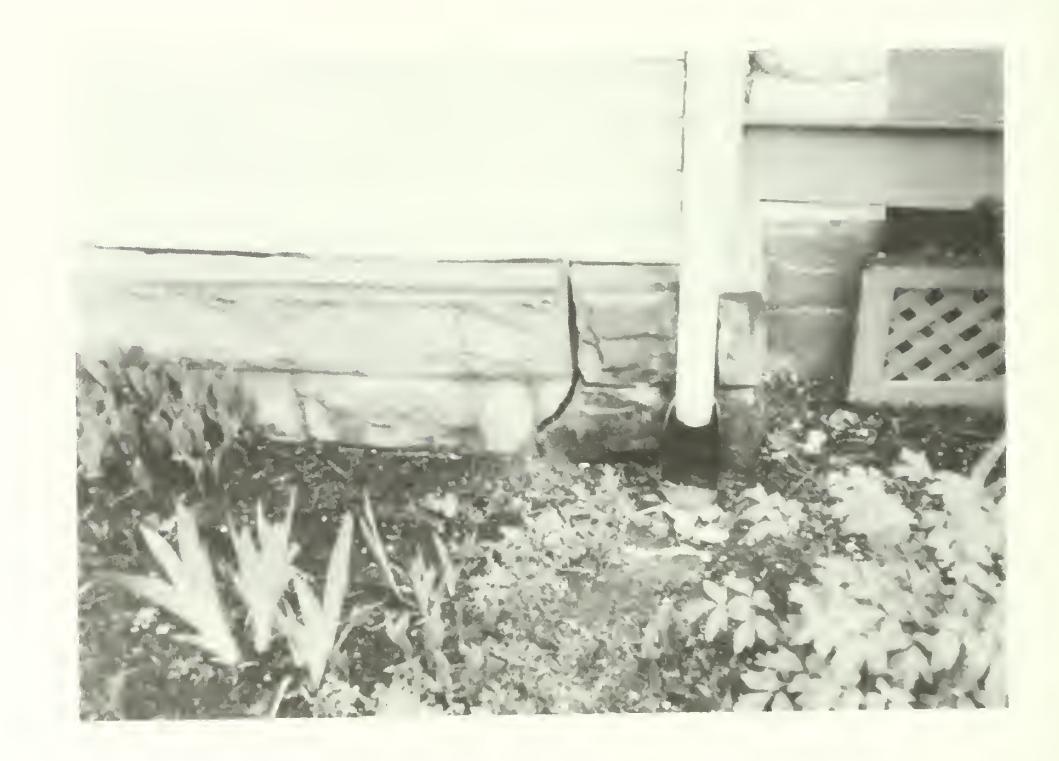
SP-4, Limestone veneer, west elevation, room 103.

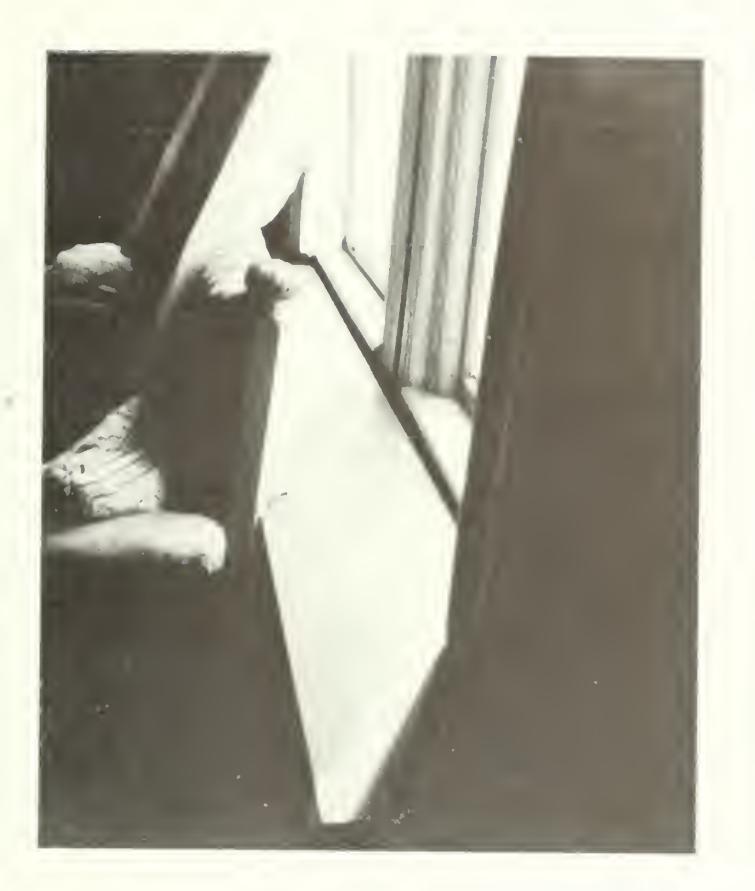
SP-9, Library window, interior view.

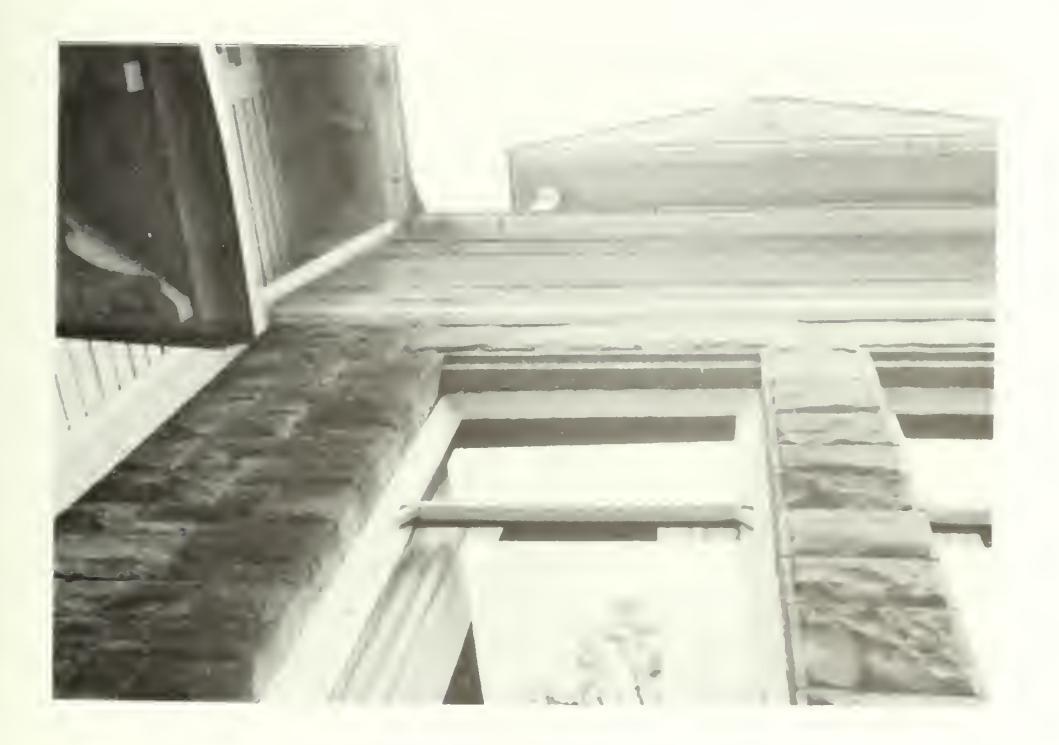
SP-10, Library window, exterior view.

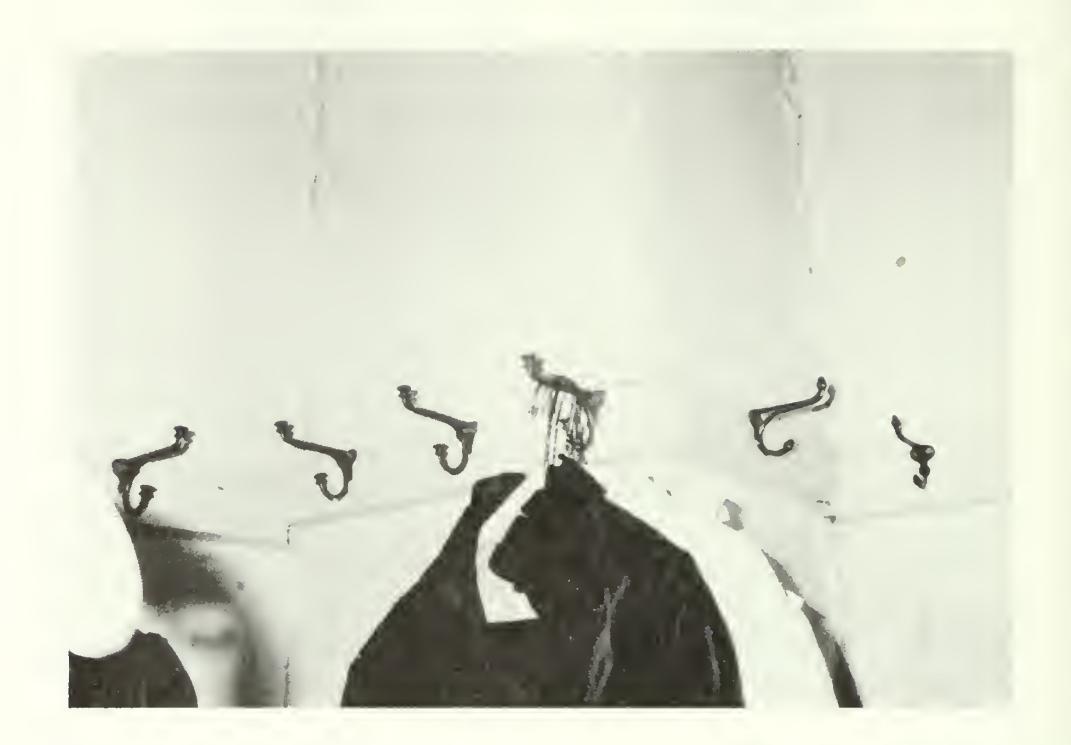
SP-11, Wall displacement, room 211.

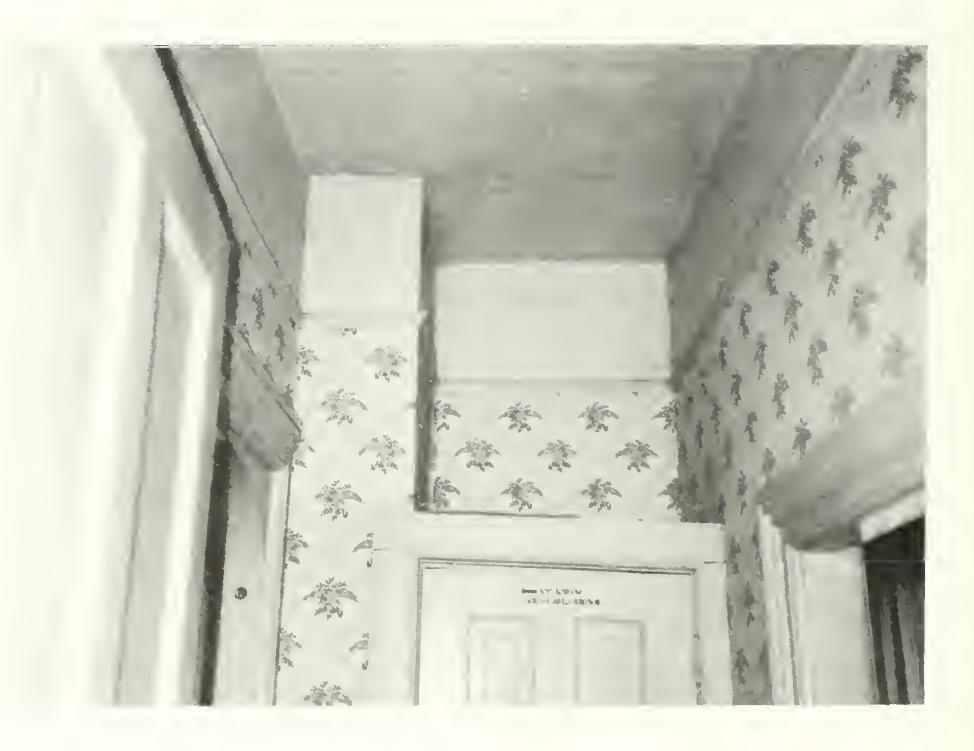
SP-12, Wall displacement, room 209.

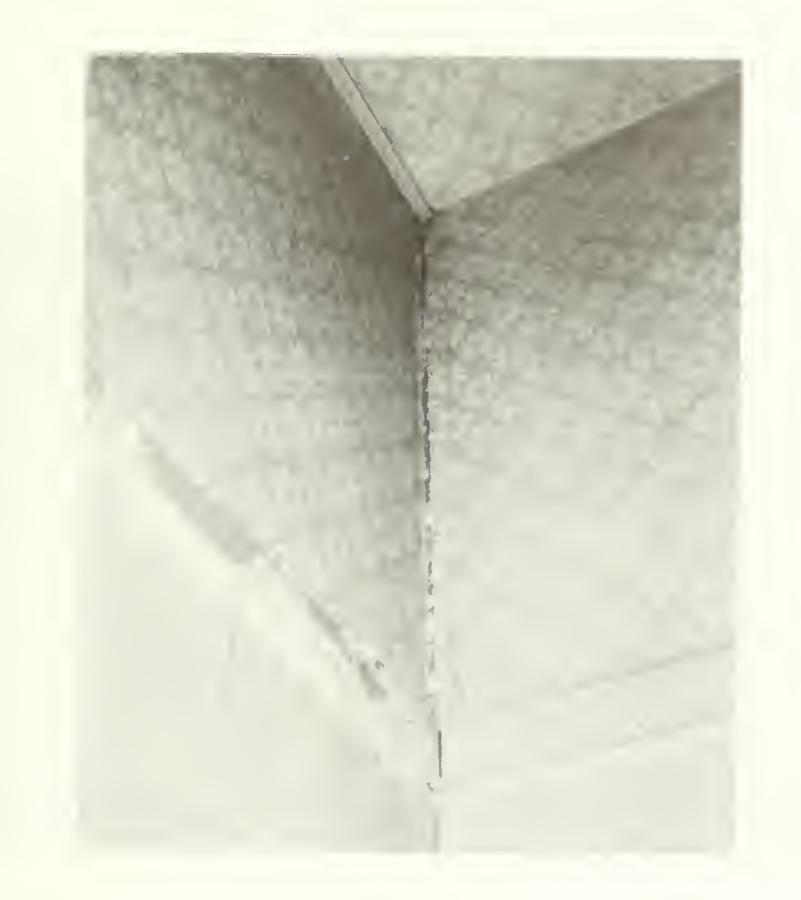
5P-13, Wall displacement, room 204.

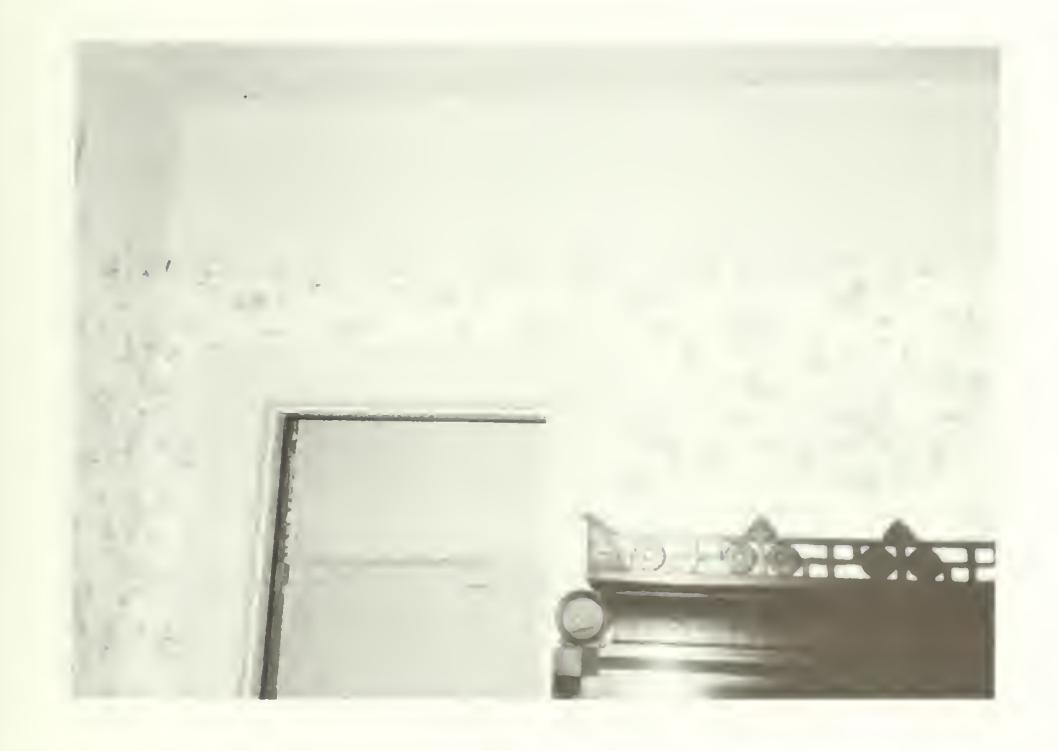
iP-14, Door displacement, rooms 203-204.

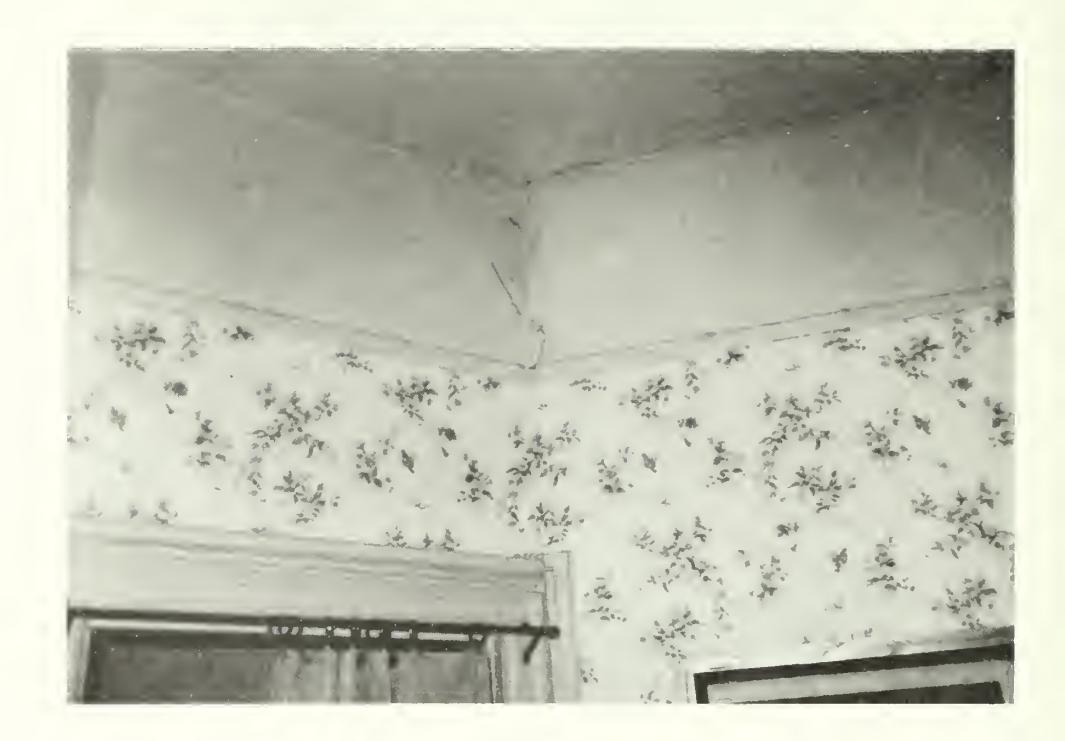
SP-15, Wall displacement, rooms 201-202.

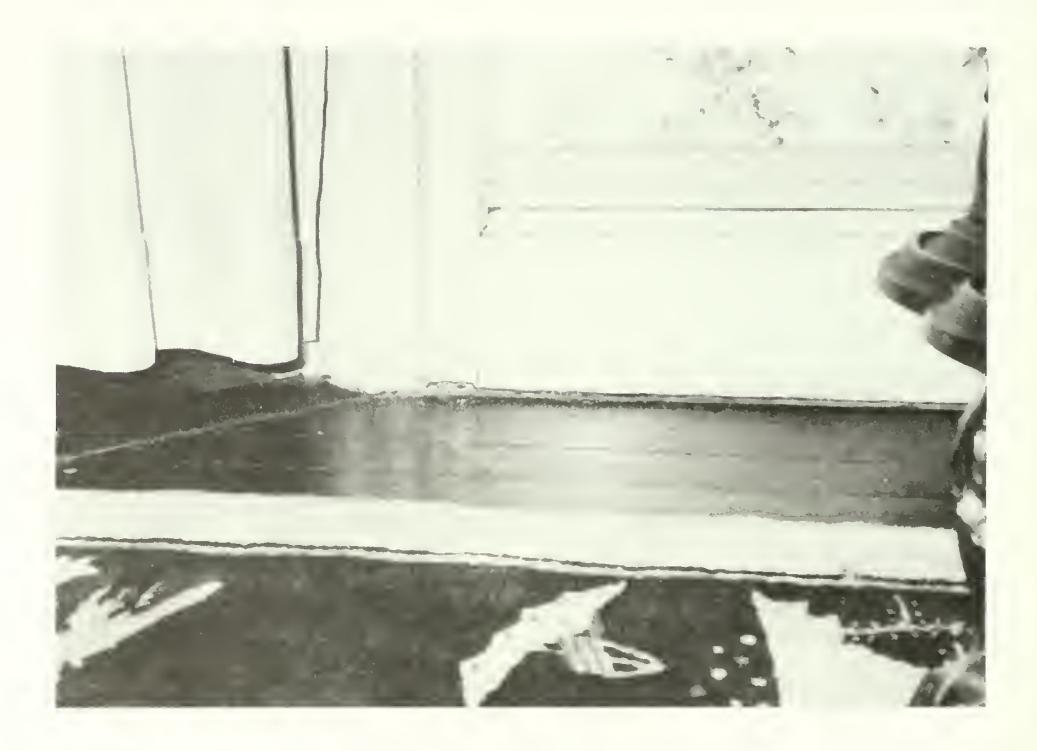
SP-16, Floor displacement, rooms 201-202.

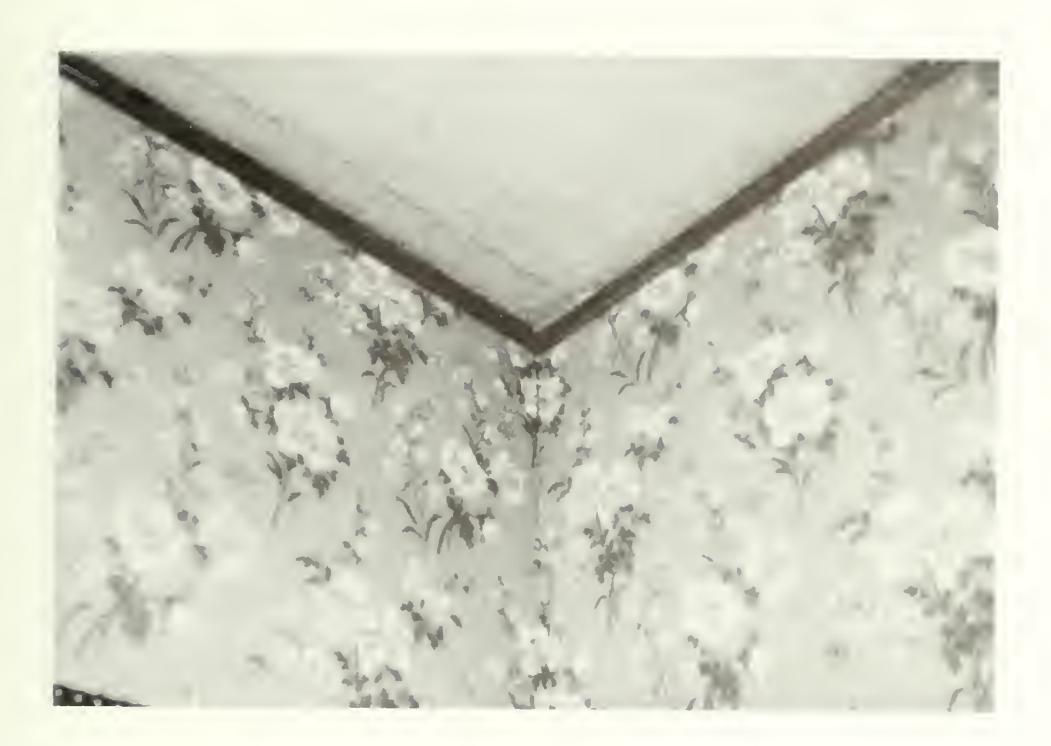
pP-17, Wall displacement, northeast corner, room 216.

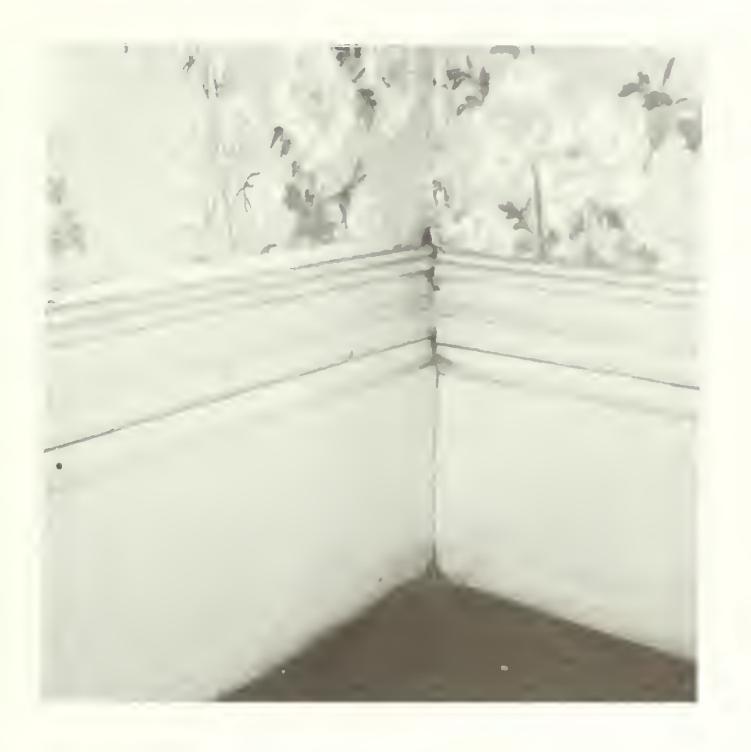
P-18, Floor trim displacement, northeast corner, room 216.

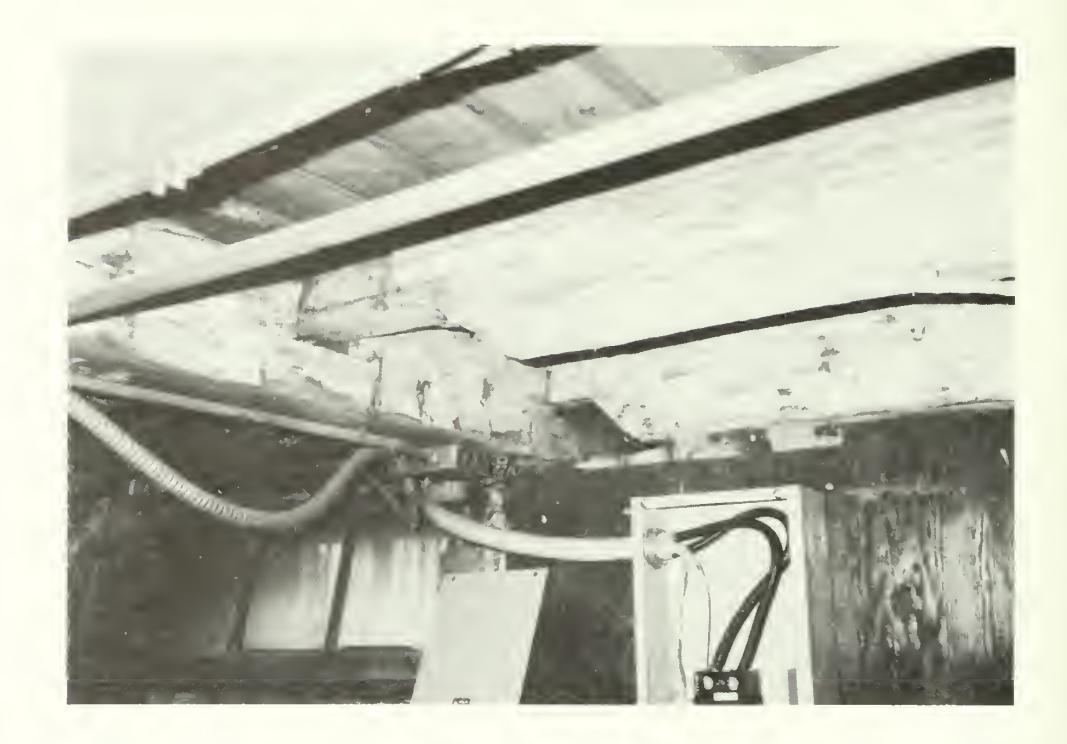
SP-19, First-floor framing beneath room 103.

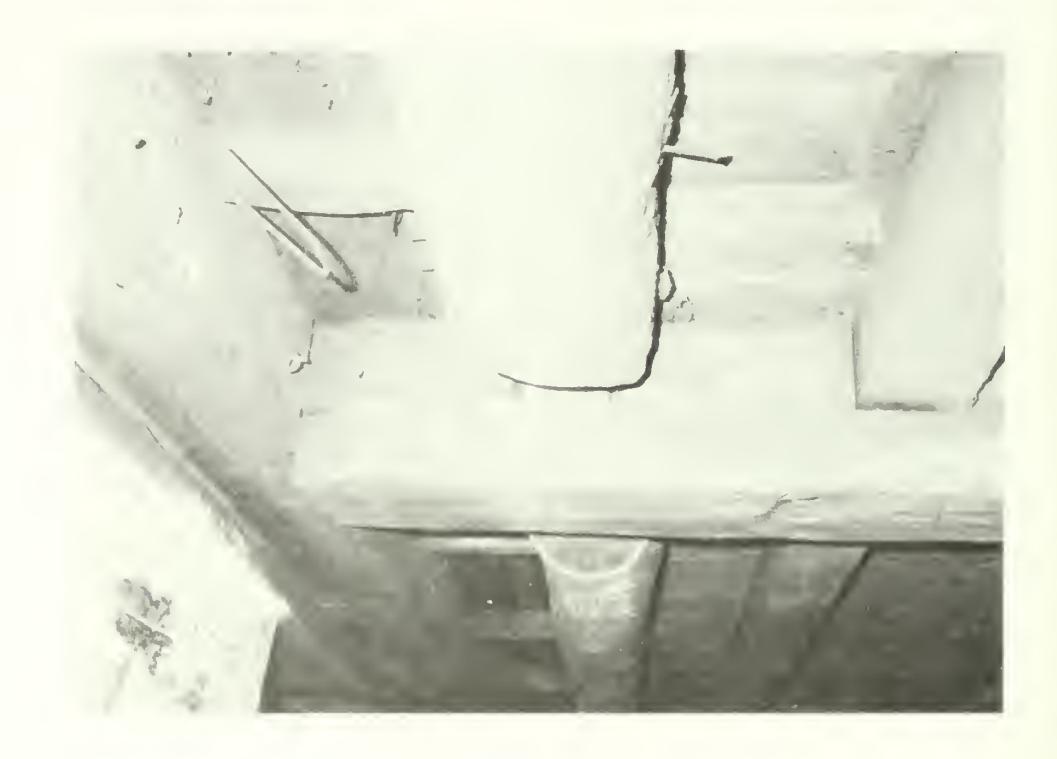
SP-20, First-floor framing beneath room 103.

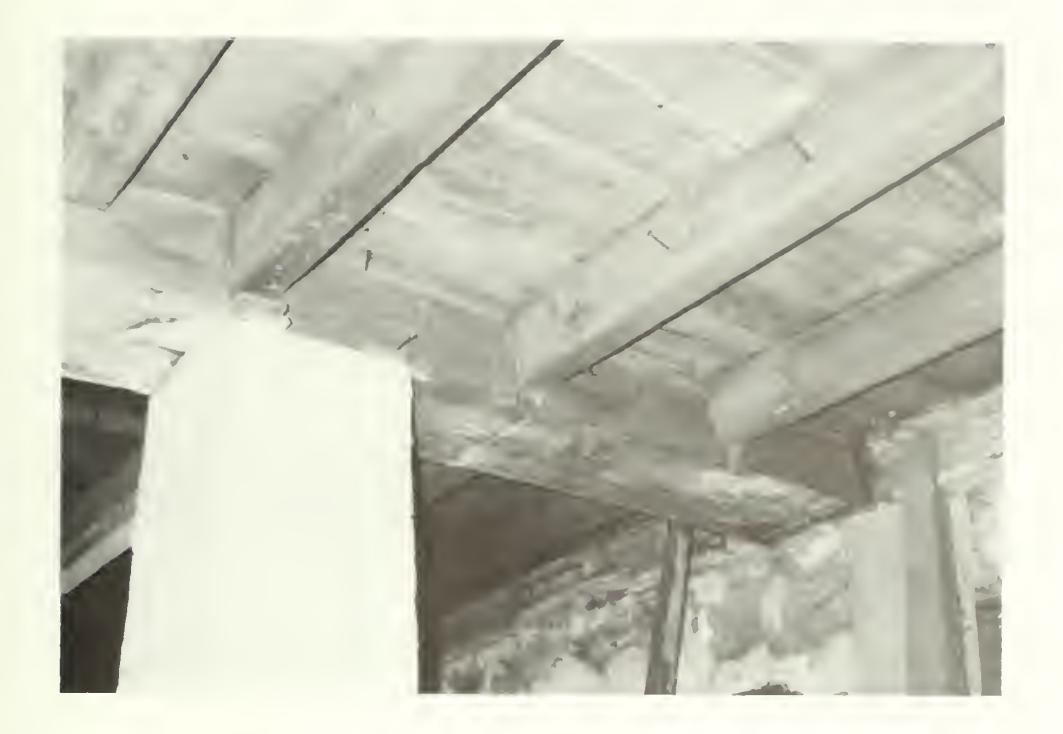
SP-21, First-floor framing, room 001.
