LAWNFIELD

HISTORIC STRUCTURE REPORT JAMES A. GARFIELD NATIONAL HISTORIC SITE

Prepared by Paul Newman

DENVER SERVICE CENTER NATIONAL PARK SERVICE UNITED STATES DEPARTMENT OF THE INTERIOR DENVER, COLORADO Digitized by the Internet Archive in 2012 with funding from LYRASIS Members and Sloan Foundation

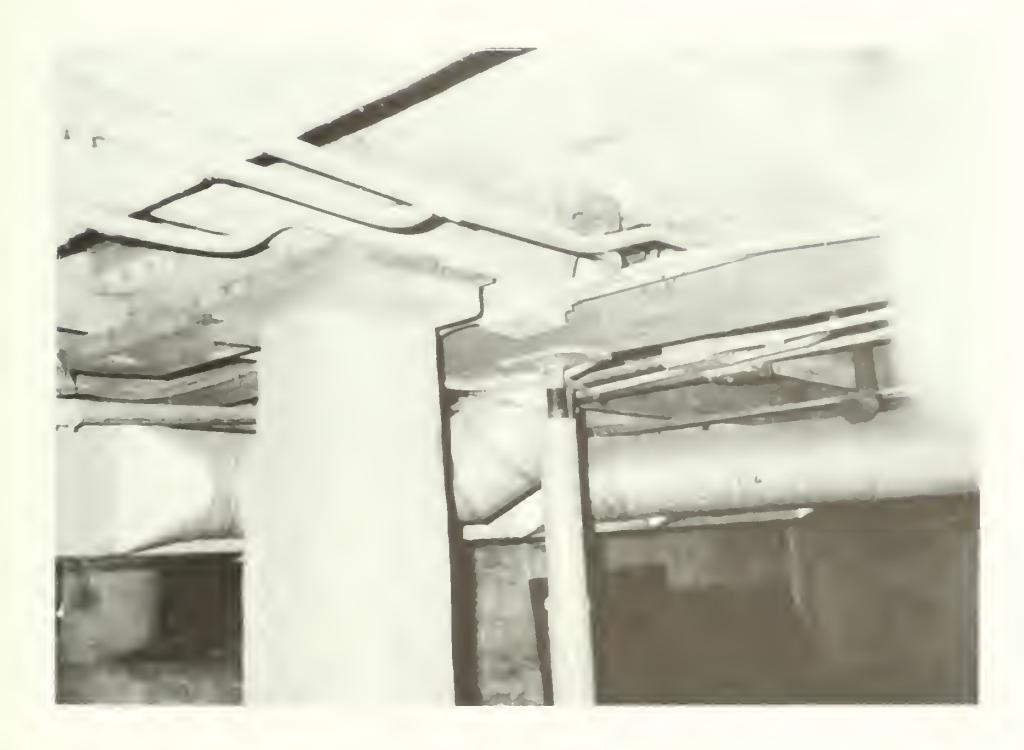
SP-22, First-floor framing, room 001.

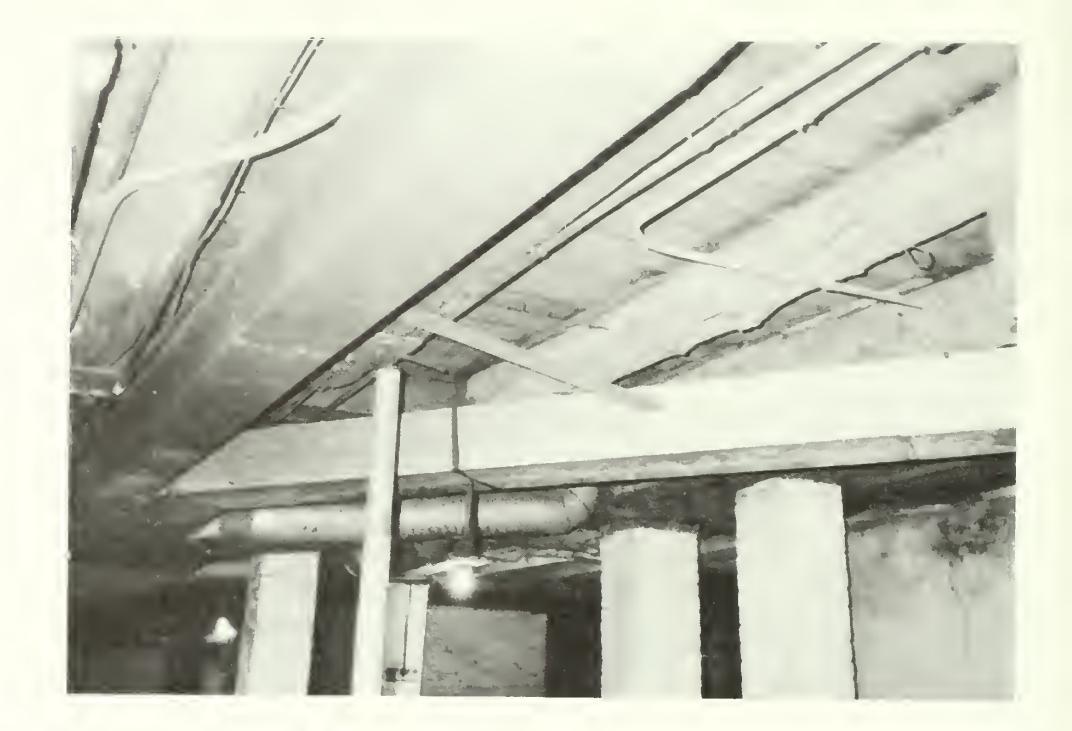
SP-23, First-floor framing, room 001.

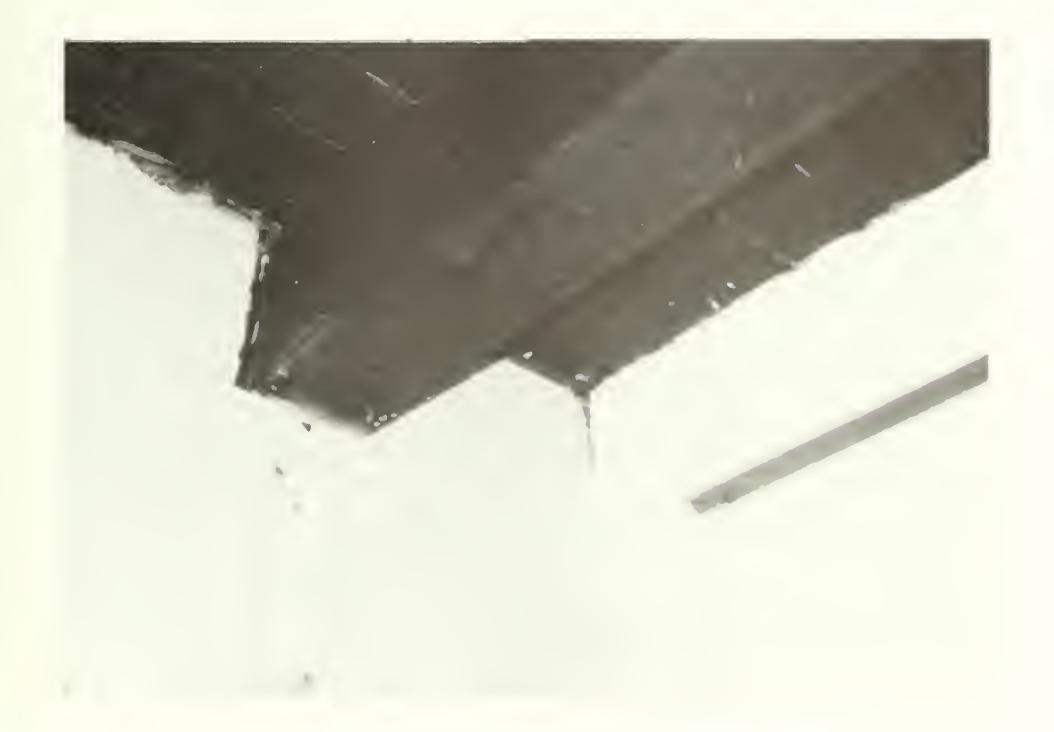
P-26, Library floor framing.

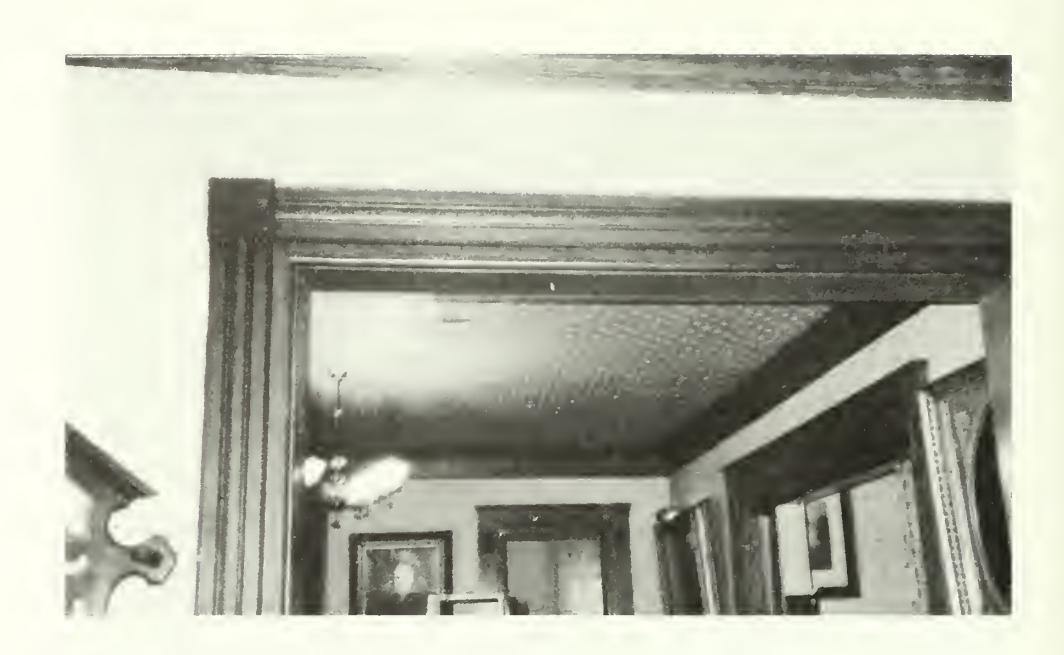
SP-27, Parlor ceiling at the beam.

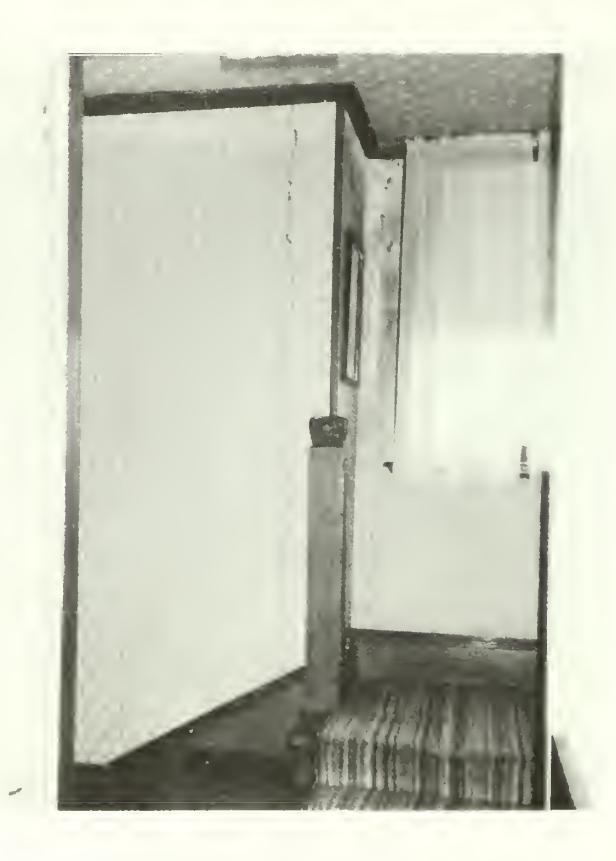
SP-28, Second-floor wall crack at the main stair.

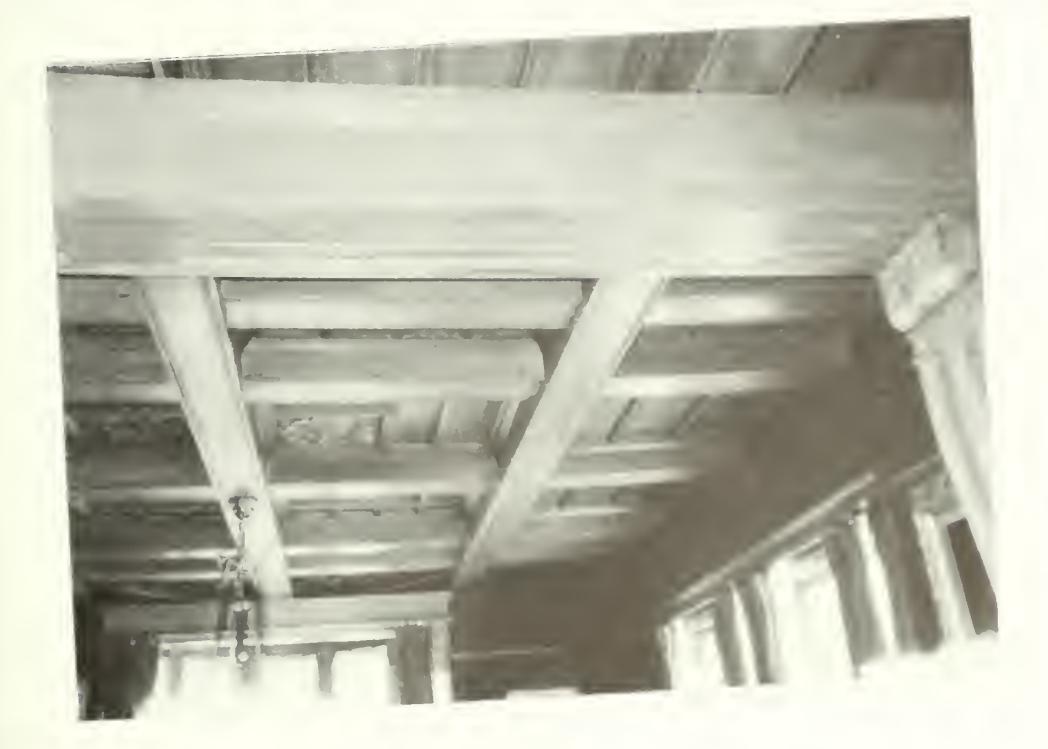
P-30, Library ceiling, southeast view.

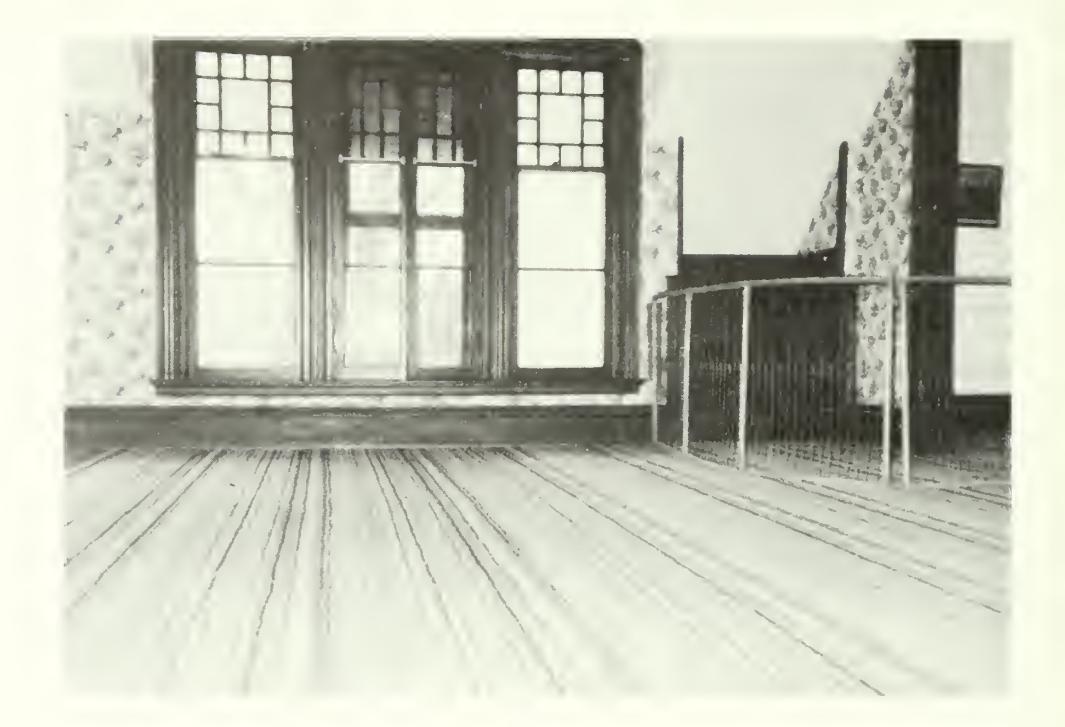
SP-31, Room 311, south view.

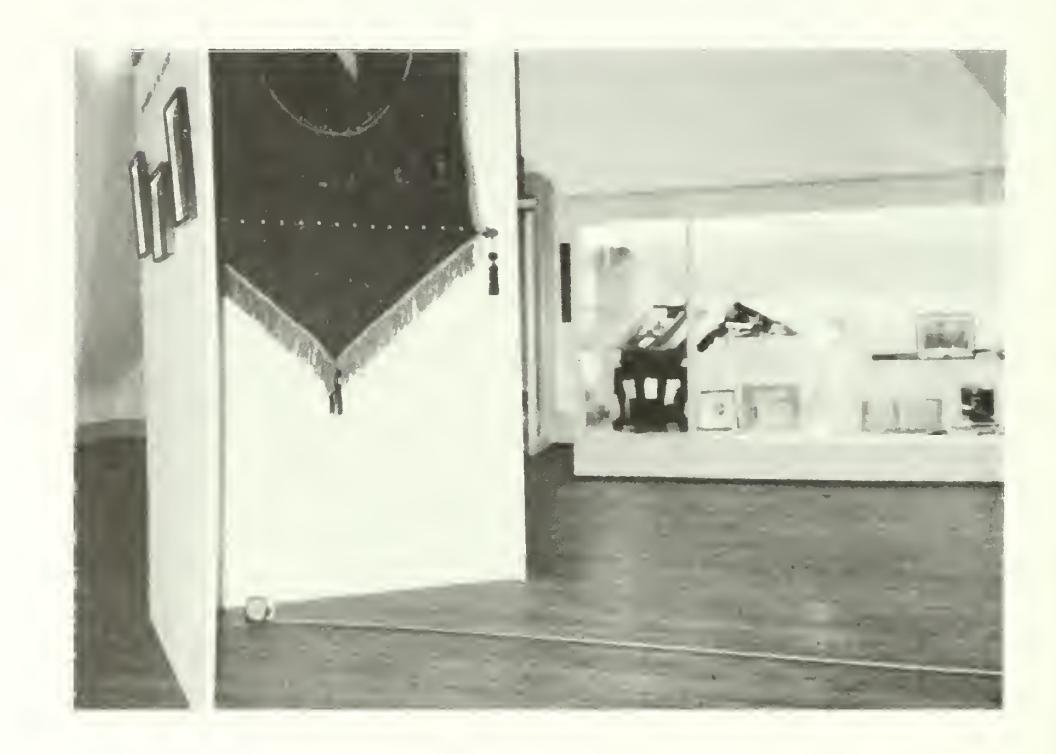
SP-32, Room 302, southwest view.

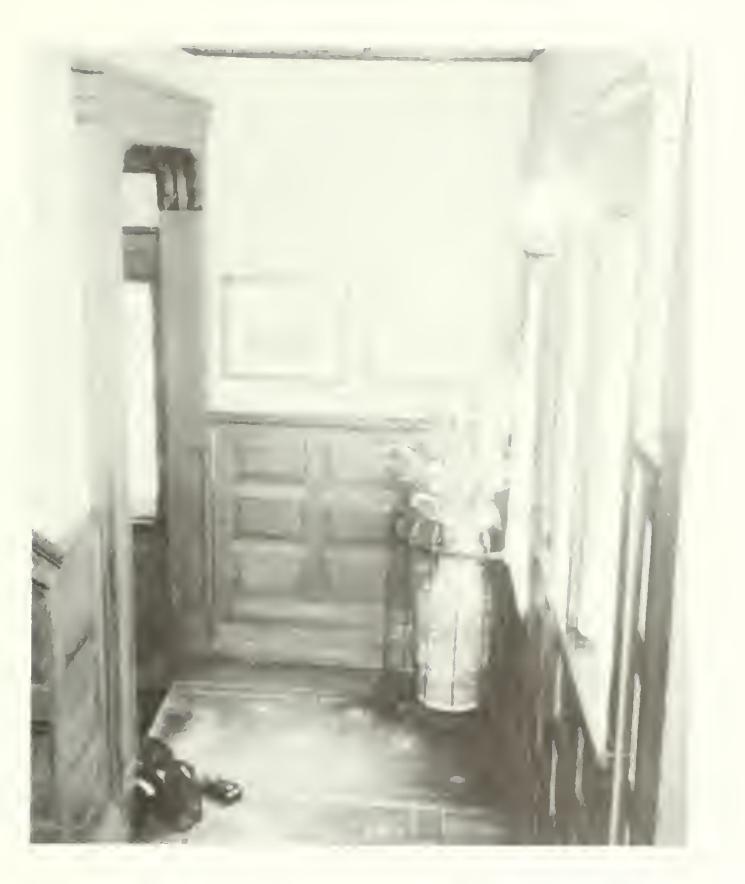
P-33, Main stair, lower landing.

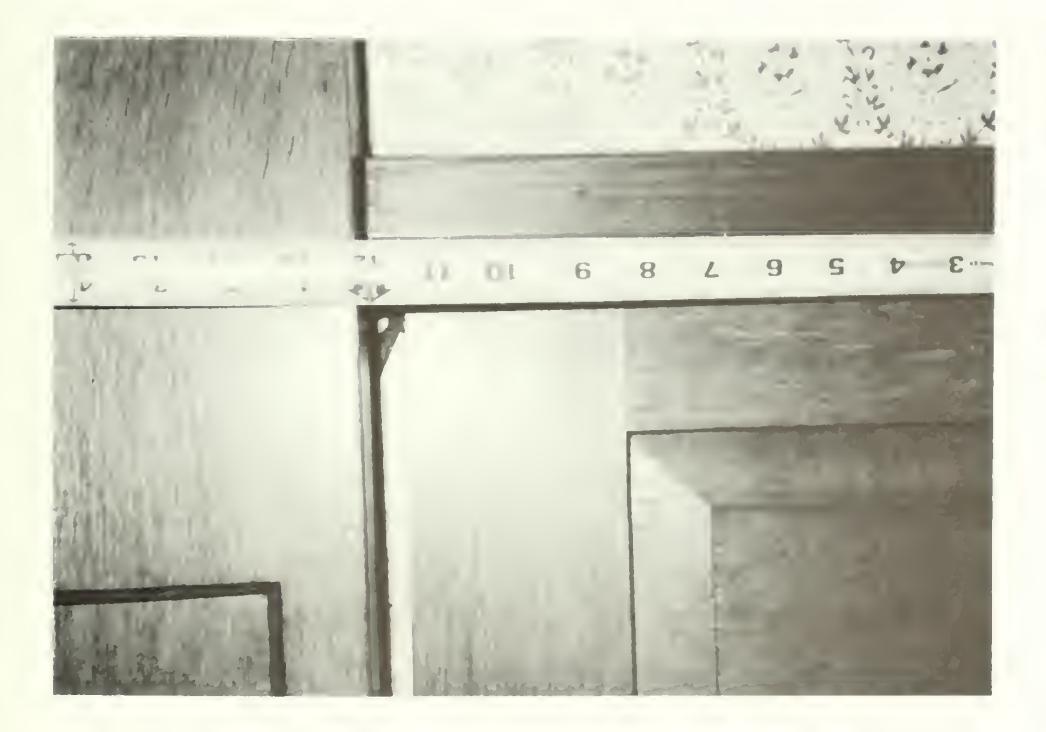
P-34, Main stair, panel displacement.

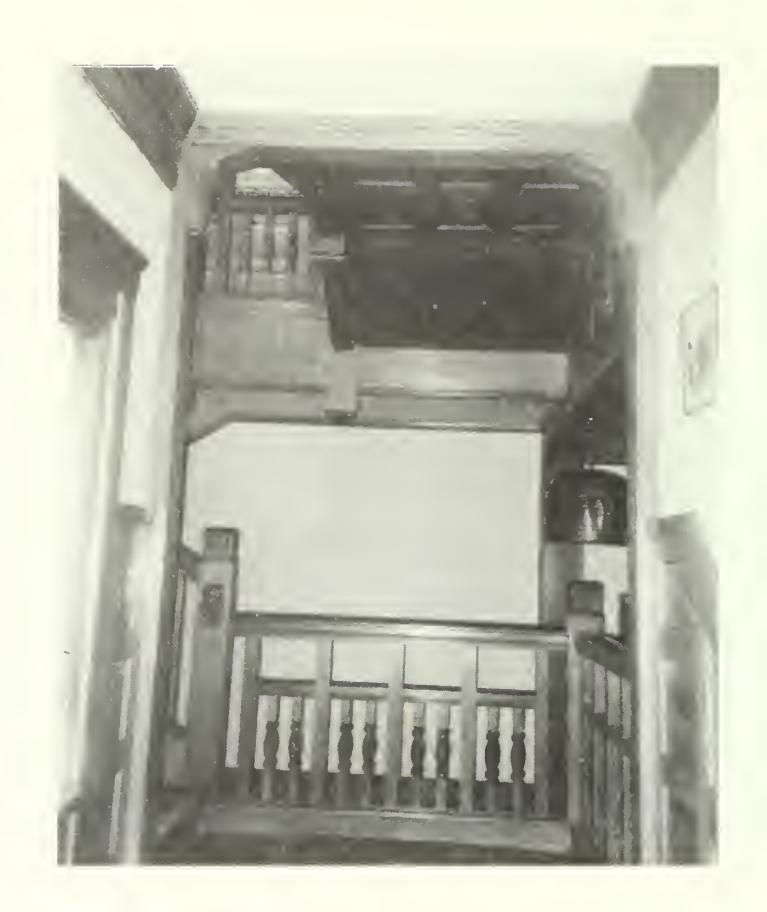
SP-35, Main stair, east view, mid-landing.

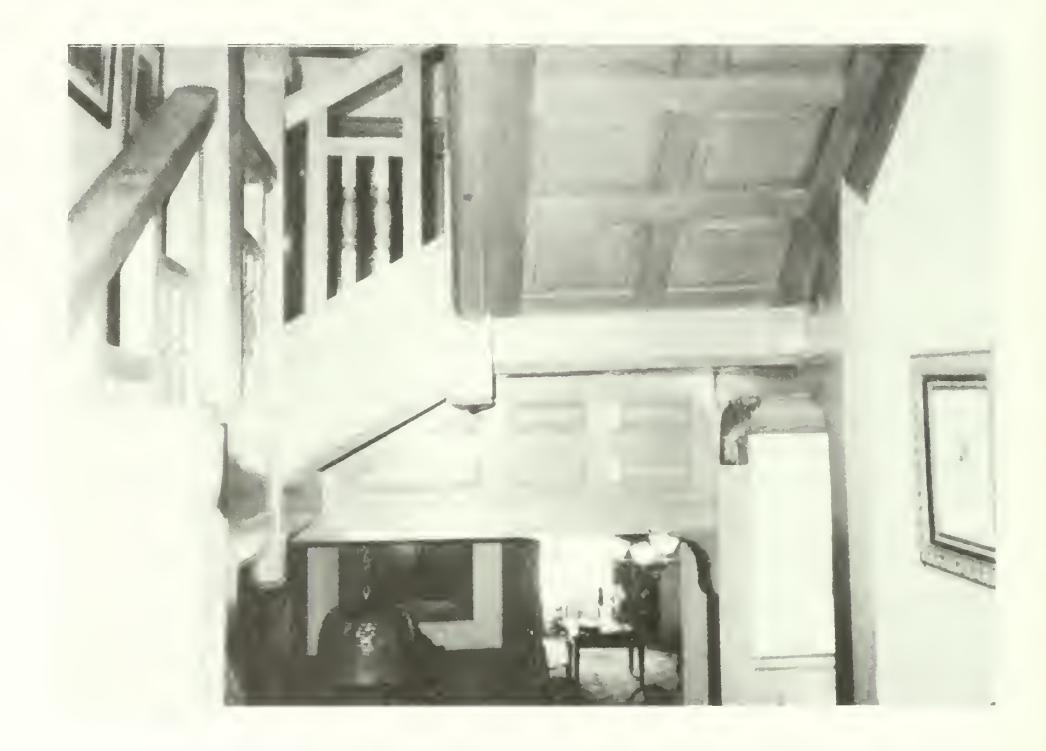
SP-36, Main stair, south view from the library level.

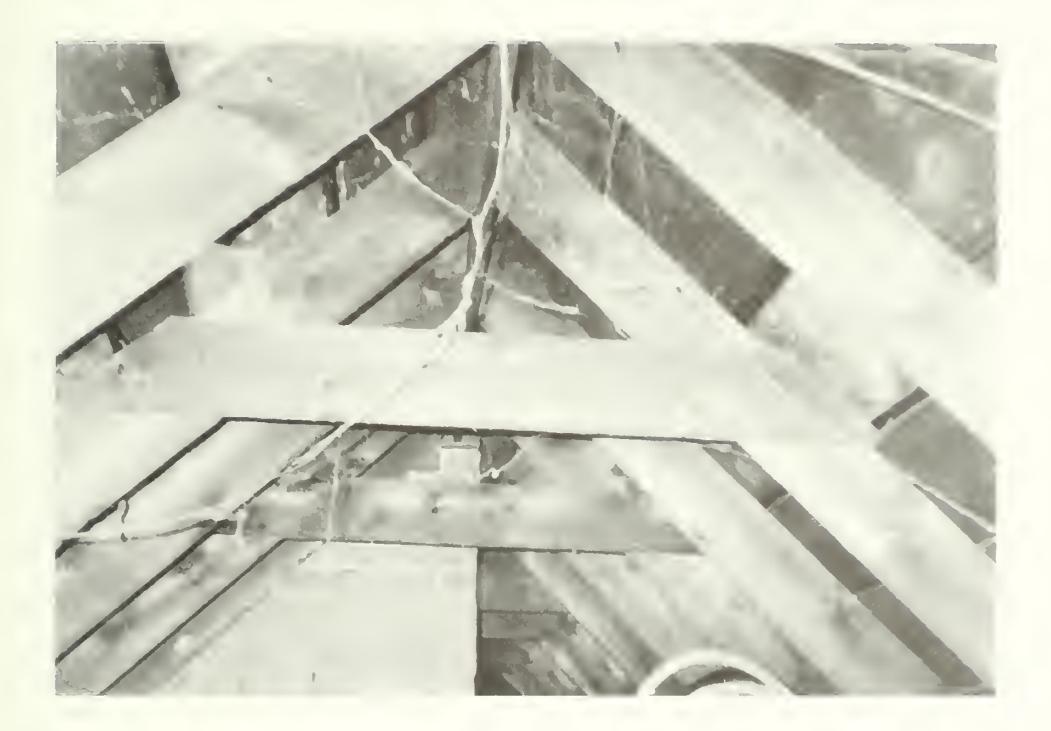
SP-37, Access unit in room 301, roof framing, west view.

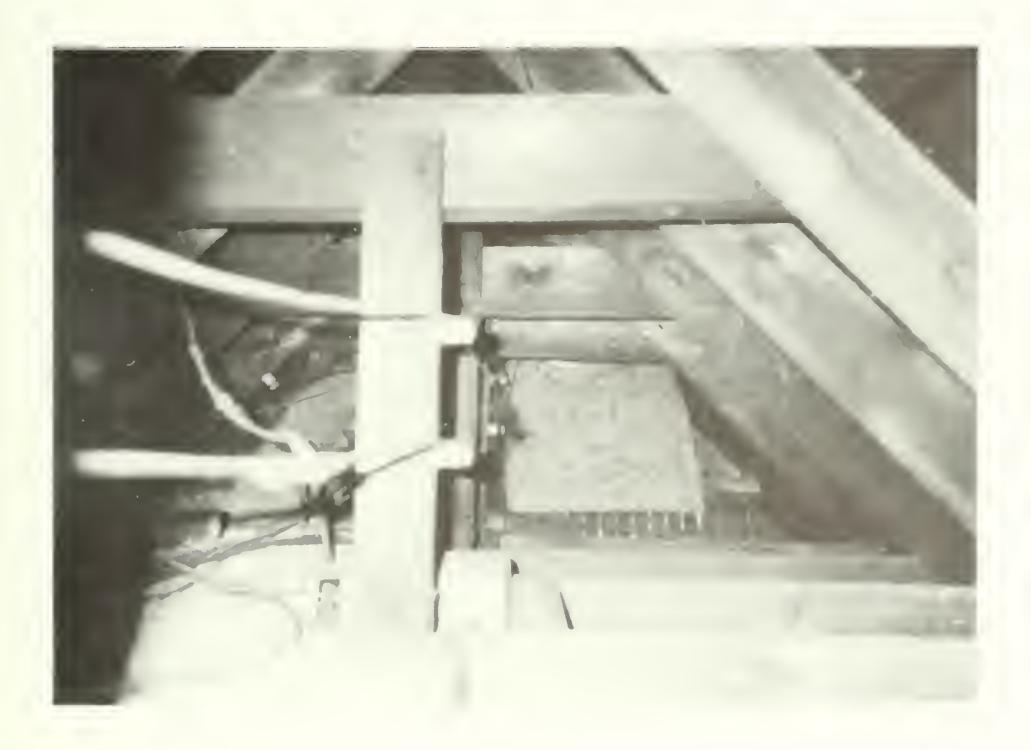
SP-38, Access unit in room 301, roof framing, east view.

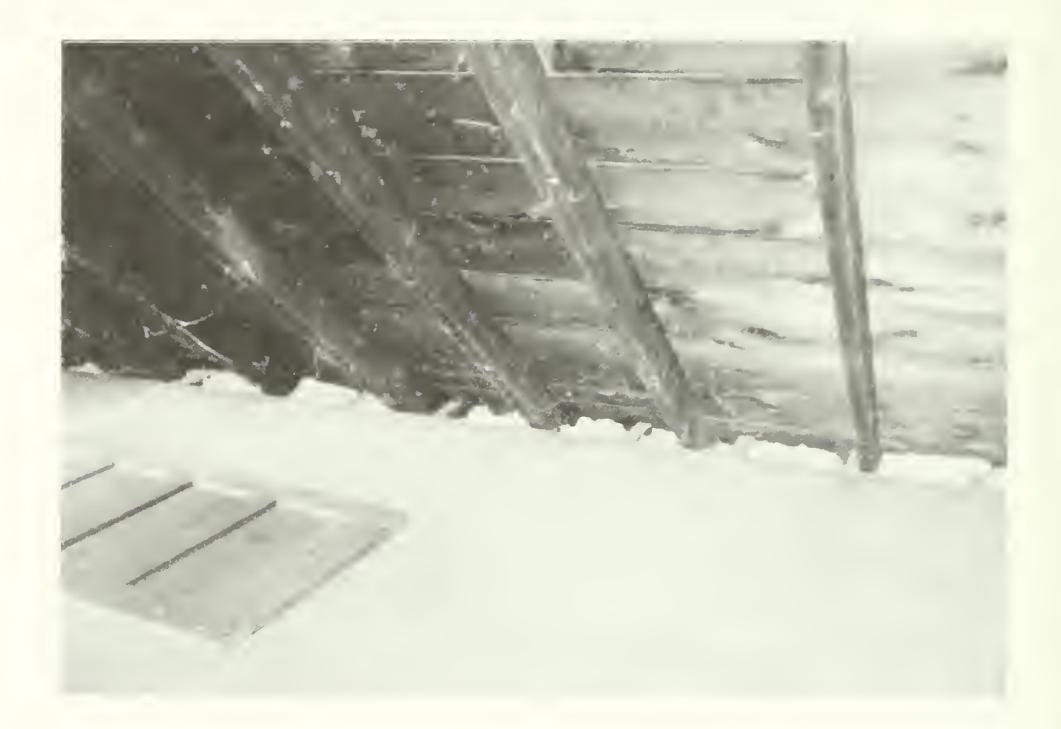
SP-39, Room 308, roof framing, north view.

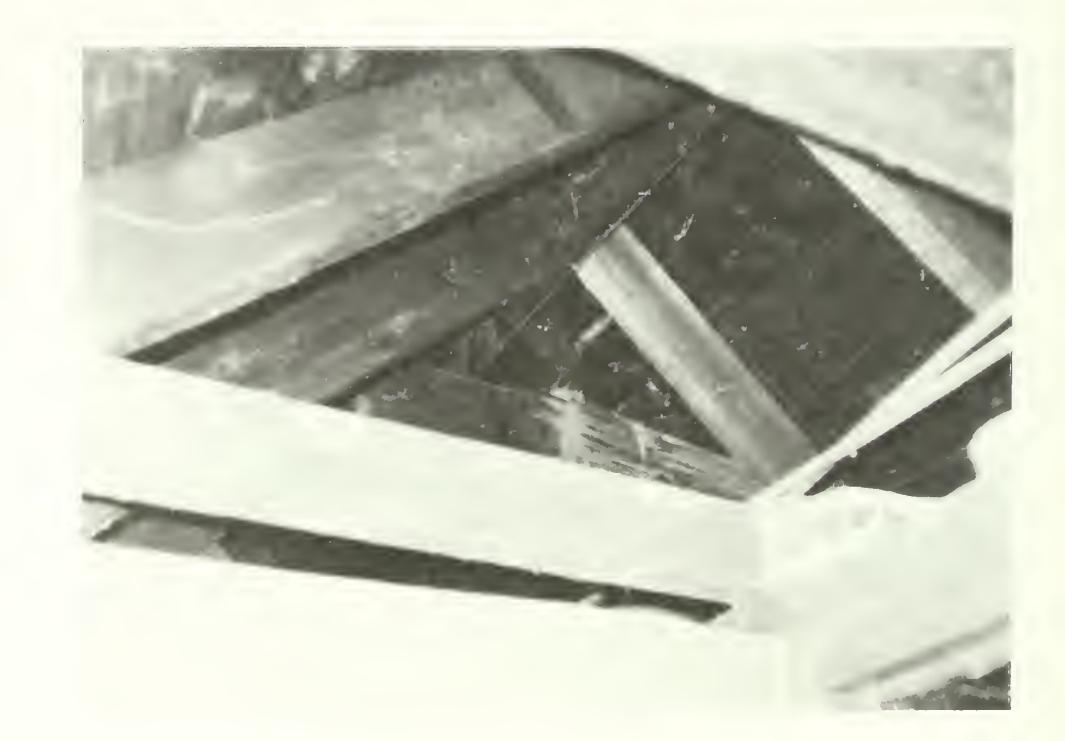
SP-40, Room 308, roof framing, southeast view.

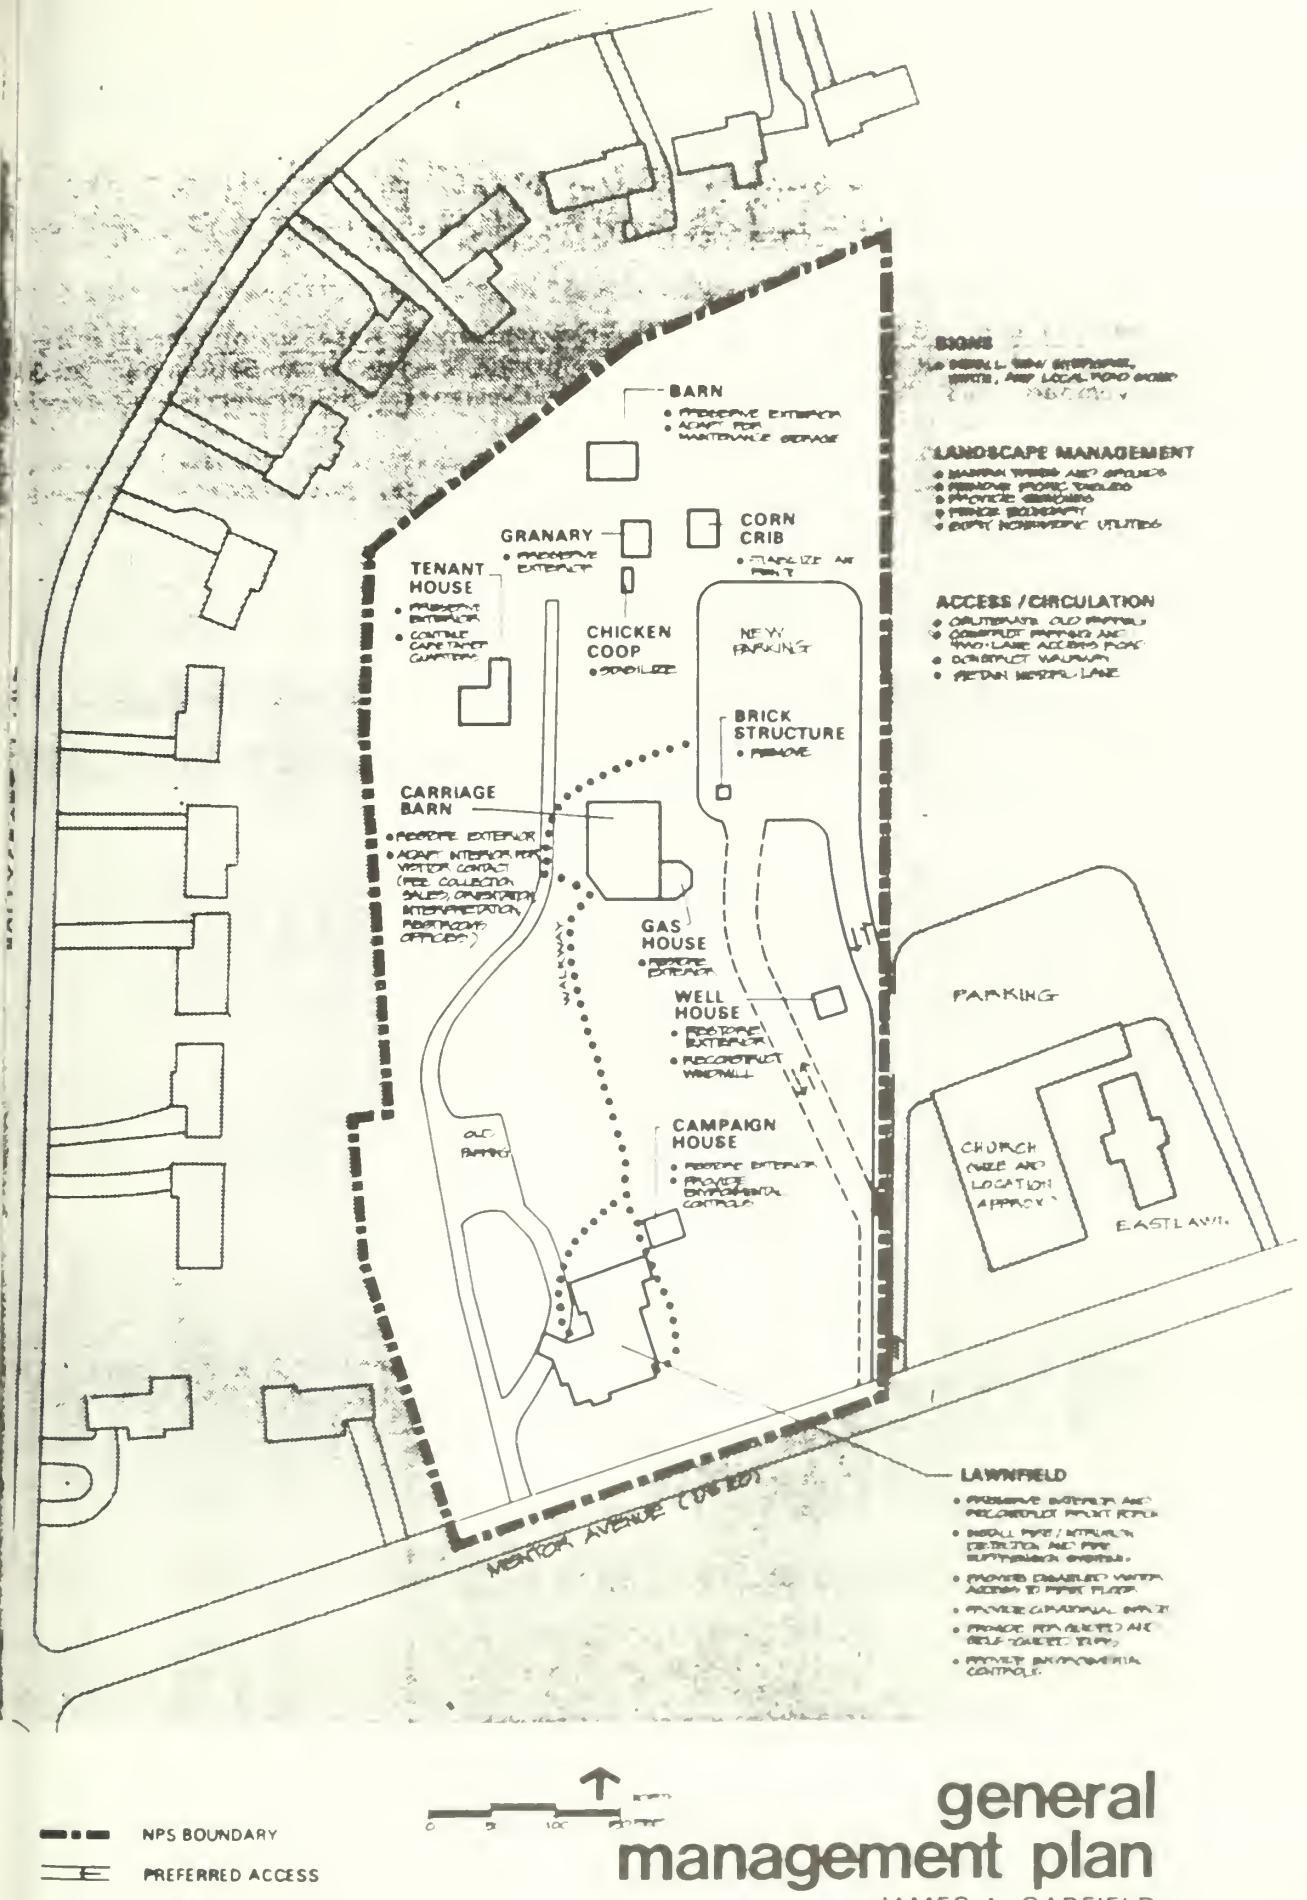
FIGURE 1

F PREFERRED ACCESS

DIE ALTERNATE ACCESS

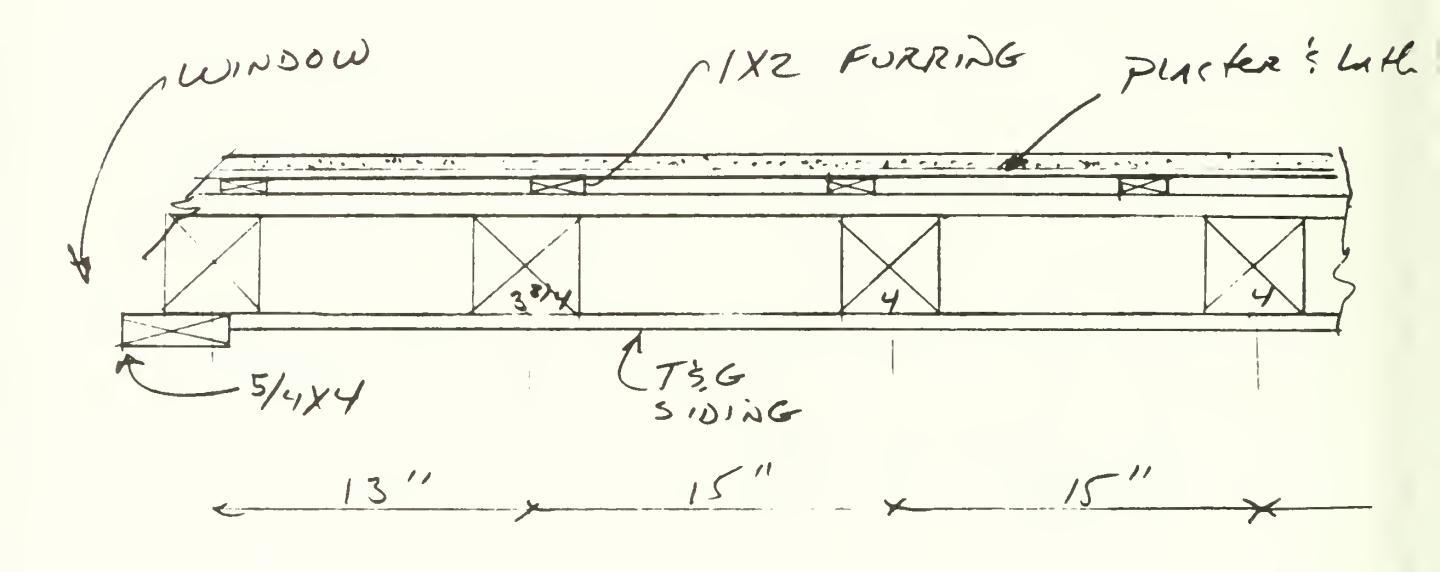
F1G 2

Ext WALL SECTION Scale 142"=1'-0"
