HISTORIC STRUCTURE REPORT

THE U.S. COMMISSIONER'S COURT,
THE U.S. COMMISSIONER'S RESIDENCE, AND THE WOMEN'S JAIL
CHISANA HISTORIC DISTRICT
WRANGELL-ST. ELIAS NATIONAL PARK & PRESERVE
ALASKA

ALASKA REGIONAL OFFICE
NATIONAL PARK SERVICE
UNITED STATES DEPARTMENT OF THE INTERIOR
ANCHORAGE, ALASKA

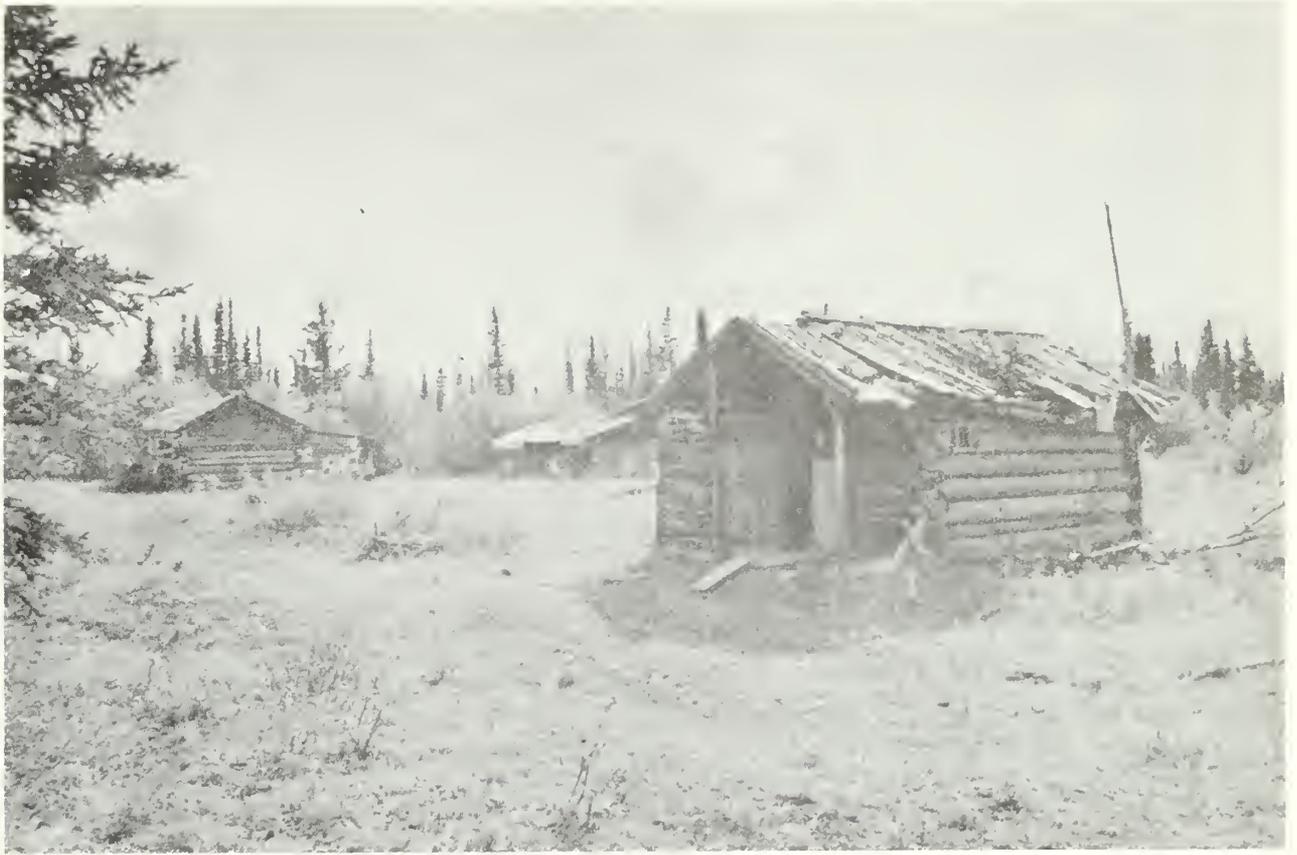
Photograph 1
Women's Jail, Chisana
Northeast Oblique.

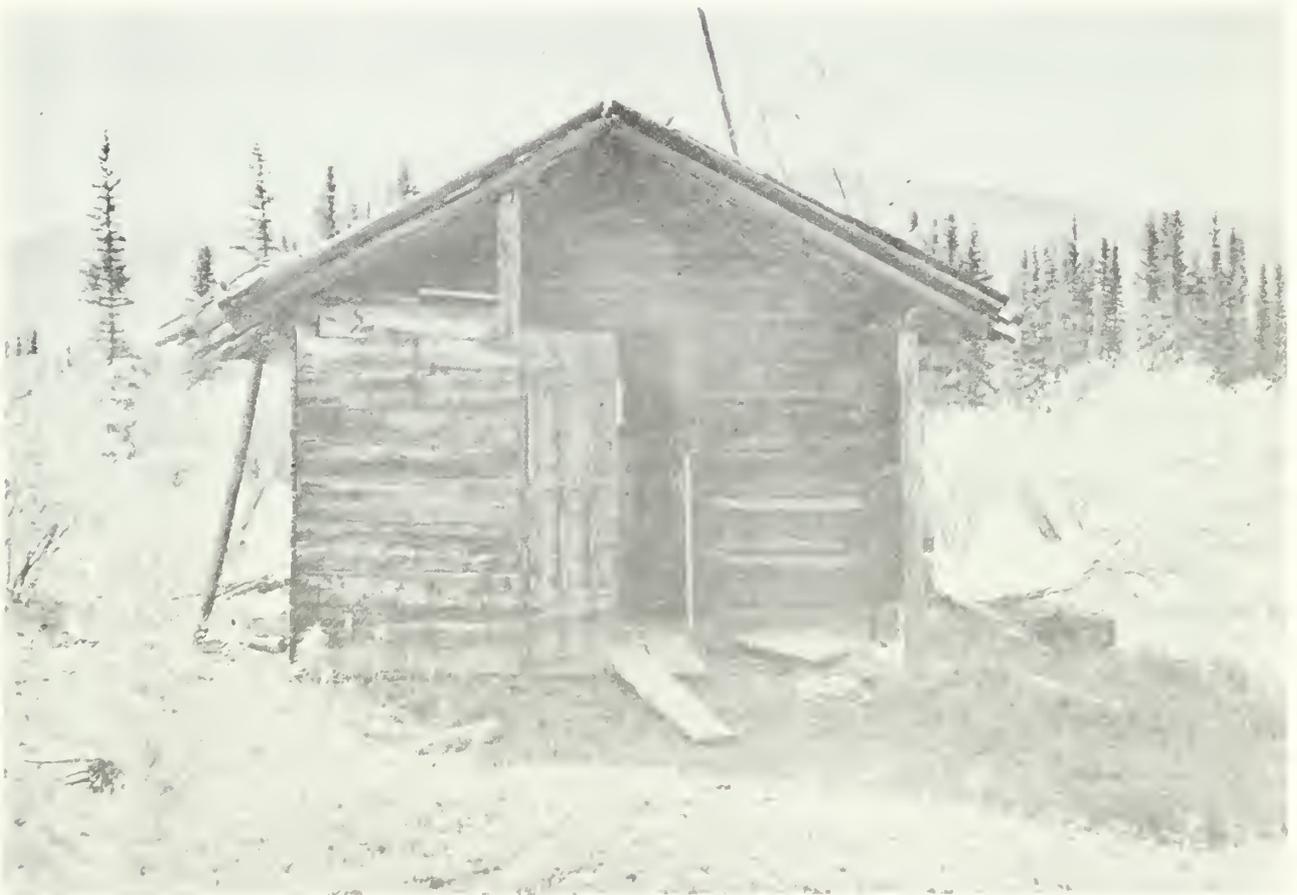
Photograph 2
Women's Jail, Chisana
East Elevation.

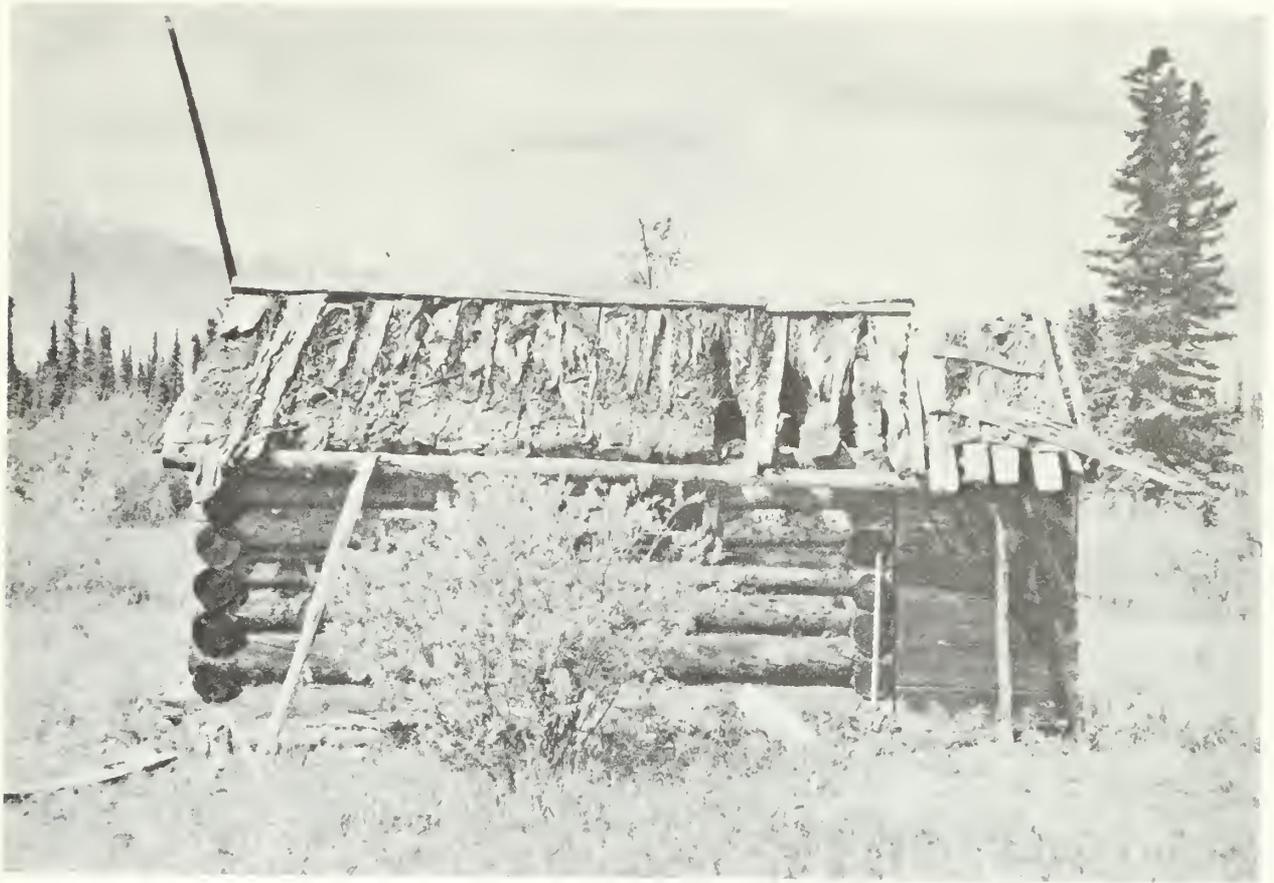
Photograph 3
Women's Jail, Chisana
South Elevation.

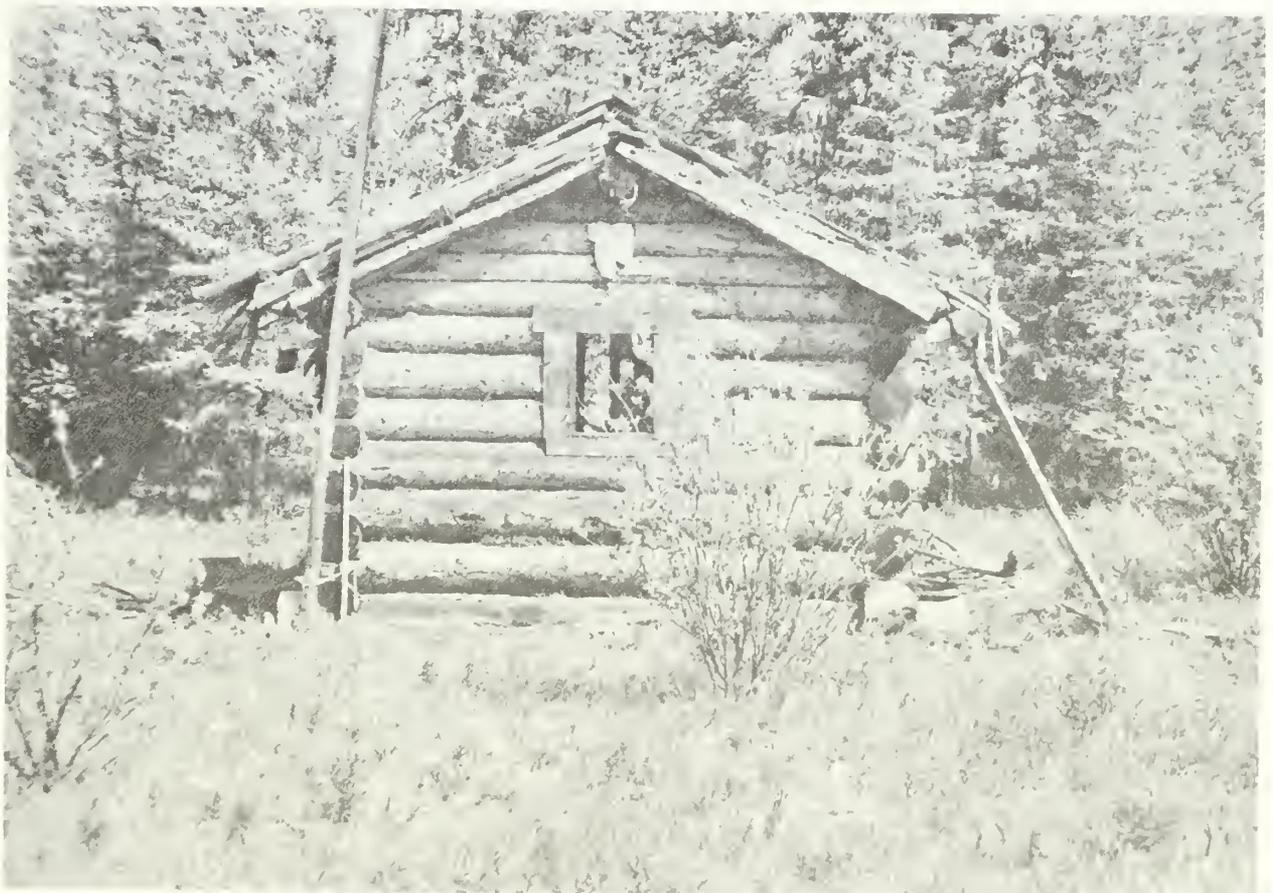
Photograph 4
Women's Jail, Chisana
West Elevation.

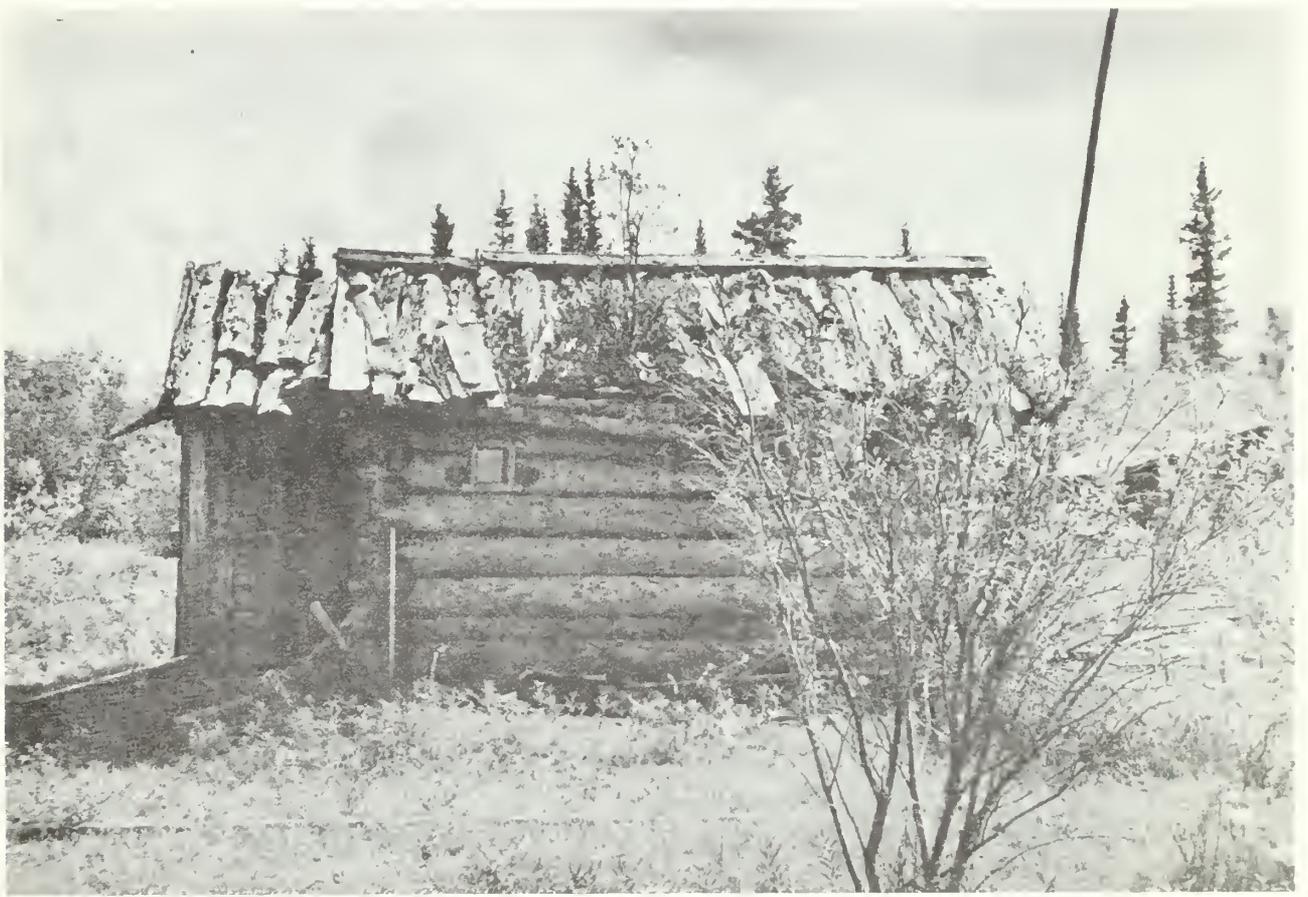
Photograph 5
Women's Jail, Chisana
North Elevation.

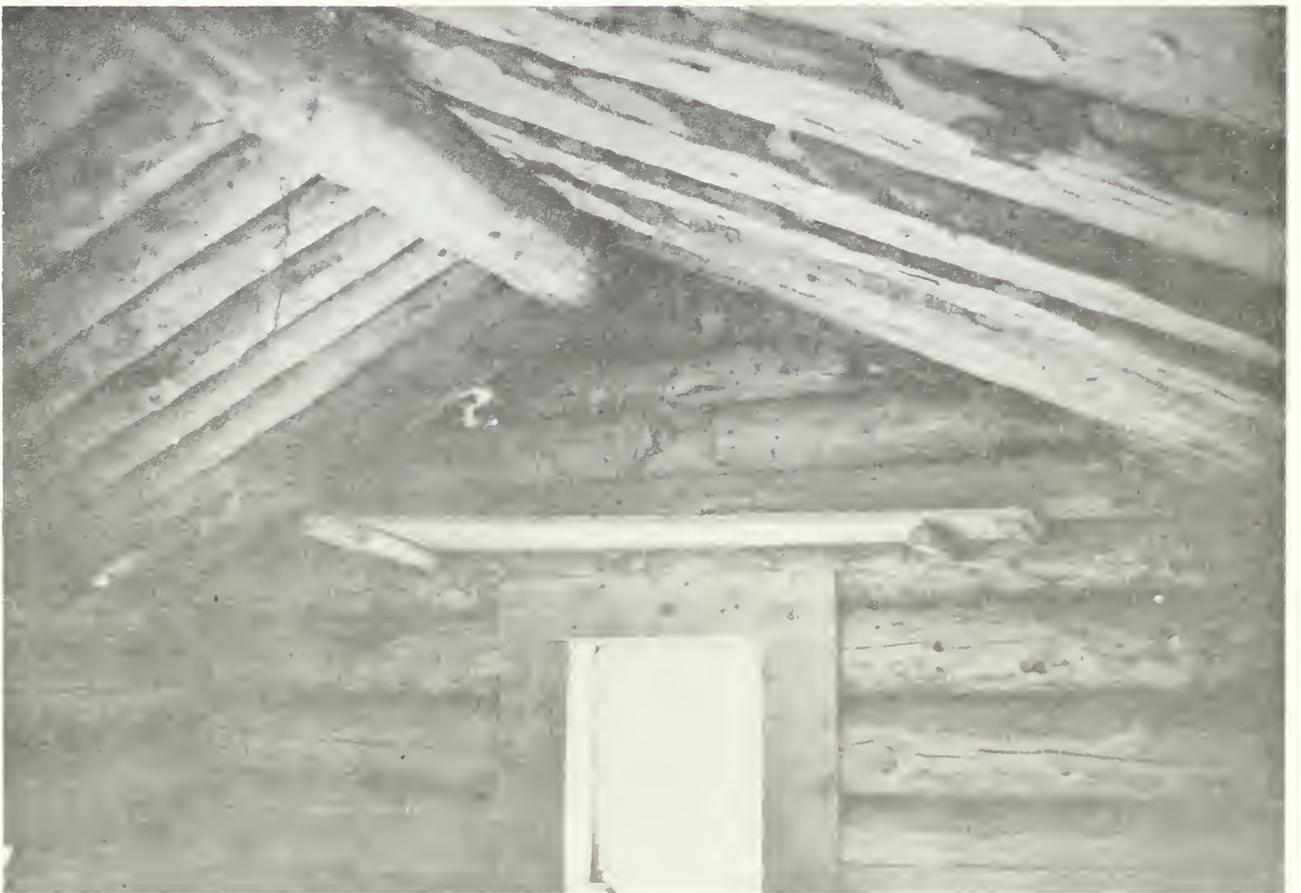
The window on the west end appears to have been a later addition. It is a different style from the north and south windows and is potentially large enough to crawl out of (not very efficient in a jail). The frame is loose, all boards are weathered and the stops are missing as is the glazing. The shelf above the window is in good shape.

Photograph 8
Women's Jail, Chisana
Interior; West wall, shelf & window.

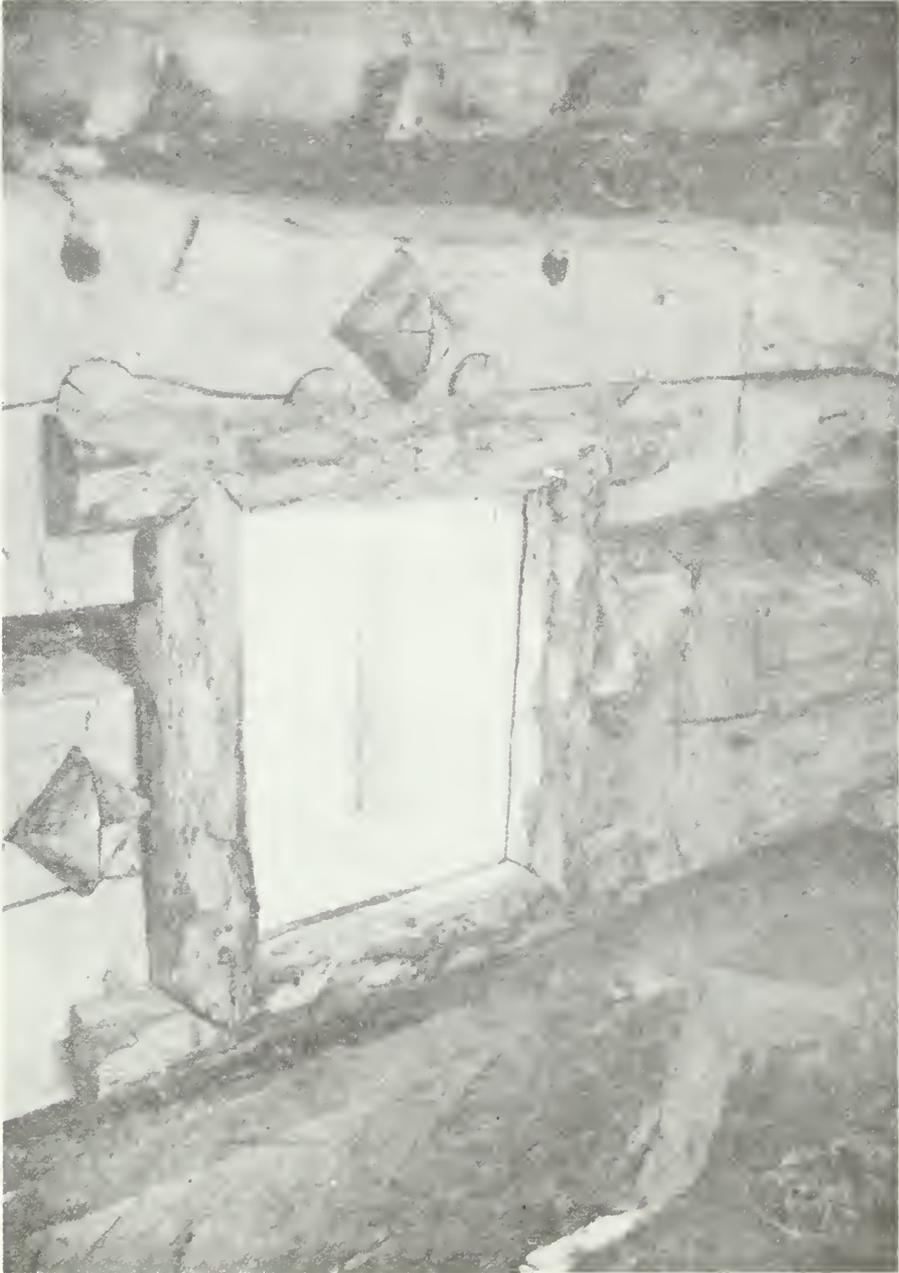
Photograph 10
Women's Jail, Chisana
Interior; Window on north wall.

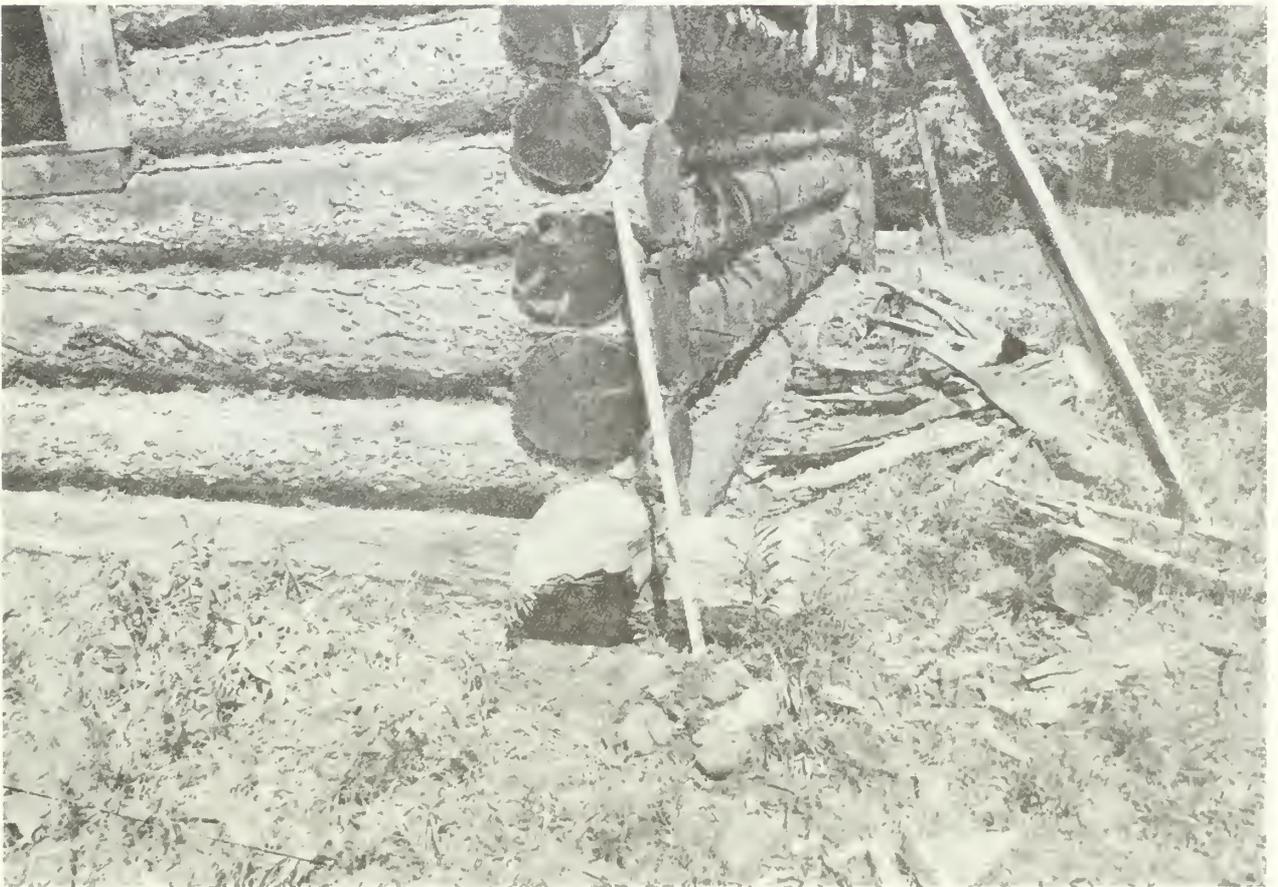
Photograph 12
Women's Jail, Chisana
Northwest corner, log connections.

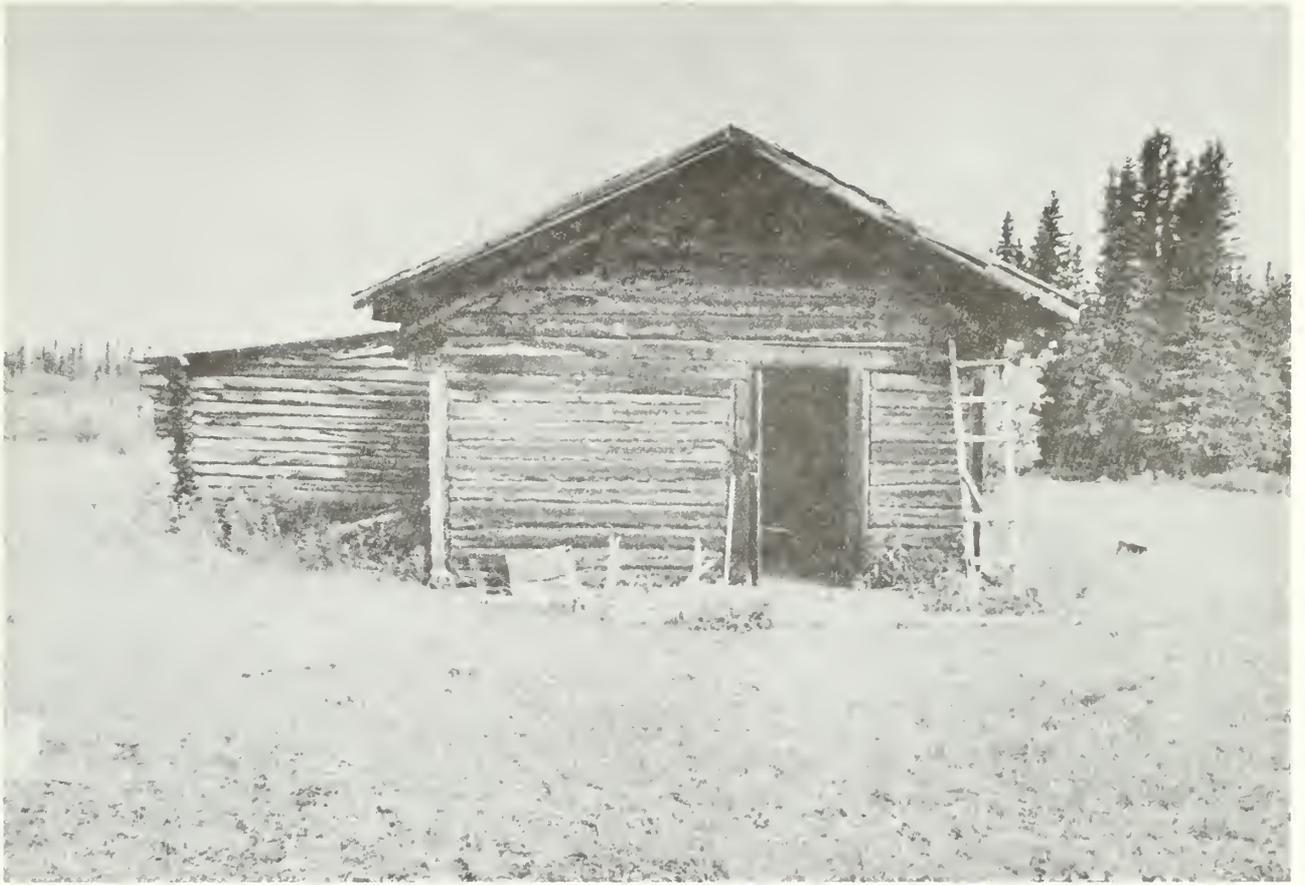
Photograph 15
U.S. Commissioner's Court
South Elevation.

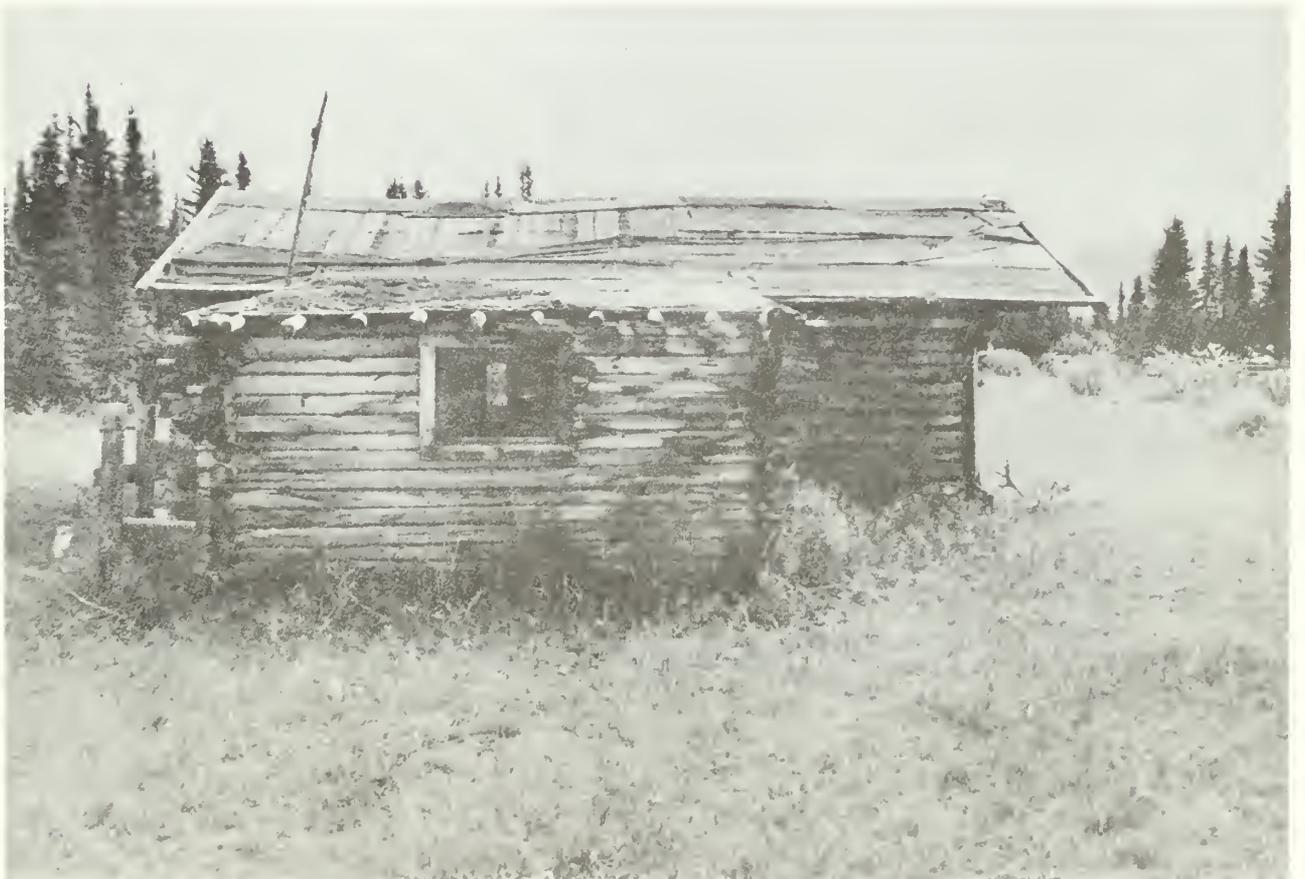
Photograph 16
U.S. Commissioner's Court, Chisana
West Elevation.

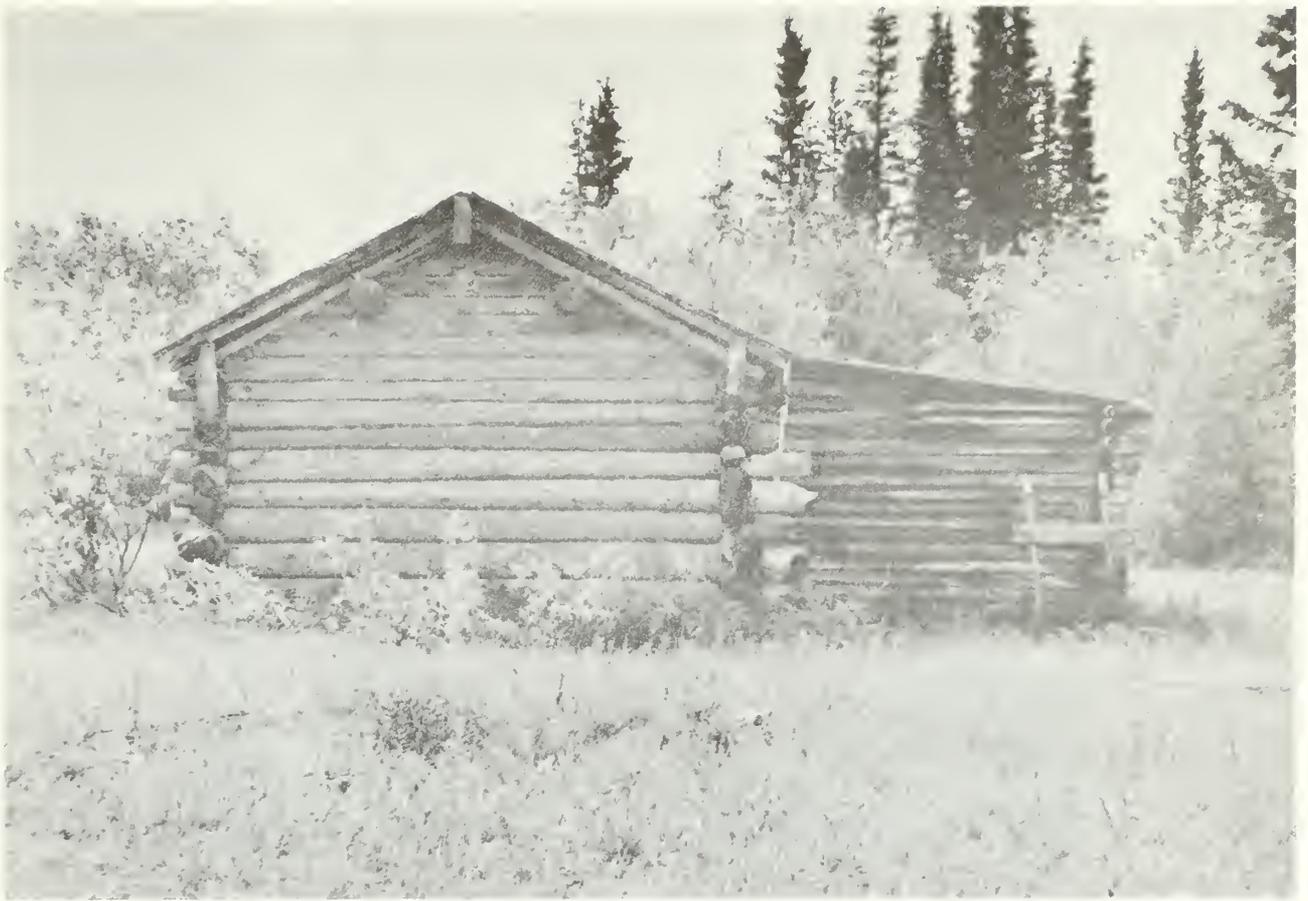
Photograph 17
U.S. Commissioner's Court, Chisana
North Elevation.

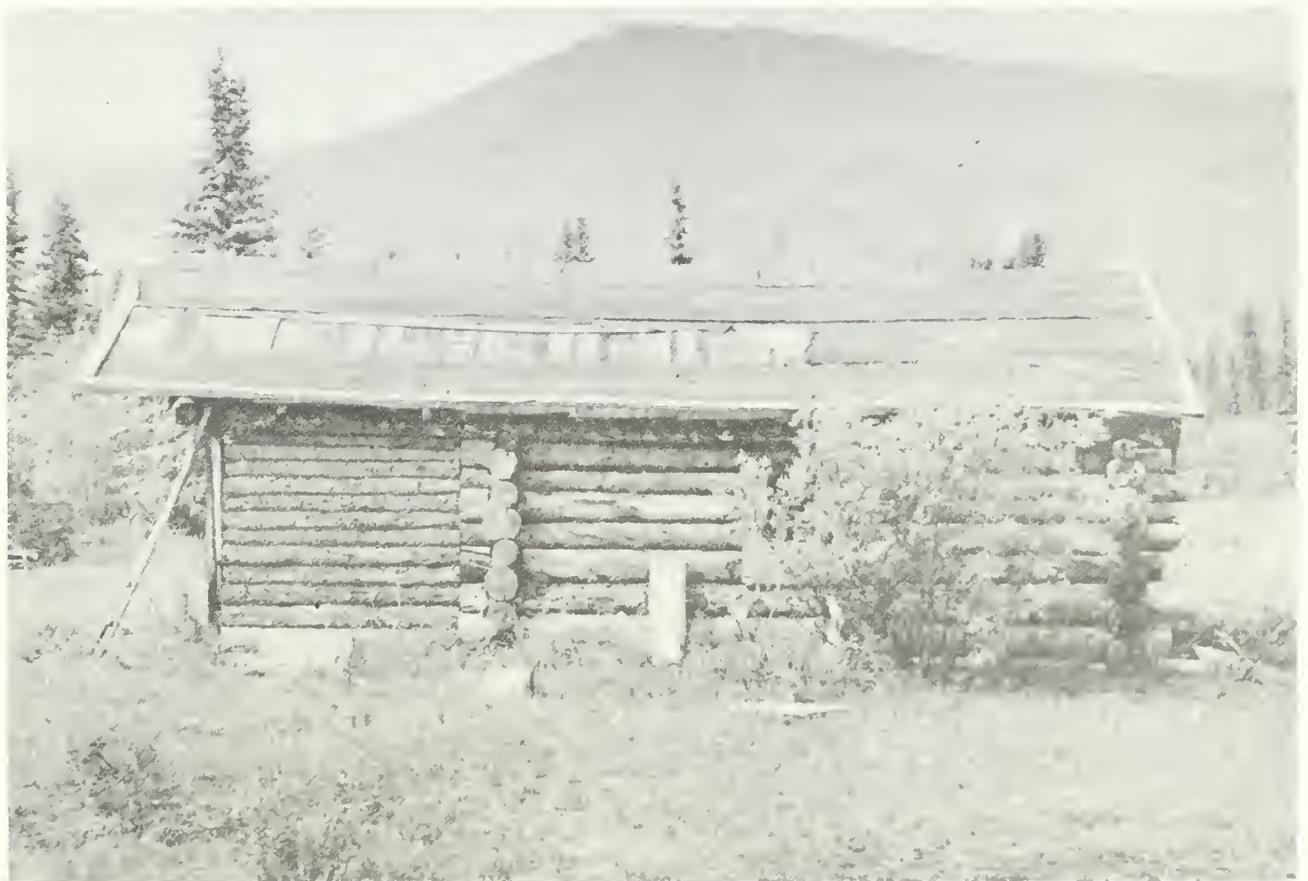
Photograph 18
U.S. Commissioner's Court, Chisana
East Elevation.

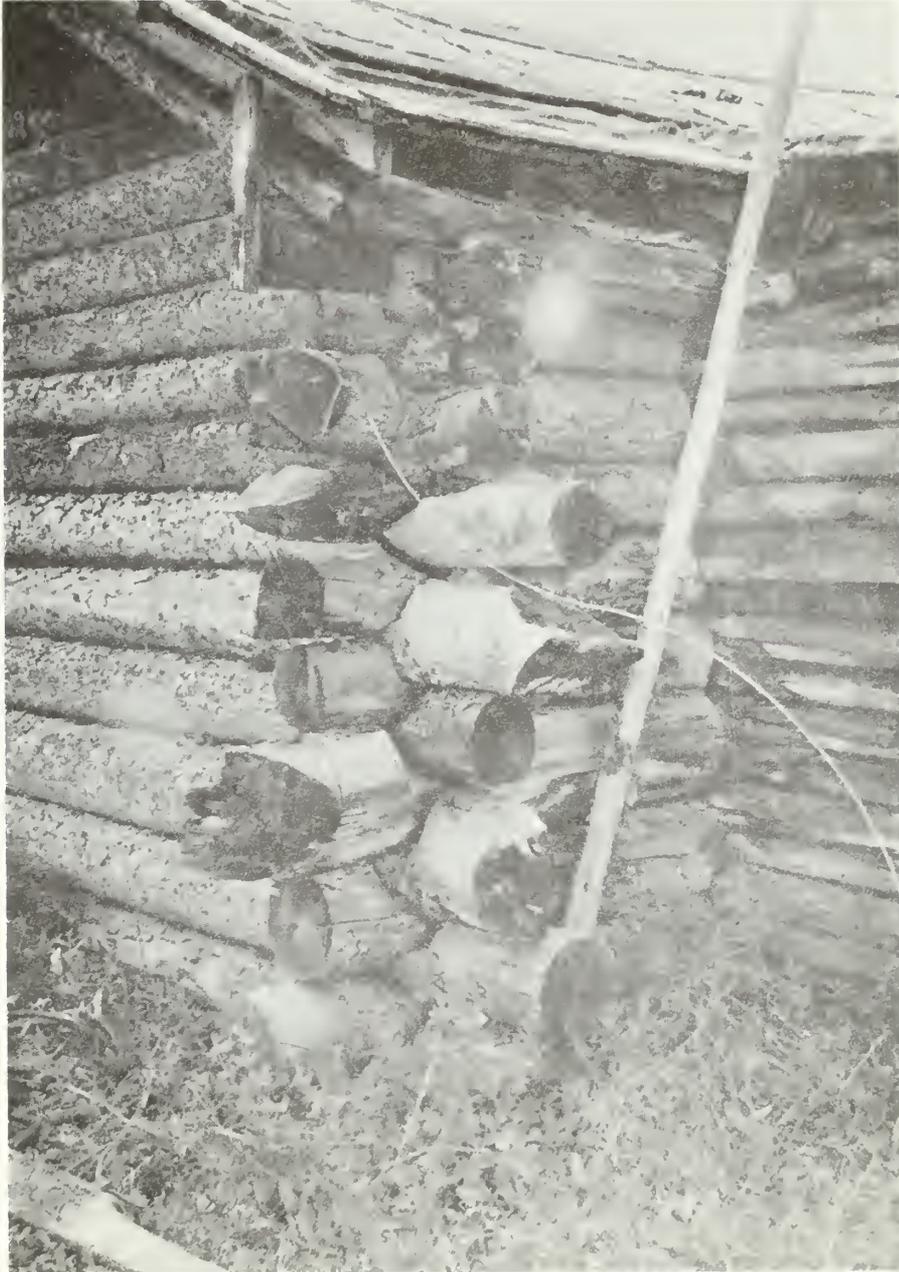
Photograph 20
U.S. Commissioner's Court, Chisana
V-notched log corner; showing
junction of addition logs and
newer roof.

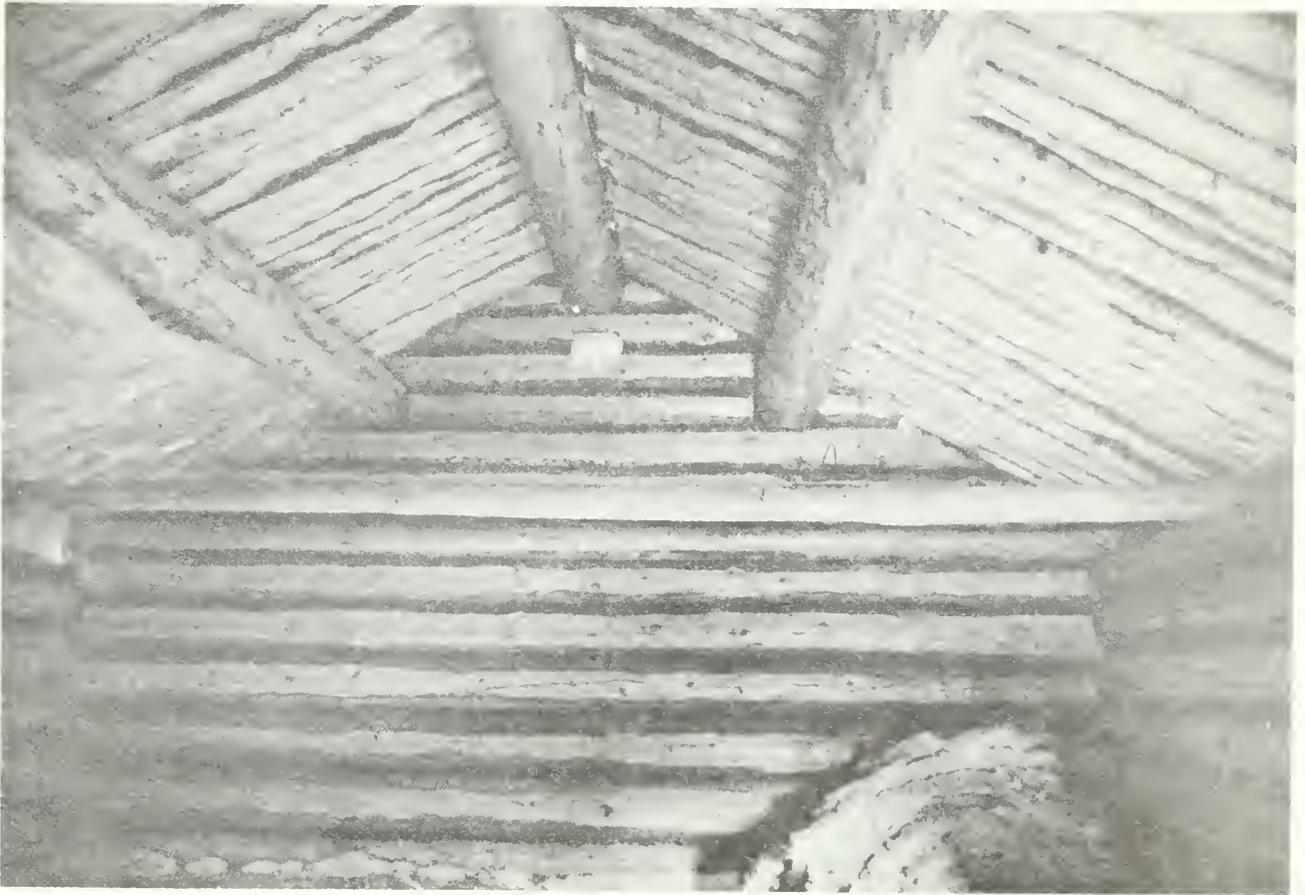
Photograph 21
U.S. Commissioner's Court, Chisana
Ceiling & North wall, showing split-
log ceiling members and peeled
purlines & ridge beam.

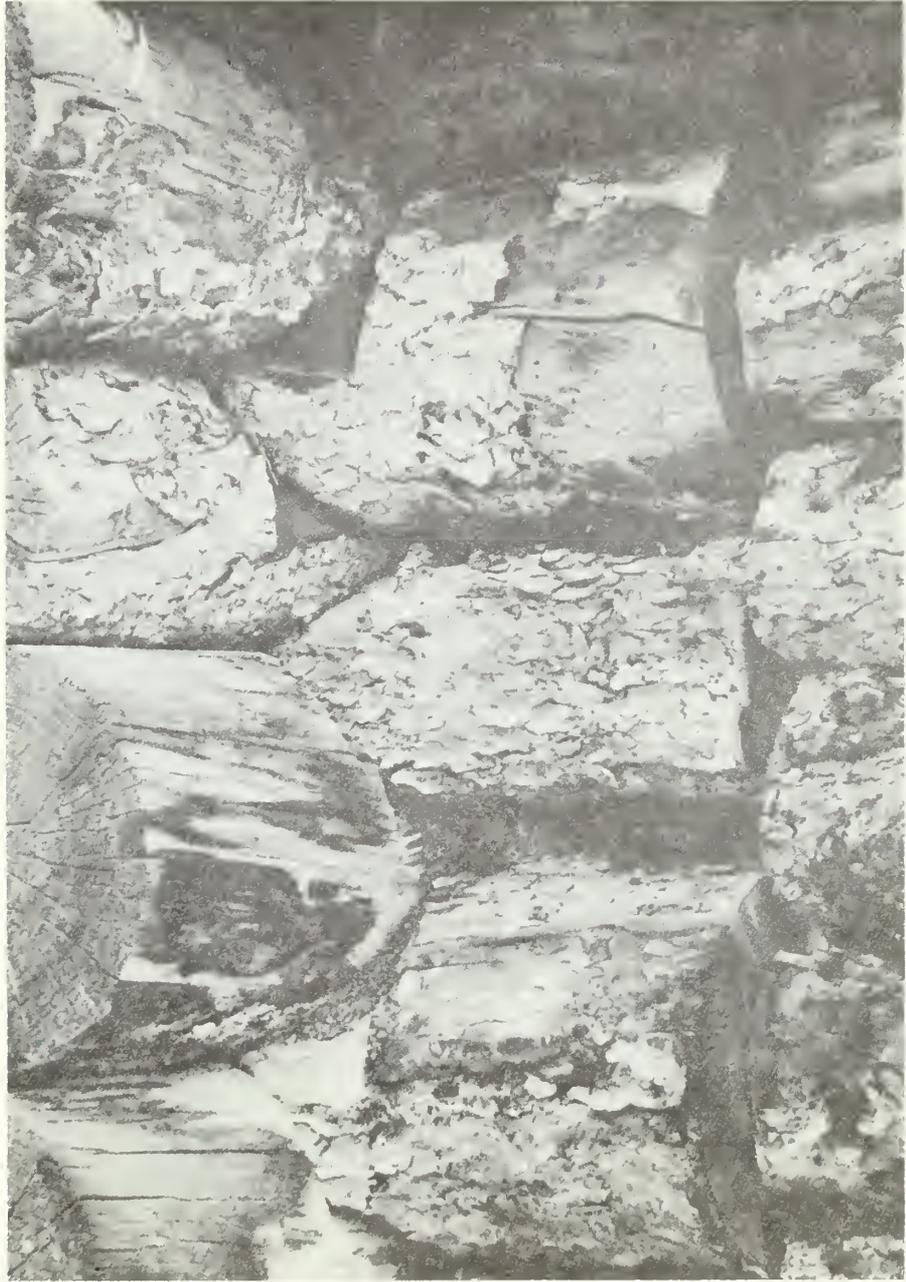
Photograph 24
U.S. Commissioner's Court, Chisana
Junction of main cabin logs and
porch logs (spline just visible
between second and third porch logs
on right)

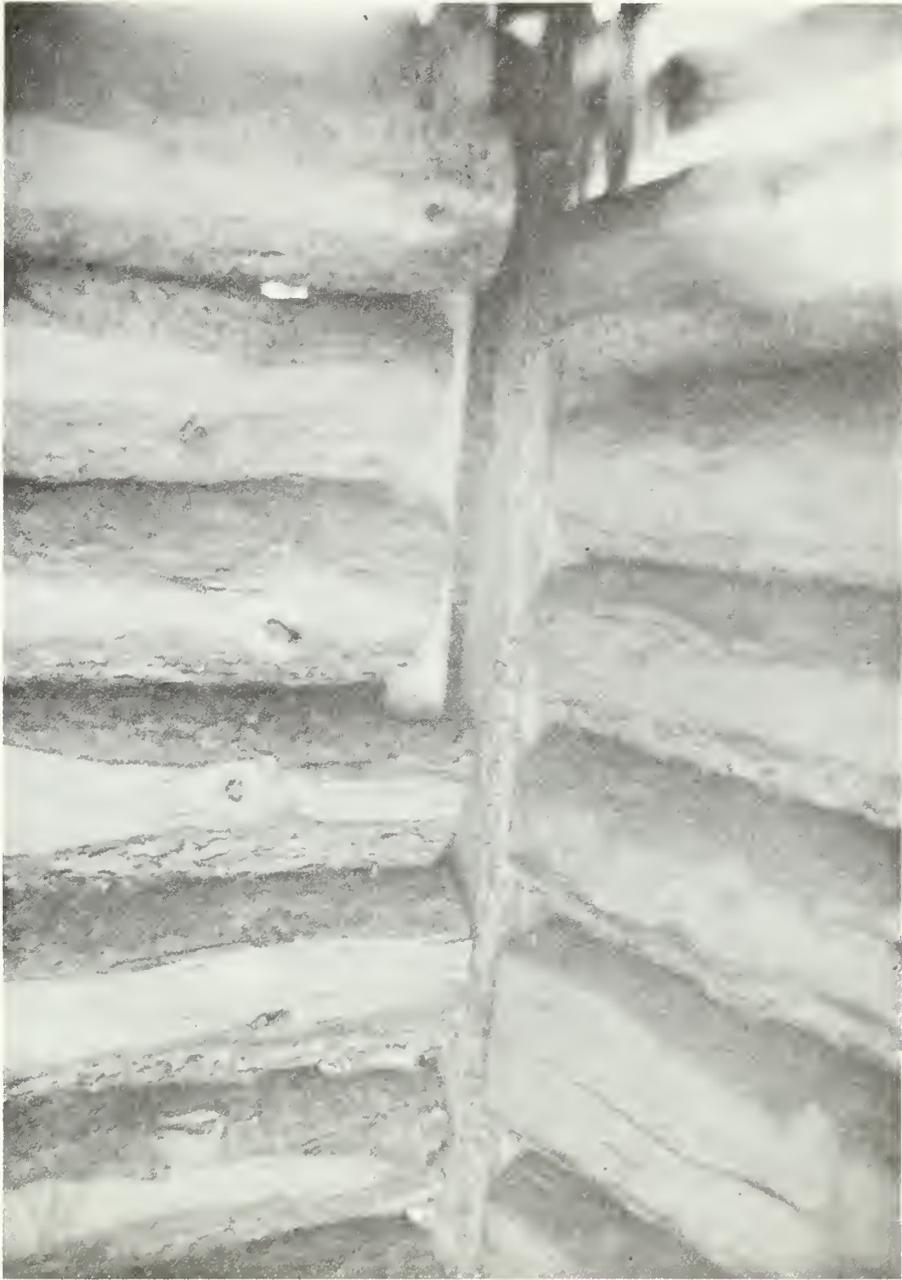
Photograph 26
U.S. Commissioner's Court, Chisana
Detail of Hudson Bay corner and
splines from interior of porch.

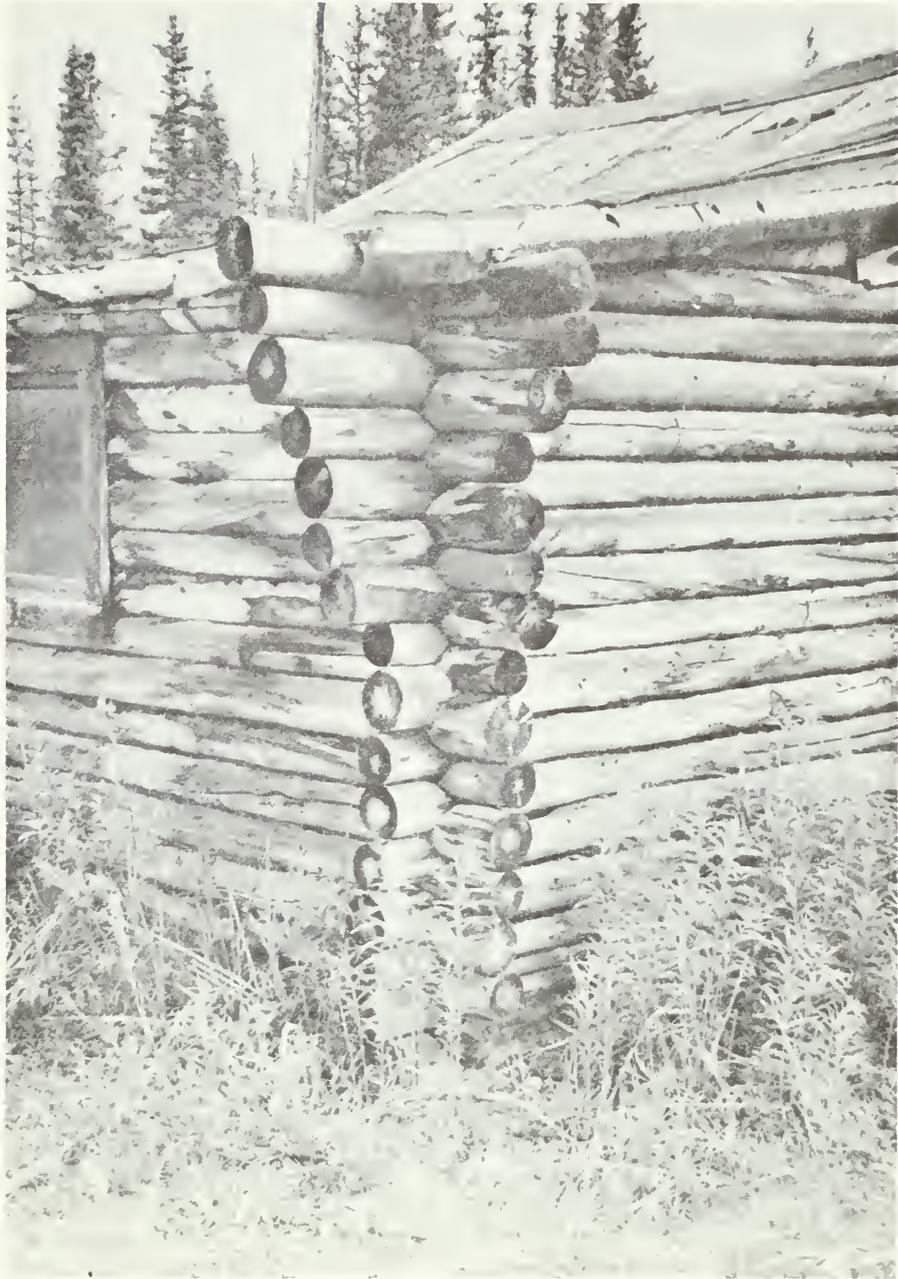
Photograph 27
U.S. Commissioner's Court, Chisana
Southwest corner of addition

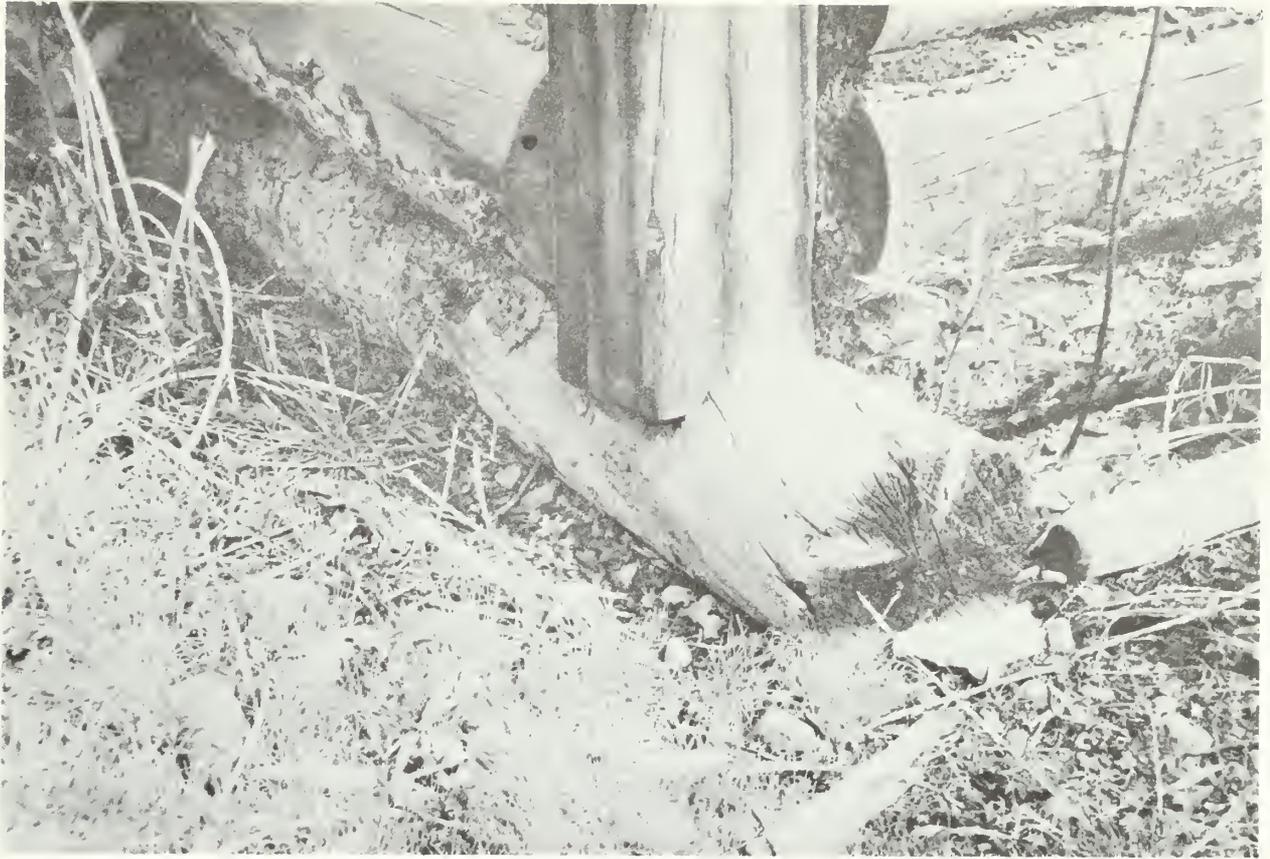
Photograph 28
U.S. Commissioner's Court, Chisana
Junction of sill log and Hudson
Bay corner post.

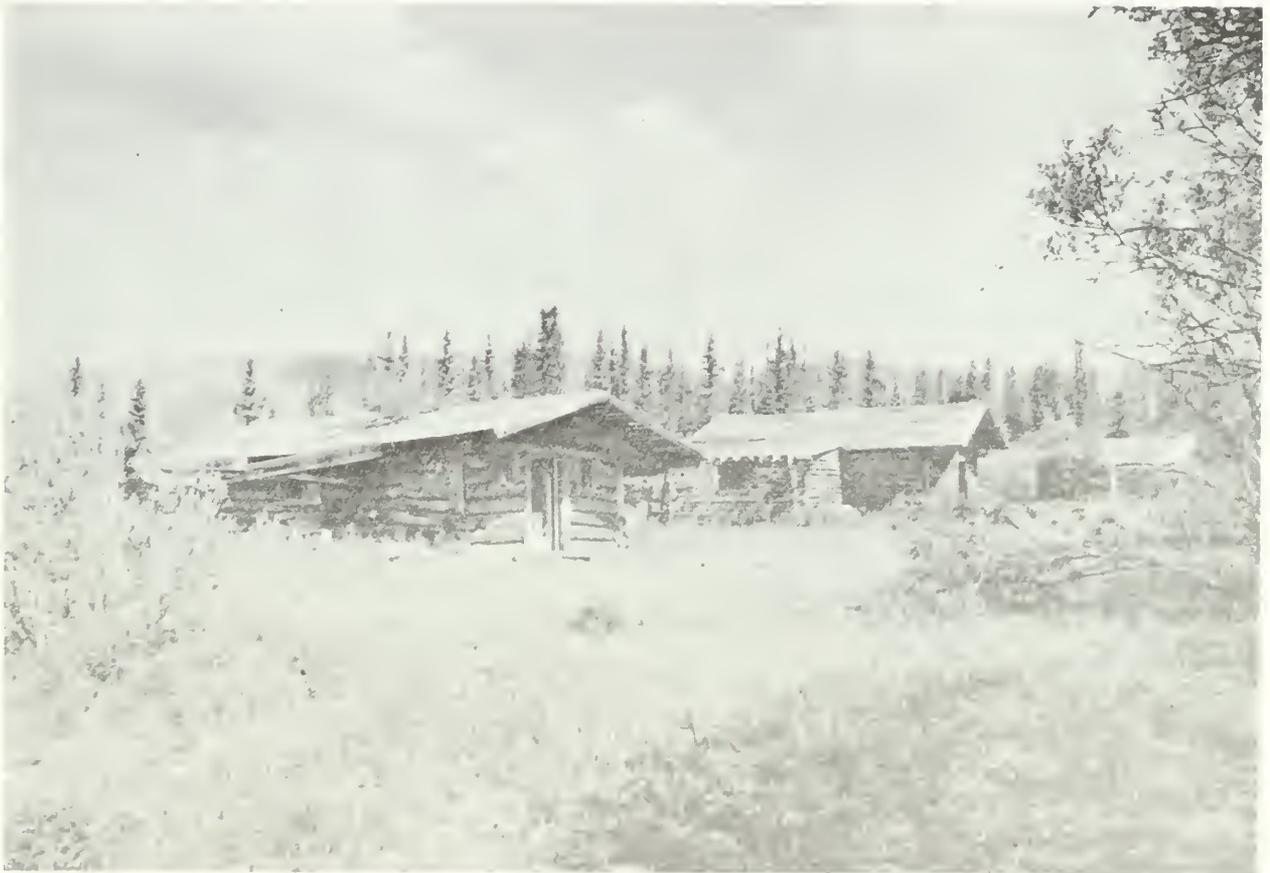
Photograph 29
U.S. Commissioner's Residence, Chisana
Southwest oblique.
