HISTORIC STRUCTURE REPORT

THE U.S. COMMISSIONER'S COURT,
THE U.S. COMMISSIONER'S RESIDENCE, AND THE WOMEN'S JAIL
CHISANA HISTORIC DISTRICT
WRANGELL-ST. ELIAS NATIONAL PARK & PRESERVE
ALASKA

ALASKA REGIONAL OFFICE
NATIONAL PARK SERVICE
UNITED STATES DEPARTMENT OF THE INTERIOR
ANCHORAGE, ALASKA

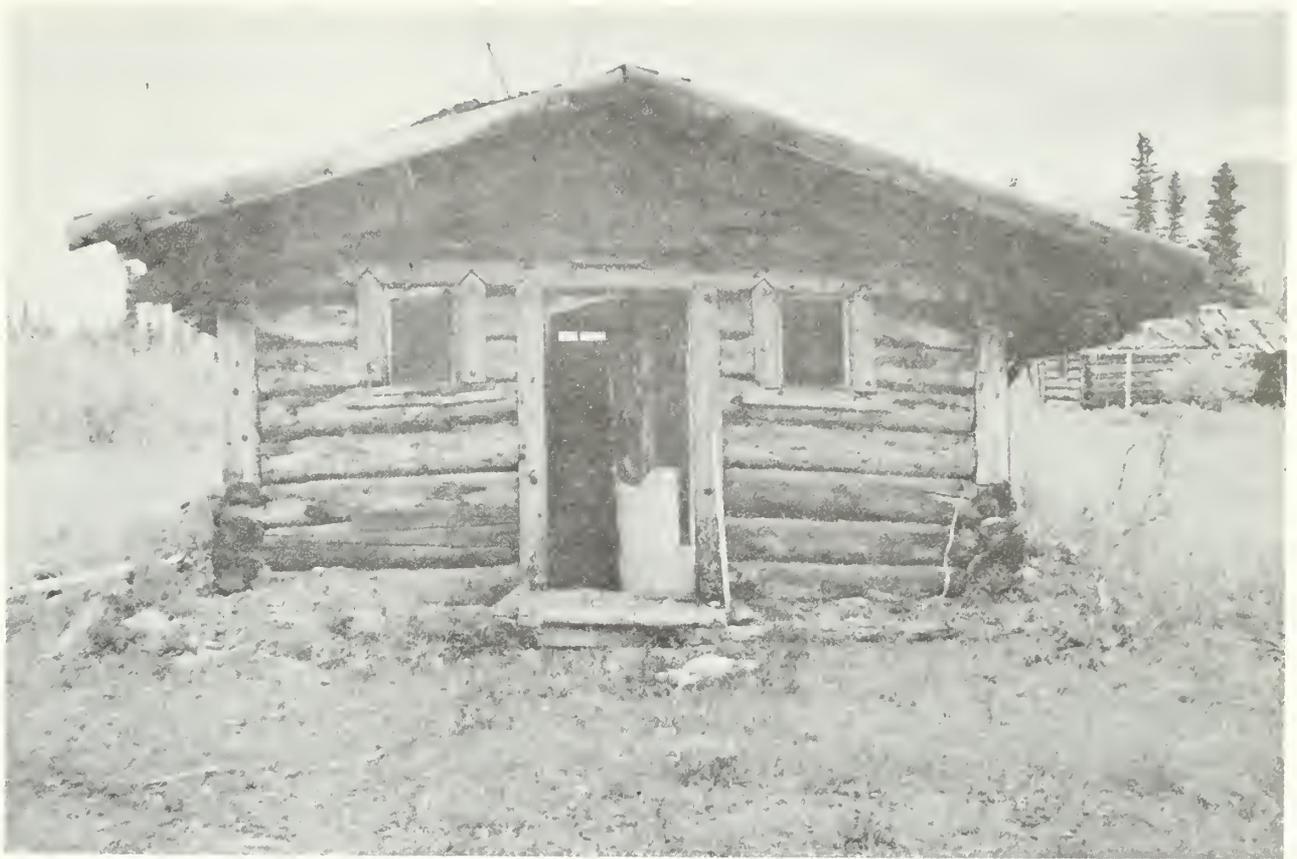
Photograph 30
U.S. Commissioner's Residence, Chisana
South Elevation.

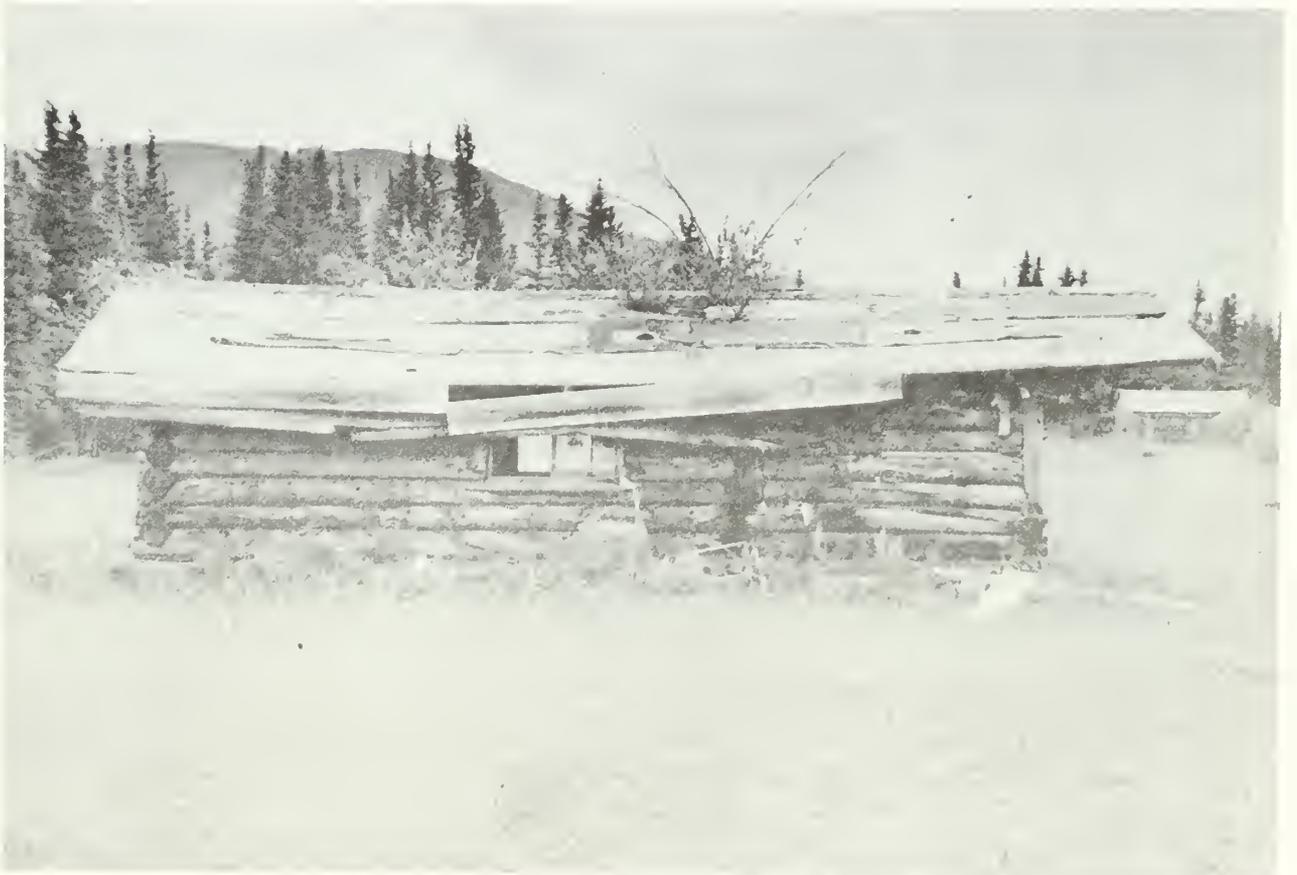
Photograph 31
U.S. Commissioner's Residence, Chisana
West Elevation.

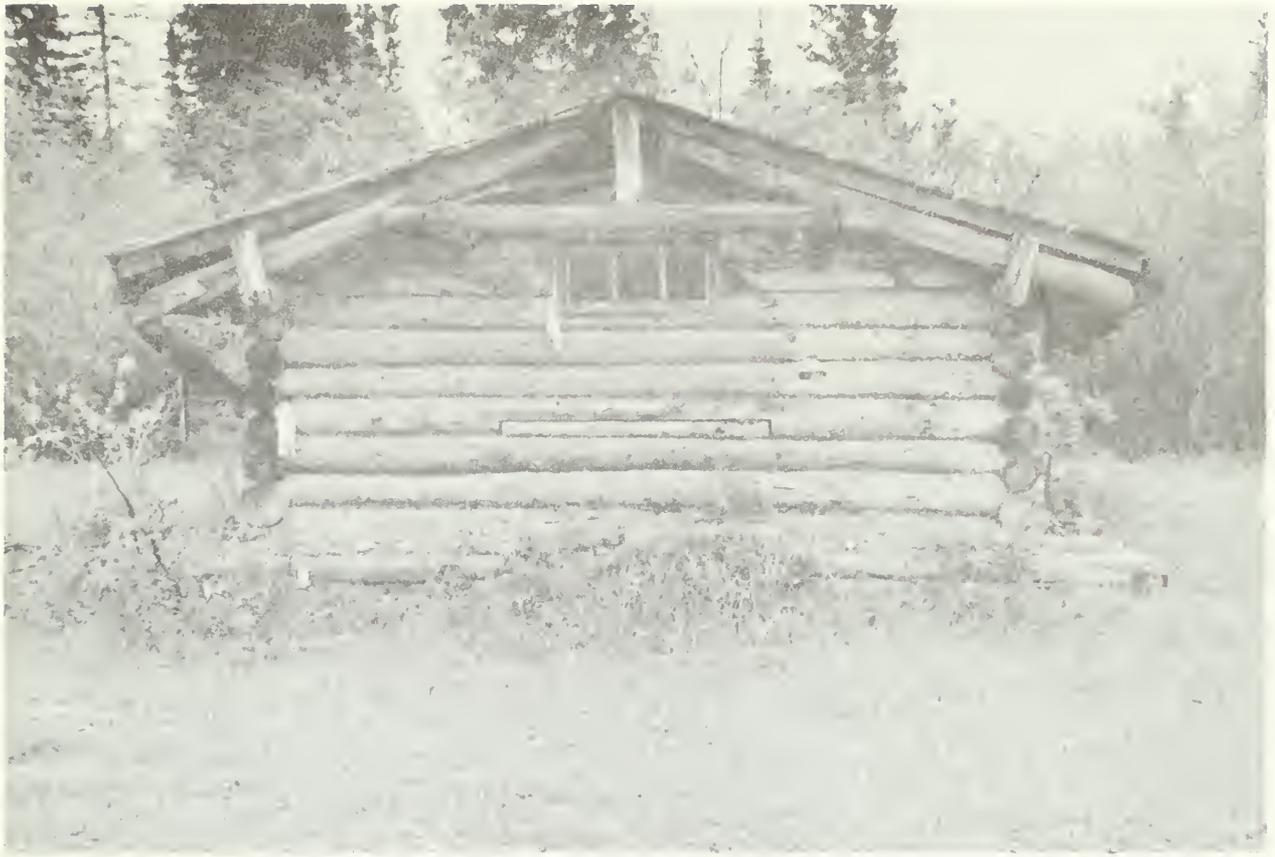
Photograph 32
U.S. Commissioner's Residence, Chisana
North Elevation.

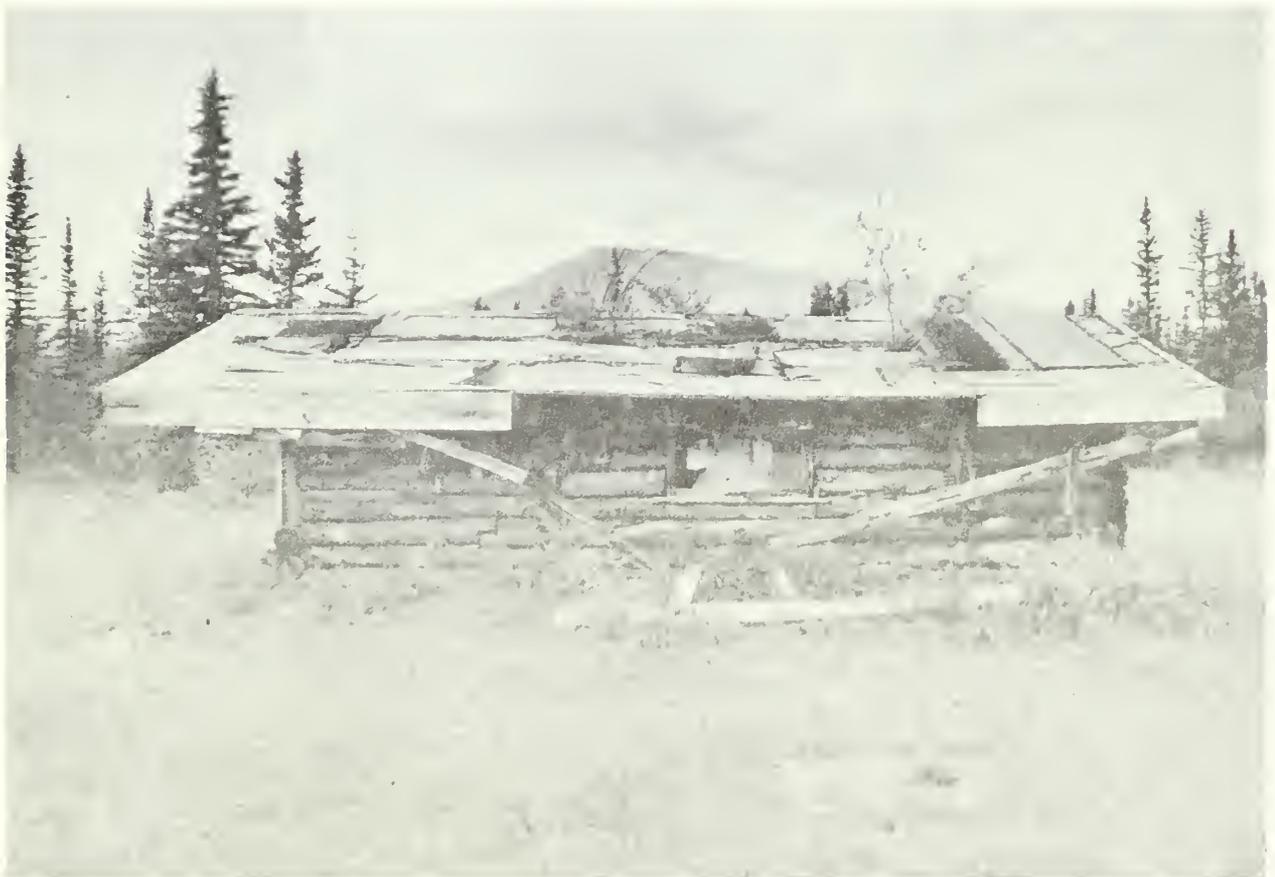
Photograph 33
U.S. Commissioner's Residence, Chisana
East Elevation.

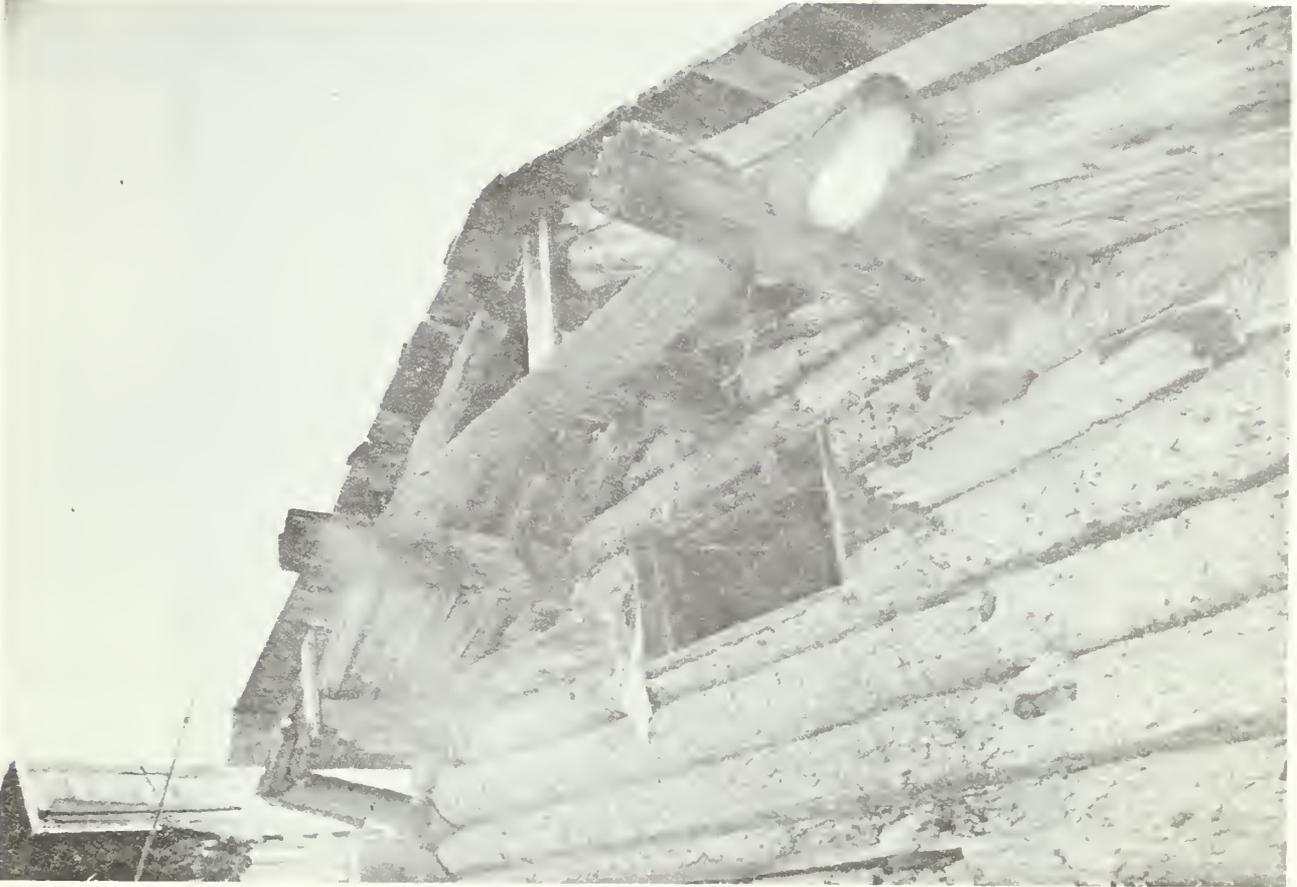
Photograph 36
U.S. Commissioner's Residence, Chisana
Collar log connecting extended purlins
(note 8" overhang of rewer roof).

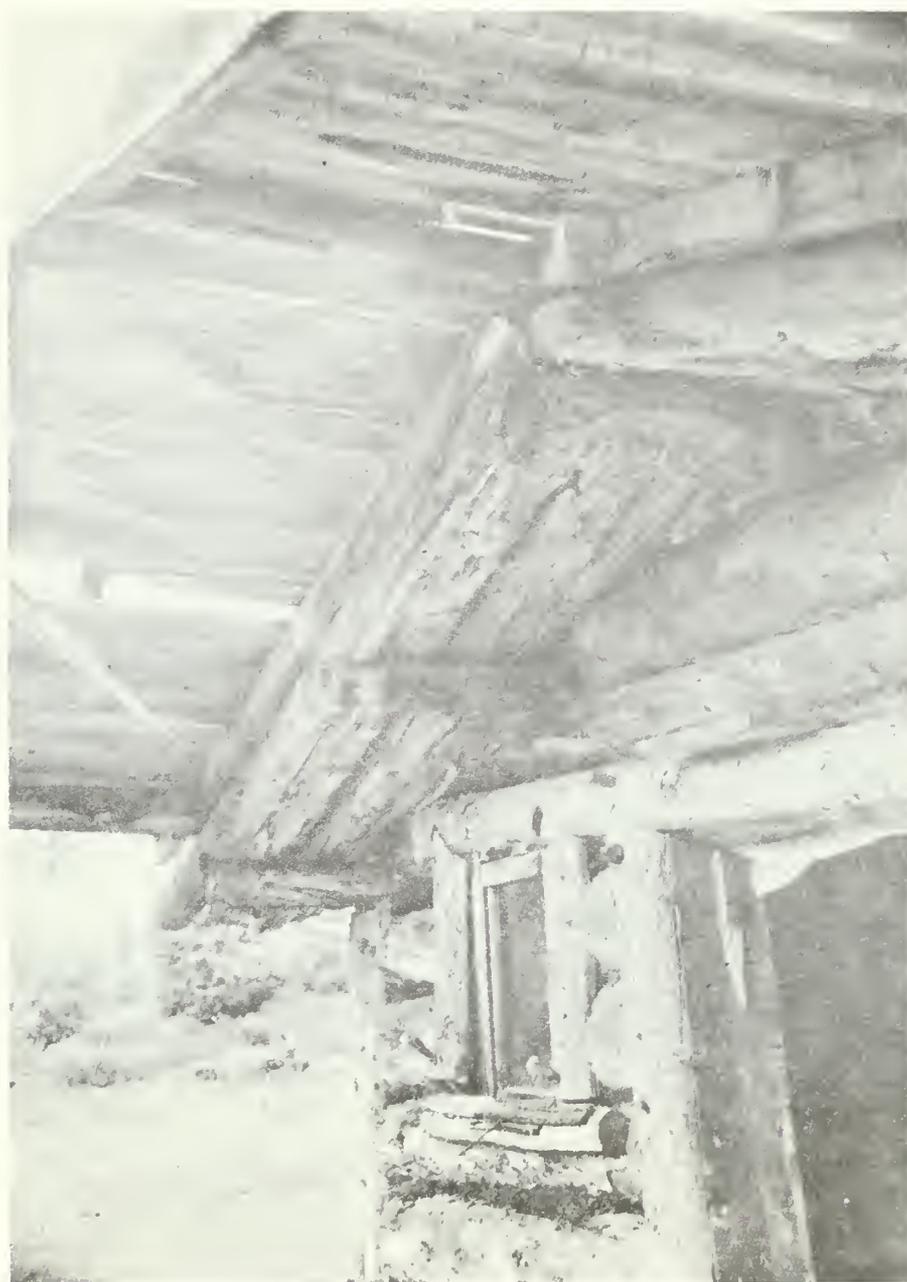
Photograph 37
U.S. Commissioner's Residence, Chisana
Newer roof extension over entry on south
side supported by purlins and ridge board.

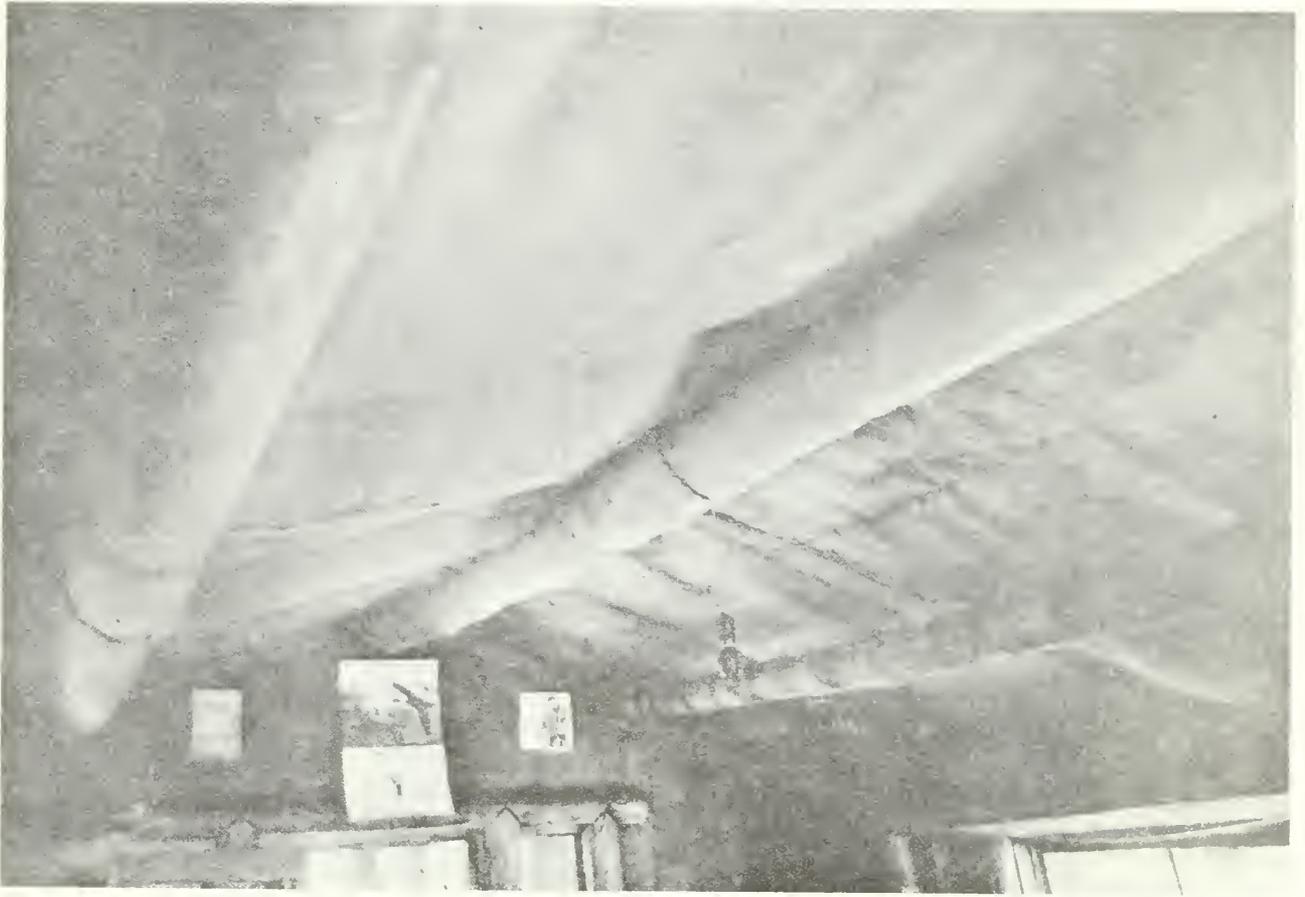
Photograph 38
U.S. Commissioner's Residence, Chisana
Canvas covering ceiling, looped around
purlins and ridge beam.

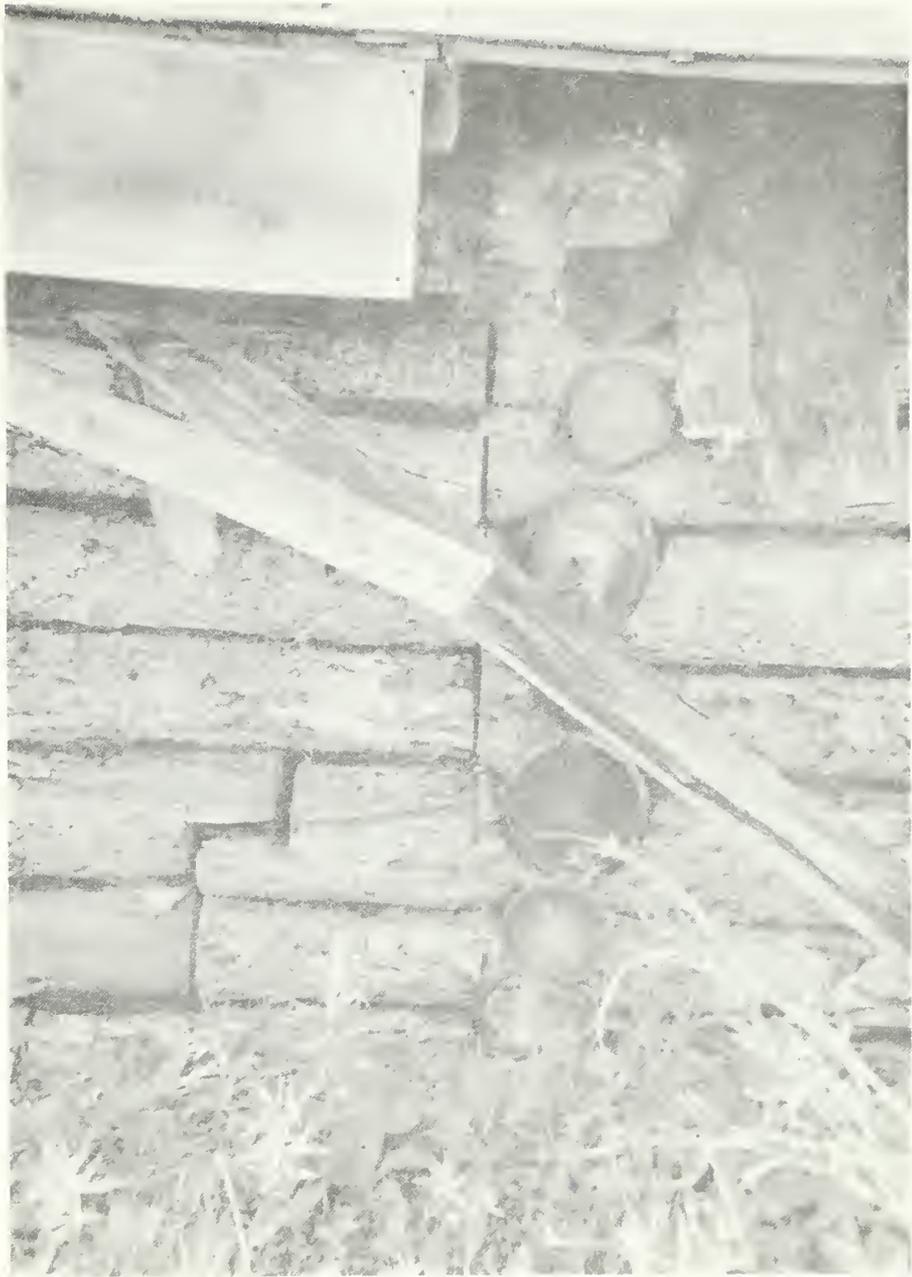
Photograph 40
U.S. Commissioner's residence, Chisana
Junction of main cabin logs (right)
and porch logs.

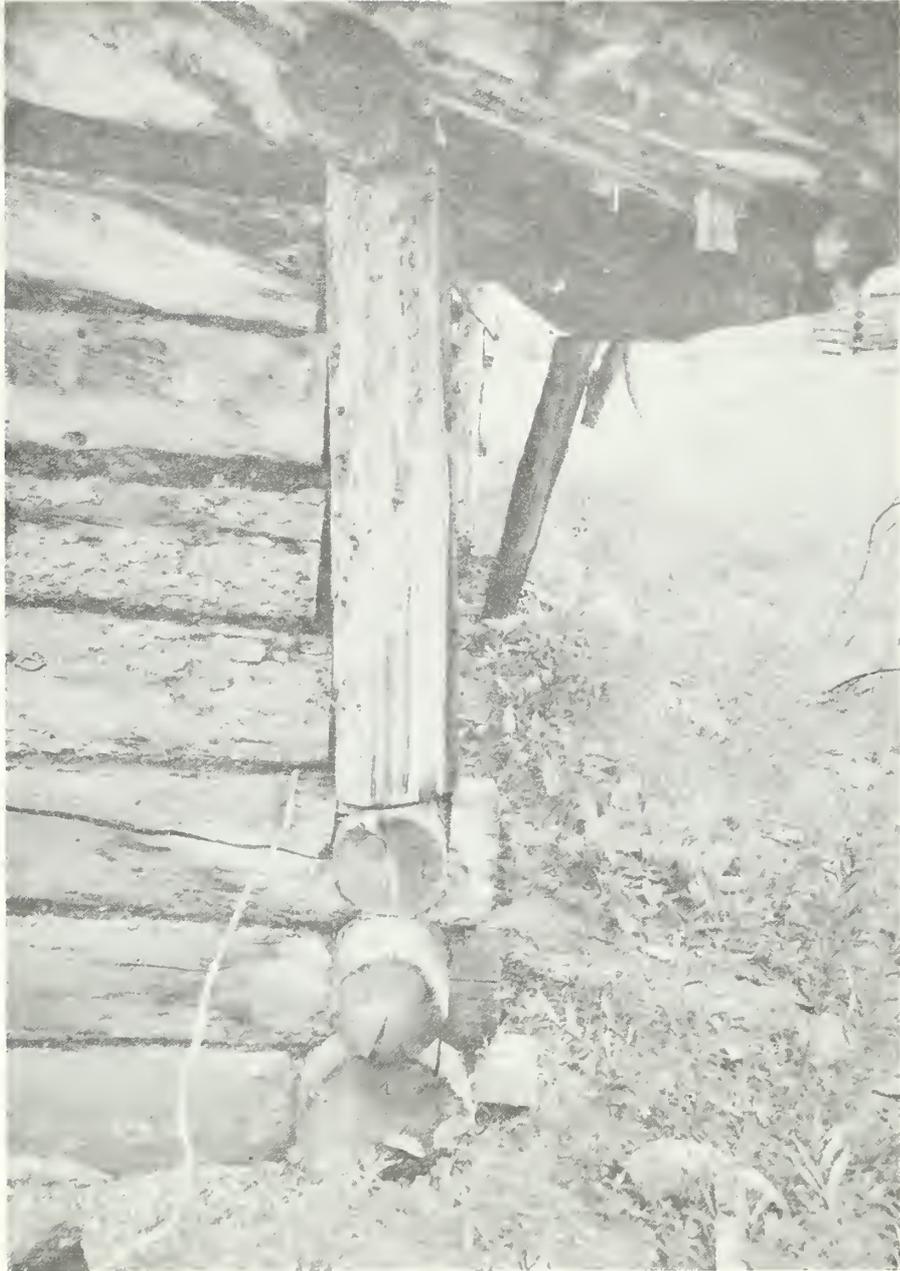
Photograph 41
U.S. Commissioner's Residence, Chisana
Hudson Bay post at southeast corner of porch.

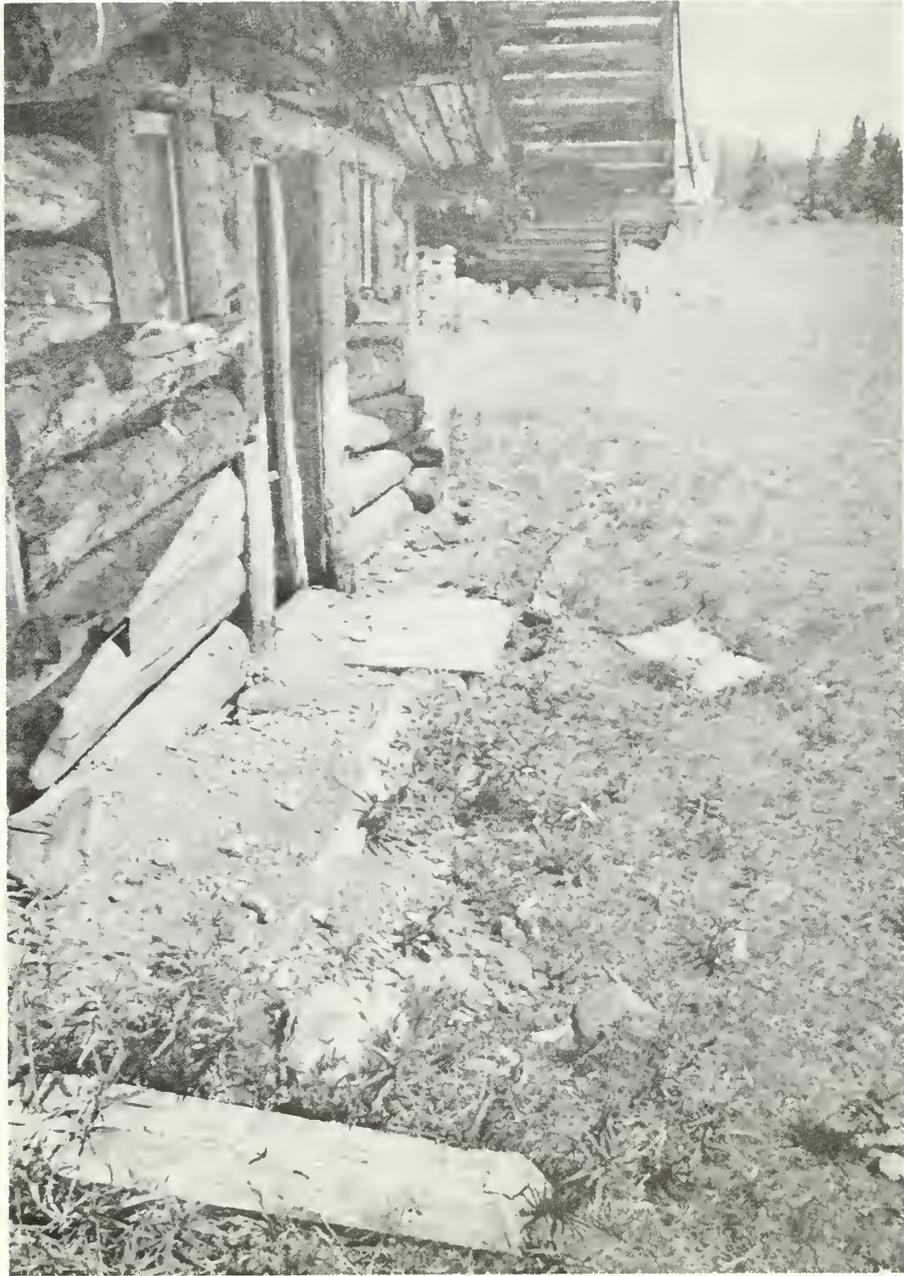
Photograph 44
U.S. Commissioner's Residence, Chisana
South end with frame for gravel berming
around walls.
